# Fire Risk Assessment

Property assessed: B Hodgson Court Nightingale  
Avenue London HA1 3GX

Client: Network Homes Ltd

FRA Inspection Date: 01/09/2020  
FRA Issued to Client: 21/10/2020  
FRA valid to: 21/10/2021  
FRA completed by: Savills (UK) Ltd,  
33 Margaret Street, London W1G 0JD  
T: 020 7409 8737  
E: fireriskhousing@savills.com

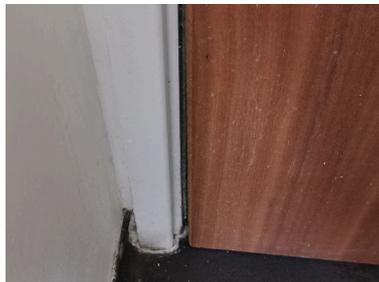
| Details | | Comments/recommendations | Photo |
|---|---|---|---|
| Question | M.5 | <p>Comment: Not all self-closing devices fitted to common area fire doors (where required) are considered adequate. The following doors were not fully closing into the frame at the time of the assessment: 163 and 263 Cluster kitchen doors.</p> <p>Recommendation: The self-closing devices noted should be repaired or an effective self-closing device should be fitted to the doors as noted.</p> | |

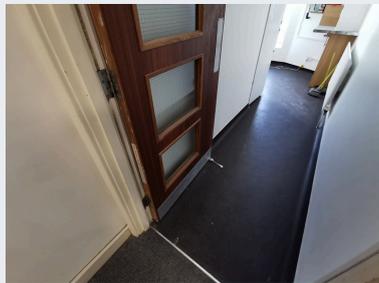
| Details | | Comments/recommendations | Photo |
|---|---|---|---|
| Question | M.7 | <p>Comment: Common area fire doors were noted being wedged open or otherwise obstructed at the time of inspection. Cluster kitchens doors 162/163 were being wedged open at the time of the assessment. The wedges/obstructions were removed by or for the assessor at the time of inspection.</p> <p>Recommendation: Management should inform/remind all staff and/or residents that self-closing fire doors must not be wedged open or otherwise obstructed. A programme of regular checks should be put in place to ensure that the fire doors remain unobstructed.</p> | |

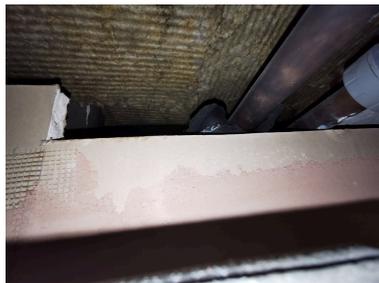
| Details | | Comments/recommendations | Photo |
|---|---|---|---|
| Question | Q.2 | <p>Comment: There were various compartmentation breaches noted throughout the escape route above the suspended ceilings adjacent to the bedroom riser cupboards. As previously recommended - an intrusive inspection should be undertaken throughout the communal areas (above suspended ceilings) and noted breaches fire-stopped to provide 60 minutes of fire-resistance. Breaches were noted above the suspended ceilings within the following locations: Ground-floor, Cable breach above the suspended ceiling within the entrance lobby adjacent to B03 and adjacent to the BTU lounge and kitchen. Above bedroom riser cupboards 007/008 and 011/012. First-floor, above cupboard B12 and B13 within the common area. Above the lobby door 113-116. Above bedrooms riser cupboard's 113-114/117-118/115-116. Cluster lobby 107-112, breaches noted above all bedroom riser cupboard doors.</p> <p>Recommendation: The compartmentation breaches noted within the voids above the false ceilings should be made good with appropriate fire-resisting materials/construction. Period of fire resistance required is 60 minutes.</p> | |

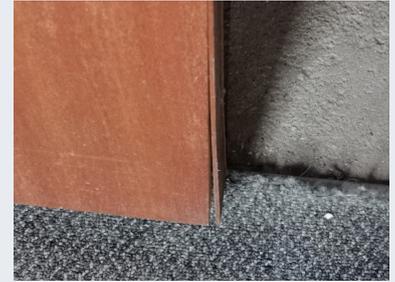
| Question | M.2 | <p>Comment: Excessive gaps were noted to some common area fire doors which will not resist the passage of cold smoke, they are as follows:- (Noted gaps to the sides and tops of the doors are over 3mm and the bottom of the doors over 6mm as specified) Ground-floor:- B04 - leading-edge and top gaps. Stairwell door - leading-edge and top gaps. 024 - Cluster kitchen - leading-edge and top gaps. B03 - Left-hand side door - Internal-edge and top gaps. First-floor:- 113-118 - Landing/lobby door - leading-edge, top and bottom gaps. Link door to Block C - top gap. B12 - middle and top gaps. 163 - Cluster kitchen - leading-edge and top gaps. 107-112 - Landing/ lobby door - leading-edge and top gaps. Link door - bottom and top gaps. 162 - Cluster kitchen - bottom and top gaps. B13 - top and inside-edge gaps. Second-floor:- 213-218 - Landing/lobby door - leading-edge, top, and inside-edge gaps. B22 - middle, top, and inside-edge gaps. 207-212 - Landing/lobby door - leading-edge and top gaps. Link door - top, leading-edge, and bottom gaps. 262 - Cluster kitchen - both sides, top, and bottom gaps. Damage was noted to the following fire doors: Ground-floor: B03 - Delaminated stile to both doors (leading-edge) First-floor: B13 - Delaminated stile. Second-floor: B22 and B23, Damaged/delaminated stiles to doors.</p> | |

| Quantity | | <p>Recommendation: The common area doors noted should be repaired (or if necessary replaced) to reduce the threshold gap to a maximum of 6mm. Alternatively, a threshold seal capable of resisting cold smoke should be fitted.</p> | |

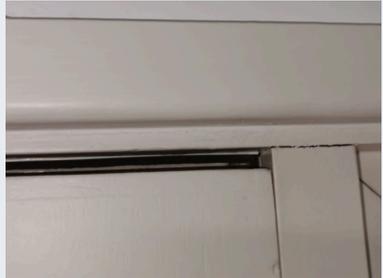
| Question | M.2 | <p>Comment: Excessive gaps were noted to some common area fire doors which will not resist the passage of cold smoke, they are as follows:- (Noted gaps to the sides and tops of the doors are over 3mm and the bottom of the doors over 6mm as specified) Ground-floor:- B04 - leading-edge and top gaps. Stairwell door - leading-edge and top gaps. 024 - Cluster kitchen - leading-edge and top gaps. B03 - Left-hand side door - Internal-edge and top gaps. First-floor:- 113-118 - Landing/lobby door - leading-edge, top and bottom gaps. Link door to Block C - top gap. B12 - middle and top gaps. 163 - Cluster kitchen - leading-edge and top gaps. 107-112 - Landing/ lobby door - leading-edge and top gaps. Link door - bottom and top gaps. 162 - Cluster kitchen - bottom and top gaps. B13 - top and inside-edge gaps. Second-floor:- 213-218 - Landing/lobby door - leading-edge, top, and inside-edge gaps. B22 - middle, top, and inside-edge gaps. 207-212 - Landing/lobby door - leading-edge and top gaps. Link door - top, leading-edge, and bottom gaps. 262 - Cluster kitchen - both sides, top, and bottom gaps. Damage was noted to the following fire doors: Ground-floor: B03 - Delaminated stile to both doors (leading-edge) First-floor: B13 - Delaminated stile. Second-floor: B22 and B23, Damaged/delaminated stiles to doors.</p> | |

| Quantity | | <p>Recommendation: The fire doors noted should be repaired (or if necessary replaced) to reduce the perimeter gap between the door and frame to a maximum of 3mm.</p> | |

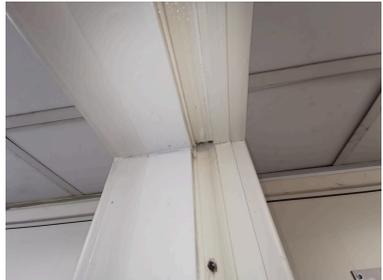
| Question | M.6 | <p>Comment: Missing or damaged smoke seals were noted to the following Doors-The double doors to service/ store cupboards do not have intumescent strips and cold smoke seals to the meeting stiles of the doors, smoke seals missing from the top of the heating cupboard door frame (B03), 1st-floor cross-cluster/block door, 1st floor cluster kitchen door 162, 1st floor service cupboard door B12, top floor cross cluster/block door, top floor cluster kitchen door 263. In addition to the above - missing combined intumescent strips and cold smoke seals were also noted to the link door to block A and block C.</p> | |

| Quantity | | <p>Recommendation: Common area fire doors as noted should be fitted with intumescent strips and smoke seals.</p> | |

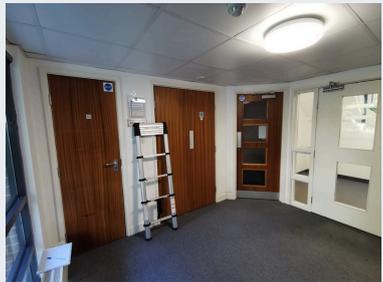
| Question | O.2 | <p>Comment: Fire door signage is not considered adequate. Fire door signage is required for the following doors: B03, B04, B11, B12, B13, B21, B22, and B23 require 'Fire door keep locked' signage - these doors are either provided with the wrong fire door signage or a double door set (each openable fire door should be fitted with fire door signage) The ground floor stairwell door requires a 'Fire door keep closed' sign to both sides of the door at eye level.</p> <p>Recommendation: Provide 'Fire door keep locked' notices to common area fire doors as noted.</p> | |

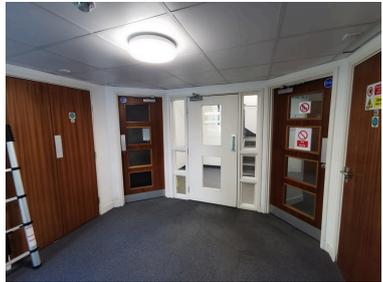
| Question | O.2 | <p>Comment: Fire door signage is not considered adequate. Fire door signage is required for the following doors: B03, B04, B11, B12, B13, B21, B22, and B23 require 'Fire door keep locked' signage - these doors are either provided with the wrong fire door signage or a double door set (each openable fire door should be fitted with fire door signage) The ground floor stairwell door requires a 'Fire door keep closed' sign to both sides of the door at eye level.</p> <p>Recommendation: Provide 'Fire door keep shut' notices to common area fire doors as noted.</p> | |

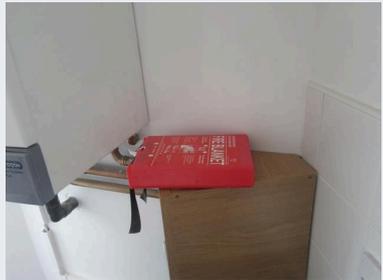
| Question | E.5 | Comment: Network homes current policy is that no fire extinguishing equipment is provided in the communal areas. Information received on site, all fire extinguishing equipment should have been removed. | | |

| Quantity | | Recommendation: In accordance with current Network homes policy recommend all the fire blankets are removed from the shared cluster kitchens. | | |

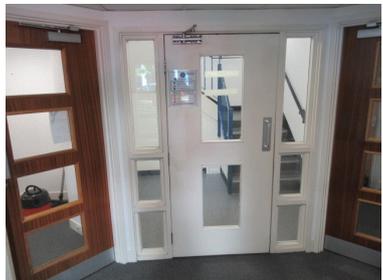
| Question | K.1 | Comment: Previous FRA comment- BS9991 - 9.8.1 recommends; The cluster should be lobbied from any staircases serving the building (i.e. a protected lobby should be formed between the cluster front entrance door and the stair door). There is no lobby separating the stairway and cluster entrance doors on the 1st and 2nd floors off the stairway. Lobby protection is provided to the stairs at ground floor level separating the cluster corridor from the stairway. Bedrooms discharge directly into a protected corridor leading to a protected stairway or stair lobby for ground floor flats. Previous recommendation of a C priority not considered suitable so completed and this recommendation with an R priority used. | | |

| Quantity | | Recommendation: When the buildings are next refurbished the cluster should be lobbied from any staircases serving the building (i.e. a protected lobby should be formed between the cluster front entrance door and the stair door) as recommended by BS 9991 - 9.8.1. | | |

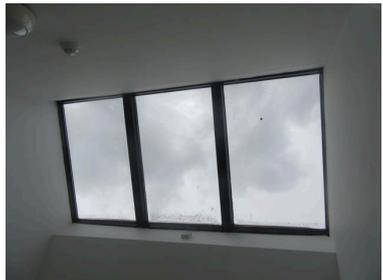
| Question | K.15 | Comment: The stairs and/or lobbies are NOT provided with an adequate automatic or remotely operated smoke ventilation system. Previous comments noted the AOV at the head of the stairs appears to have had its actuation mechanism removed. | | |

| Quantity | | Recommendation: Recommend the missing AOV motor/ actuator is replaced to the AOV at the head of the staircase. | | |

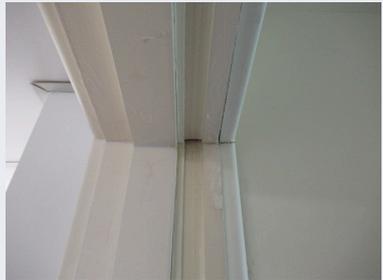
| Question | L.7 | Comment: No intumescent strips and cold smoke seals were fitted to the sampled flat 216 entrance door. No access to other flats. | |

| Quantity | | Recommendation: Intumescent strips and smoke seals should be fitted to the doors as noted. | |

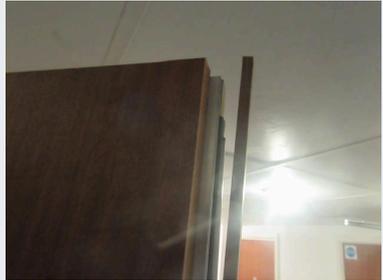
| Question | M.2 | Comment: A 1st-floor heating cupboard door (B13) has a damaged door stile/side strip and a top floor heating cupboard door (B23) has a missing door stile strip. | |

| Quantity | | Recommendation: Minor joinery repairs are required to the door(s)/frame(s) noted - Recommend the noted damaged door stiles to heating cupboard doors B13 and B23 are repaired. | |

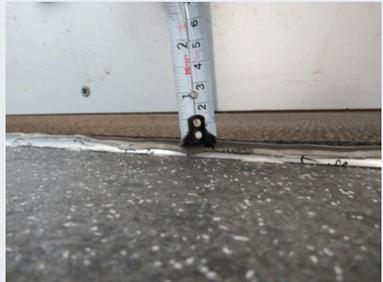
| Question | M.7 | <p>Comment: Other common area fire door issues noted at the time of inspection include - Excessive threshold gap to the 1st-floor stair door to cluster 113-118.</p> | |

| - Known | 1 | Recommendation: The common area doors noted should be repaired (or if necessary replaced) to reduce the threshold gap to a maximum of 6mm. Alternatively, a threshold seal capable of resisting cold smoke should be fitted. | |

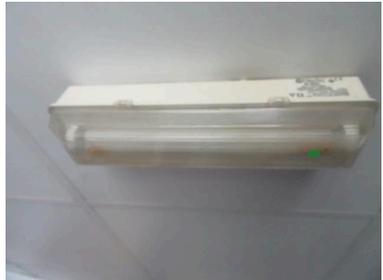
| Question | N.2 | <p>Comment: No LEDs to signify the emergency light fitting is operative in the ground floor entrance area.</p> | |

| - Known | 1 | Recommendation: Recommend the light fitting is checked to confirm its serviceability. | |

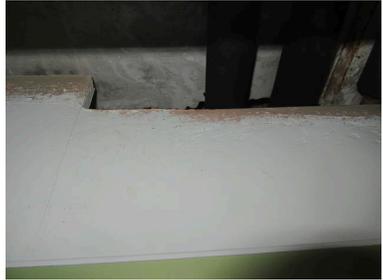
| Question | Q.2 | <p>Comment: Voids were noted above some sampled sections of the false ceilings where services pass between the riser shafts and common parts in the ground, first and second floors.</p> <p>Recommendation: Recommend the noted compartment breaches are sealed with a proprietary fire stopping material affording 60 minutes fire separation.</p> | |

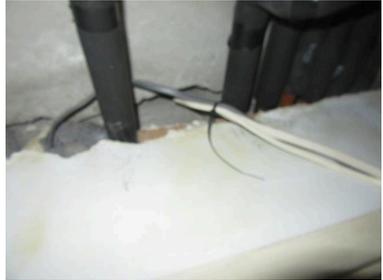
| Question | Q.3 | <p>Comment: The top floor riser cupboards have not been adequately fire separated from the roof void/ space. Post-build compartment breaches noted within sampled riser shafts and ducts where cables/services pass. Compartmentation breaches noted within a ground floor service cupboard BO2, 1st floor riser cupboard and wall of common part, above the top floor cross cluster/block exit door where cables pass.</p> <p>Recommendation: The breaches noted between the riser shafts and common parts should be sealed to provide 60 minutes fire resistance.</p> | |

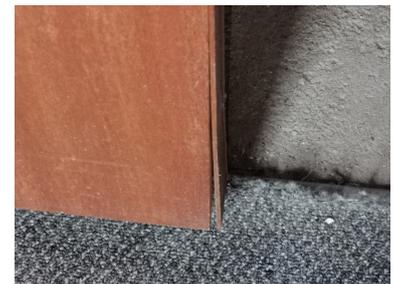
Comment: Excessive gaps were noted to some common area fire doors which will not resist the passage of cold smoke, they are as follows:- (Noted gaps to the sides and tops of the doors are over 3mm and the bottom of the doors over 6mm as specified) Ground-floor:- B04 - leading-edge and top gaps. Stairwell door - leading-edge and top gaps. 024 - Cluster kitchen - leading-edge and top gaps. B03 - Left-hand side door - Internal-edge and top gaps. First-floor:- 113-118 - Landing/lobby door - leading-edge, top and bottom gaps. Link door to Block C - top gap. B12 - middle and top gaps. 163 - Cluster kitchen - leading-edge and top gaps. 107-112 - Landing/lobby door - leading-edge and top gaps. Link door - bottom and top gaps. 162 - Cluster kitchen - bottom and top gaps. B13 - top and inside-edge gaps. Second-floor:- 213-218 - Landing/lobby door - leading-edge, top, and inside-edge gaps. B22 - middle, top, and inside-edge gaps. 207-212 - Landing/lobby door - leading-edge and top gaps. Link door - top, leading-edge, and bottom gaps. 262 - Cluster kitchen - both sides, top, and bottom gaps. Damage was noted to the following fire doors: Ground-floor: B03 - Delaminated stile to both doors (leading-edge) First-floor: B13 - Delaminated stile. Second-floor: B22 and B23, Damaged/delaminated stiles to doors.

Recommendation: Minor joinery repairs are required to the door/frame as noted - B03, B12, B22, B23 - Delaminated stiles.

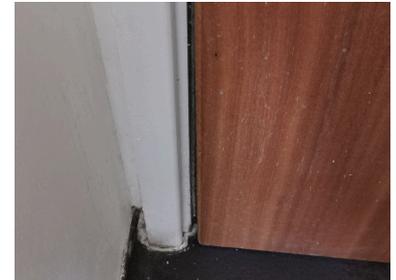
Comment: Not all self-closing devices fitted to common area fire doors (where required) are considered adequate. The following doors were not fully closing into the frame at the time of the assessment: 163 and 263 Cluster kitchen doors.

Recommendation: The self-closing devices noted should be repaired or an effective self-closing device should be fitted to the doors as noted.

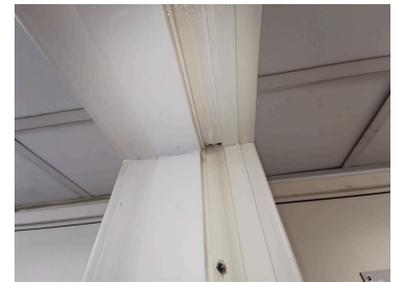
Comment: Missing or damaged smoke seals were noted to the following Doors-The double doors to service/store cupboards do not have intumescent strips and cold smoke seals to the meeting stiles of the doors, smoke seals missing from the top of the heating cupboard door frame (BO3), 1st-floor cross-cluster/block door, 1st floor cluster kitchen door 162, 1st floor service cupboard door B12, top floor cross cluster/block door, top floor cluster kitchen door 263. In addition to the above - missing combined intumescent strips and cold smoke seals were also noted to the link door to block A and block C.

Recommendation: Common area fire doors as noted should be fitted with intumescent strips and smoke seals.

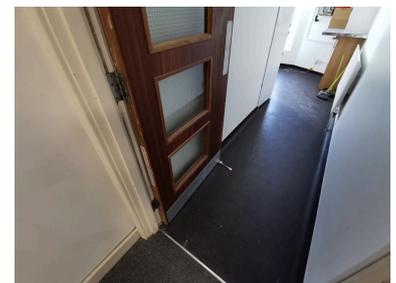
Comment: Common area fire doors were noted being wedged open or otherwise obstructed at the time of inspection. Cluster kitchens doors 162/163 were being wedged open at the time of the assessment. The wedges/obstructions were removed by or for the assessor at the time of inspection.

Recommendation: Management should inform/remind all staff and/or residents that self-closing fire doors must not be wedged open or otherwise obstructed. A programme of regular checks should be put in place to ensure that the fire doors remain unobstructed.

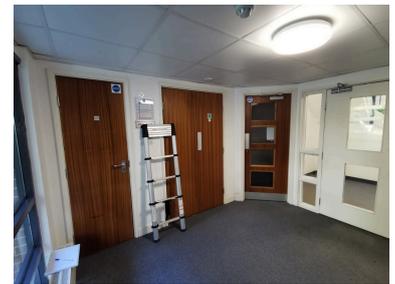
Comment: Fire door signage is not considered adequate. Fire door signage is required for the following doors: B03, B04, B11, B12, B13, B21, B22, and B23 require 'Fire door keep locked' signage - these doors are either provided with the wrong fire door signage or a double door set (each openable fire door should be fitted with fire door signage) The ground floor stairwell door requires a 'Fire door keep closed' sign to both sides of the door at eye level.

Recommendation: Provide 'Fire door keep locked' notices to common area fire doors as noted.

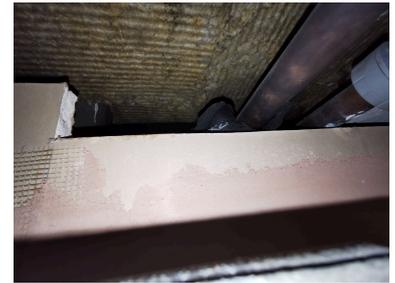
Comment: There were various compartmentation breaches noted throughout the escape route above the suspended ceilings adjacent to the bedroom riser cupboards. As previously recommended - an intrusive inspection should be undertaken throughout the communal areas (above suspended ceilings) and noted breaches fire-stopped to provide 60 minutes of fire-resistance. Breaches were noted above the suspended ceilings within the following locations: Ground-floor, Cable breach above the suspended ceiling within the entrance lobby adjacent to B03 and adjacent to the BTU lounge and kitchen. Above bedroom riser cupboards 007/008 and 011/012. First-floor, above cupboard B12 and B13 within the common area. Above the lobby door 113-116. Above bedrooms riser cupboard's 113-114/ 117-118/ 115-116. Cluster lobby 107-112, breaches noted above all bedroom riser cupboard doors.

Recommendation: The compartmentation breaches noted within the voids above the false ceilings should be made good with appropriate fire-resisting materials/construction. Period of fire resistance required is 60 minutes.

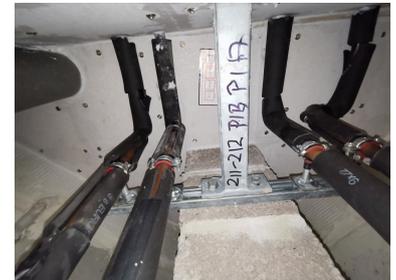
Comment: Previous recommendation - Firestopping around services exiting the risers/cupboards sampled would not appear to be adequate (Not all soil pipes which enter the roof void have been provided with an Intumescent collar) - they are as follows: Bedroom riser cupboards 211-212 and 209.

Recommendation: A 60 minutes fire rated collar should be fitted around the non fire rated service pipe or duct up to 200mm diameter as noted.
