# Fire Risk Assessment

Property assessed: A Lister Court Nightingale Avenue  
London HA1 3GX

Client: Network Homes Ltd

FRA Inspection Date: 04/09/2020  
FRA Issued to Client: 21/10/2020  
FRA valid to: 21/10/2021  
FRA completed by: Savills (UK) Ltd,  
33 Margaret Street, London W1G 0JD  
T: 020 7409 8737  
E: [fireriskhousing@savills.com](mailto:fireriskhousing@savills.com)

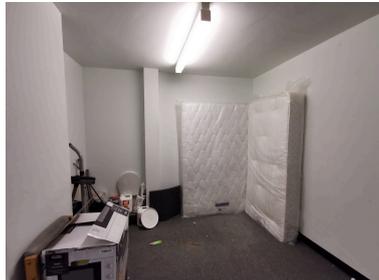
Details		Comments/recommendations	Photo
Question	G.6	Comment: Previous comment - A number of storerooms were identified as having excessive amounts of storage/ fire loading within.

Section	House-Keeping		
Action ID	544422		
Quantity		Recommendation: Recommend all storage cupboards are opened and all/any unwanted or excessive fire loading is removed.

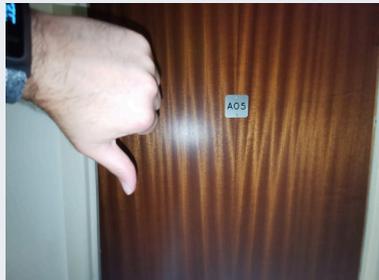
- Known	N/A		
- Potential	N/A		
Priority	Man1	Due Date: 21/11/2020	Client Status: Approved
Question	Q.3	Comment: The bedroom service riser cupboards on the ground, first and second-floors appear to have no internal lining provided within the cupboards and above the door. Network Homes confirmed previous recommendation is complete; to check all risers are suitably fire stopped - (All bedroom riser cupboards have been fire-stopped to the floor) The top floor bedroom riser cupboards have been fire stopped to the ceiling and above the door (Internally) to an adequate standard. Additional compartmentation breaches were noted within the following cupboards at the time of the assessment, they are as follows: Ground-floor: A03 - damage to boxing. Second-floor: A26 - to high-level wall and ceiling around pipe-egress. A05, A15, and the externally accessed bike store should be accessed and inspected for adequate fire-stopping to the walls and ceiling.

Section	Limiting Fire Spread		
Action ID	544421		
Quantity		Recommendation: Management should check within services risers/shafts/ducts/cupboards as noted to confirm that they are appropriately enclosed with fire resisting construction and adequately fire-stopped.

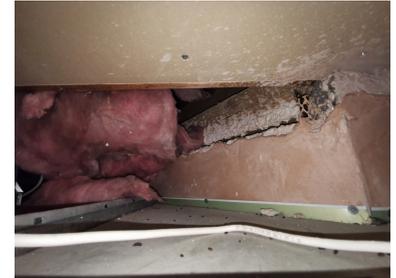
Question	Q.2	<p>Comment: Compartmentation would not appear to be adequate:- There were various compartmentation breaches noted throughout the escape route above the suspended ceilings adjacent to the bedroom riser cupboards. As previously recommended - an intrusive inspection should be undertaken throughout the communal areas (above suspended ceilings) and noted breaches fire-stopped to provide 60 minutes of fire-resistance. Breaches were noted in the following sampled areas: Ground-floor:- 002-006 - Above the suspended ceiling adjacent to the cluster door. 002-006 Cluster lobby - Above the suspended ceiling adjacent to the bedroom riser cupboards. 007-012 Cluster lobby - Above the suspended ceiling adjacent to the bedroom riser cupboards. First-floor:- 101-106 Cluster lobby - Above the suspended ceiling adjacent to the bedroom riser cupboards and cluster lobby door. A15 breach to wall noted above the suspended ceiling. Third-floor:- 301-306 Cluster lobby - Breach above stairwell door and 039. 307-312 Cluster lobby - breach noted above stairwell/ landing door. Lack of compartmentation above the suspended ceiling throughout the third-floor.</p>

Quantity		<p>Recommendation: The compartmentation breaches noted within the voids above the false ceilings should be made good with appropriate fire-resisting materials/ construction. The period of fire resistance required is 60 minutes.</p>
- Known	22	
- Potential	22

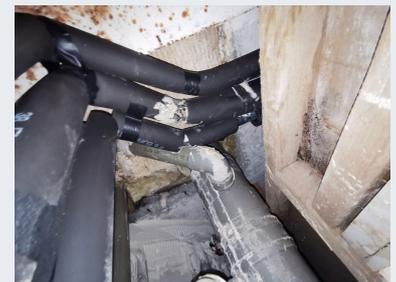
Question	Q.3	<p>Comment: The bedroom service riser cupboards on the ground, first and second-floors appear to have no internal lining provided within the cupboards and above the door. Network Homes confirmed previous recommendation is complete; to check all risers are suitably fire stopped - (All bedroom riser cupboards have been fire-stopped to the floor) The top floor bedroom riser cupboards have been fire stopped to the ceiling and above the door (Internally) to an adequate standard. Additional compartmentation breaches were noted within the following cupboards at the time of the assessment, they are as follows: Ground-floor: A03 - damage to boxing. Second-floor: A26 - to high-level wall and ceiling around pipe-egress. A05, A15, and the externally accessed bike store should be accessed and inspected for adequate fire-stopping to the walls and ceiling.</p>
Section	Limiting Fire Spread	
Action ID	544416

Quantity		<p>Recommendation: The plasterboard panels and sections above/either side of the bedroom riser doors (Internally) where pipework and cables run to be fire stopped using fire-resisting materials to ensure 60 minutes of fire resistance between the cupboard and communal areas. Any fire-stopping works to be undertaken by a competent passive fire engineer.</p>
- Known	19	
- Potential	19

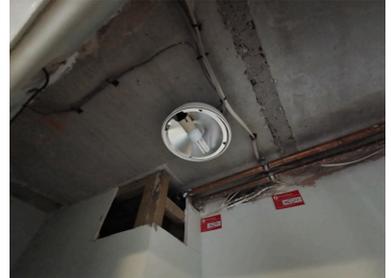
Question	Q.3	<p>Comment: The bedroom service riser cupboards on the ground, first and second-floors appear to have no internal lining provided within the cupboards and above the door. Network Homes confirmed previous recommendation is complete; to check all risers are suitably fire stopped - (All bedroom riser cupboards have been fire-stopped to the floor) The top floor bedroom riser cupboards have been fire stopped to the ceiling and above the door (Internally) to an adequate standard. Additional compartmentation breaches were noted within the following cupboards at the time of the assessment, they are as follows: Ground-floor: A03 - damage to boxing. Second-floor: A26 - to high-level wall and ceiling around pipe-egress. A05, A15, and the externally accessed bike store should be accessed and inspected for adequate fire-stopping to the walls and ceiling.</p>
Section	Limiting Fire Spread	
Action ID	544417

Quantity	Recommendation: The casings noted should be upgraded/replaced to provide 30 minutes fire resistance.	
- Known	1	
- Potential	1	
Priority	B	Due Date: 21/10/2021 Client Status: Assigned

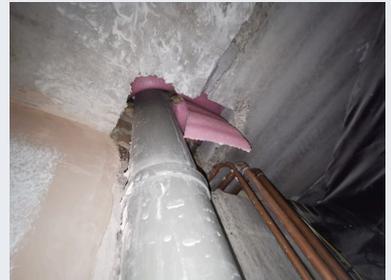
Question	Q.3	<p>Comment: The bedroom service riser cupboards on the ground, first and second-floors appear to have no internal lining provided within the cupboards and above the door. Network Homes confirmed previous recommendation is complete; to check all risers are suitably fire stopped - (All bedroom riser cupboards have been fire-stopped to the floor) The top floor bedroom riser cupboards have been fire stopped to the ceiling and above the door (Internally) to an adequate standard. Additional compartmentation breaches were noted within the following cupboards at the time of the assessment, they are as follows: Ground-floor: A03 - damage to boxing. Second-floor: A26 - to high-level wall and ceiling around pipe-egress. A05, A15, and the externally accessed bike store should be accessed and inspected for adequate fire-stopping to the walls and ceiling.</p>
Section	Limiting Fire Spread	
Action ID	544418

Quantity	Recommendation: The holes noted should be sealed with a suitable fire-stopping material such as an intumescent paste. The period of fire resistance required is 60 minutes.	
- Known	1	
- Potential	1	
Priority	B	Due Date: 21/10/2021 Client Status: Assigned

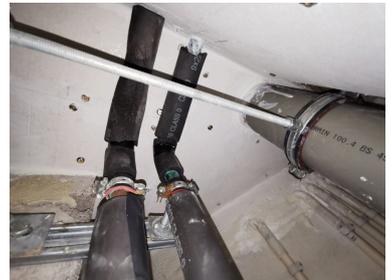
Question	Q.4	<p>Comment: There was evidence that fire-stopping works have been undertaken within the bedroom riser cupboards on the top floor. However, not all soil-pipes which enter the roof void have been provided with Intumescent collars. They are as follows: 304, 307-308.</p>
Section	Limiting Fire Spread	
Action ID	544419

Quantity	Recommendation: A 60 minutes fire rated collar should be fitted around the non fire rated service pipe or duct up to 200mm diameter as noted.	
- Known	2	
- Potential	2	
Priority	B	Due Date: 21/10/2021 Client Status: Assigned

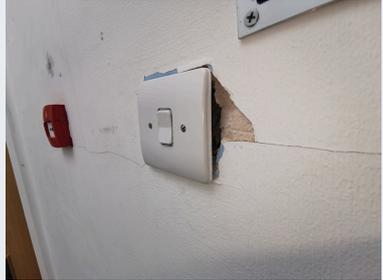
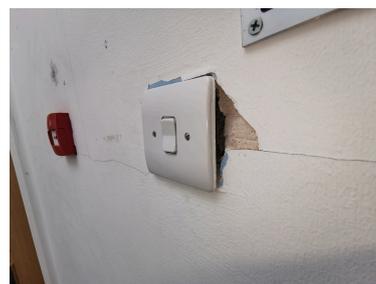
Question	A.3	<p>Comment: The following defects were noted in the common area fixed electrical installation (from cursory visual inspection only). Electrical junction boxes and isolation switches noted with the bedroom service/riser cupboards containing fixed plumbing and water supplies. It was noted a number of these risers were affected by water leaks that could interact with the electrics to cause a fire situation. Although the action generated from the previous FRA has been marked as 'approved', the issue remains 'unresolved' from observations onsite. The AOV switch on the third-floor landing was loose and exposed due to there being damage to the wall around the switch.</p>

Comment: The following defects were noted in the common area fixed electrical installation (from cursory visual inspection only). Electrical junction boxes and isolation switches noted with the bedroom service/riser cupboards containing fixed plumbing and water supplies. It was noted a number of these risers were affected by water leaks that could interact with the electrics to cause a fire situation. Although the action generated from the previous FRA has been marked as 'approved', the issue remains 'unresolved' from observations onsite. The AOV switch on the third-floor landing was loose and exposed due to there being damage to the wall around the switch.

Section	Electrical Ignition Sources		
Action ID	544420		
Quantity		<p>Recommendation: The switch noted was not operational and should be repaired or replaced. The wall adjacent should also be made-good. Any electrical works to be undertaken by a competent electrical contractor.</p>

Recommendation: The switch noted was not operational and should be repaired or replaced. The wall adjacent should also be made-good. Any electrical works to be undertaken by a competent electrical contractor.

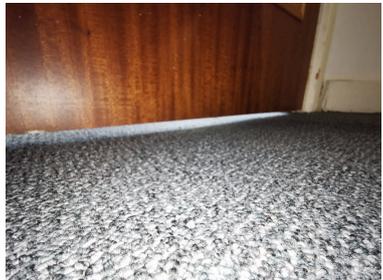
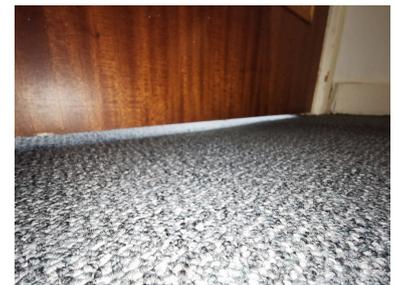
- Known	1		
- Potential	1		
Priority	C	Due Date: 21/04/2022	Client Status: Assigned
Question	M.2	<p>Comment: Previous comment - The top floor heating equipment cupboard door has been forced causing damage and large gaps between the door styles. Service cupboard A26 has excessive gaps. Excessive gaps to the bottom of cluster doors 101-106, 107-112 &amp; 201-206. The door style lip to the ground floor cupboard door AO4 and the 2nd-floor heating equipment cupboard door A23 has become detached from the door. The frame to service cupboard door A30 is damaged. In addition to the above recommendation, gaps were noted to the following doors between the door and frames, they are as follows:            Ground-floor: A03 - Leading-edge and bottom gaps. 002-006 - Cluster lobby door - top and bottom gaps. 007-012 - Cluster lobby door - top gap. 041 - Cluster kitchen - top and bottom gaps. Stairwell door - leading-edge and top gaps. First-floor: 101-106 - Cluster lobby door - top and leading-edge gaps. A13 - middle gaps. 140 - Cluster kitchen door - top and leading-edge gaps. First-floor link door - bottom gap. 340 - Cluster kitchen door - inside-edge and leading-edge gaps. Second-floor: 201-206 - Cluster lobby door - Leading-edge and top gaps. 207-212 - Cluster lobby door - top and leading-edge gaps. Third-floor: 301-306 - Cluster lobby door - Leading-edge gaps. 341 - Cluster kitchen door - Leading-edge gap. Link door to alternative exit - top gap. Link door - top gap.</p>

Section	Common Area Fire Doors		
Action ID	544413		
Quantity		<p>Recommendation: The common area doors noted should be repaired (or if necessary replaced) to reduce the threshold gap to a maximum of 6mm. Alternatively, a threshold seal capable of resisting cold smoke should be fitted.</p>

Recommendation: The common area doors noted should be repaired (or if necessary replaced) to reduce the threshold gap to a maximum of 6mm. Alternatively, a threshold seal capable of resisting cold smoke should be fitted.

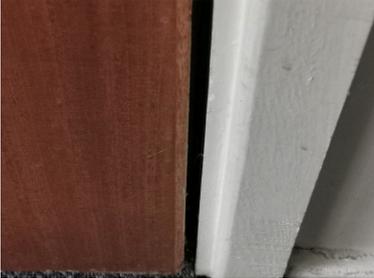
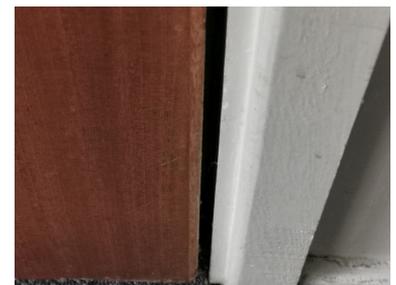
Question	M.2	<p>Comment: Previous comment - The top floor heating equipment cupboard door has been forced causing damage and large gaps between the door styles. Service cupboard A26 has excessive gaps. Excessive gaps to the bottom of cluster doors 101-106, 107-112 &amp; 201-206. The door style lip to the ground floor cupboard door AO4 and the 2nd-floor heating equipment cupboard door A23 has become detached from the door. The frame to service cupboard door A30 is damaged. In addition to the above recommendation, gaps were noted to the following doors between the door and frames, they are as follows:            Ground-floor: A03 - Leading-edge and bottom gaps. 002-006 - Cluster lobby door - top and bottom gaps. 007-012 - Cluster lobby door - top gap. 041 - Cluster kitchen - top and bottom gaps. Stairwell door - leading-edge and top gaps. First-floor: 101-106 - Cluster lobby door - top and leading-edge gaps. A13 - middle gaps. 140 - Cluster kitchen door - top and leading-edge gaps. First-floor link door - bottom gap. 340 - Cluster kitchen door - inside-edge and leading-edge gaps. Second-floor: 201-206 - Cluster lobby door - Leading-edge and top gaps. 207-212 - Cluster lobby door - top and leading-edge gaps. Third-floor: 301-306 - Cluster lobby door - Leading-edge gaps. 341 - Cluster kitchen door - Leading-edge gap. Link door to alternative exit - top gap. Link door - top gap.</p>

Section	Common Area Fire Doors		
Action ID	544414		
Quantity		<p>Recommendation: The fire doors noted should be repaired (or if necessary replaced) to reduce the perimeter gap between the door and frame to a maximum of 3mm.</p>

Recommendation: The fire doors noted should be repaired (or if necessary replaced) to reduce the perimeter gap between the door and frame to a maximum of 3mm.

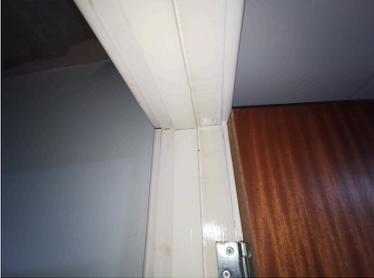
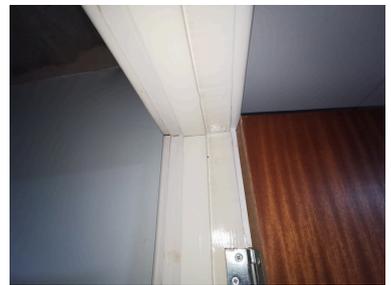
- Known	15		
- Potential	15		
Priority	C	Due Date: 21/04/2022	Client Status: Assigned
Question	M.6	<p>Comment: Previous comment - The double doors to service/store cupboards appear not to have intumescent strips and cold smoke seals to the meeting stiles of the doors. The 1st, 2nd &amp; 3rd-floor cupboard doors A11, A12, A21 and A22 have smoke seals missing. The 2nd floor lift lobby door frame has smoke seals missing. Network Homes confirmed previous recommendation is complete; to check all communal fire doors on a regular basis. In addition to the above comment - missing or damaged intumescent strips were noted to the following doors:            Ground-floor: 040 - Cluster kitchen - Paint damaged intumescent strips and cold smoke seals. First-floor: A13, Link door to alternative exit. Second-floor: A26, 240 - Cluster kitchen. Third-floor: A33.</p>

Quantity		<p>Recommendation: Common area fire doors as noted should be fitted with intumescent strips and smoke seals.</p>	
- Known	5		
- Potential	5		
Priority	C	Due Date: 21/04/2022	Client Status: Assigned

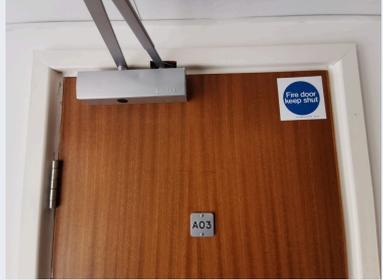
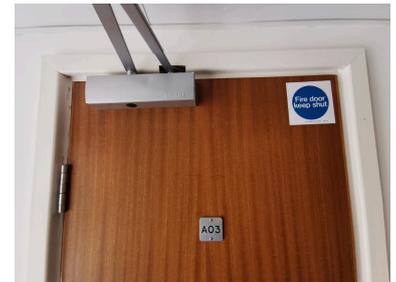
Question	O.2	<p>Comment: Fire door signage is not considered adequate:- The following fire doors are provided with the wrong signage: A03, A02, A05, A14. - The fire door signage in situ should be replaced with 'Fire door keep locked' signage. The following fire door require 'Fire door keep locked' signage: A04, 041, A13, A11/A12, A22, A33, A32. (Both openable doors within the double door cupboards will require adequate fire door signage) The following fire doors require 'Fire door keep shut' signage to both sides of the doors at eye level: 002-006 lobby door, Ground-floor - stairwell door.</p>

Section	Fire Safety Signs and Notices		
Action ID	544410		
Quantity		<p>Recommendation: Provide 'Fire door keep locked' notices to common area fire doors as noted.</p>

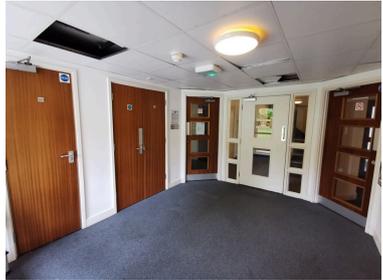
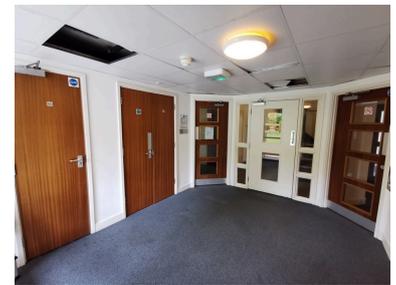
- Known	12		
- Potential	12		
Priority	C	Due Date: 21/04/2022	Client Status: Assigned
Question	O.2	<p>Comment: Fire door signage is not considered adequate:- The following fire doors are provided with the wrong signage: A03, A02, A05, A14. - The fire door signage in situ should be replaced with 'Fire door keep locked' signage. The following fire door require 'Fire door keep locked' signage: A04, 041, A13, A11/A12, A22, A33, A32. (Both openable doors within the double door cupboards will require adequate fire door signage) The following fire doors require 'Fire door keep shut' signage to both sides of the doors at eye level: 002-006 lobby door, Ground-floor - stairwell door.</p>

Section	Fire Safety Signs and Notices		
Action ID	544411		
Quantity		<p>Recommendation: Provide 'Fire door keep shut' notices to common area fire doors as noted.</p>

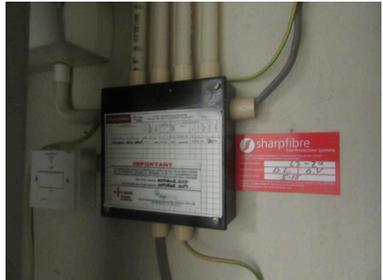
Details		Comments/recommendations	Photo
Question	A.3	<p>Comment: The following defects were noted in the common area fixed electrical installation (from cursory visual inspection only). Electrical junction boxes and isolation switches noted with the bedroom service/riser cupboards containing fixed plumbing and water supplies. It was noted a number of cupboards/risers were affected by water leaks that had affected the fixed electrical supplies.</p>

Section	Electrical Ignition Sources		
Action ID	130782		
Quantity		<p>Recommendation: Recommend management seek the professional advice from a suitably qualified electrician to determine the fire risk from the exposed electrical apparatus. No information available to confirm the recommendation has been carried out.</p>	
- Known	N/A		
- Potential	1		
Priority	Man2	Due Date: 31/03/2020	Client Status: Approved
		Review Status: Unresolved

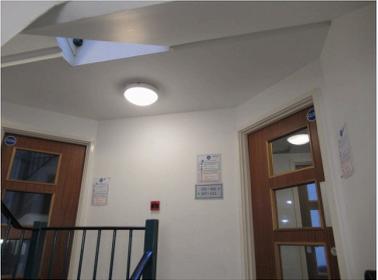
Question	K.1	<p>Comment: Previous FRA comment. BS9991 - 9.8.1 recommends; The cluster should be lobbied from any staircases serving the building (i.e. a protected lobby should be formed between the cluster front entrance door and the stair door). There is no lobby separating the stairway and cluster entrance doors on the 1st, 2nd and 3rd floors off the stairway from entrance A. Lobby protection is provided to the stairs at ground floor level separating the cluster corridor from the stairway. Lobby protection is provided to the alternative rear corner stairway on all levels separating the cluster corridor from the stairway. Bedrooms discharge directly into a protected corridor leading to a protected stairway or stair lobby for ground floor flats. There is one cluster per level with a single direction of travel of 9m from the furthest bedrooms to the lobby. Other cluster bedrooms have a choice of direction to the protected stairway or to the shared interlinked lift lobby of block B. Stairways discharge at ground floor level to the outside and away from the building. Previous recommendation of a C priority not considered suitable so completed and this recommendation with an R priority used.</p>

Section	Means of Escape			
Action ID	303941			
Quantity		<p>Recommendation: When the buildings are next refurbished the cluster should be lobbied from any staircases serving the building (i.e. a protected lobby should be formed between the cluster front entrance door and the stair door) as recommended by BS 9991 - 9.8.1.</p>

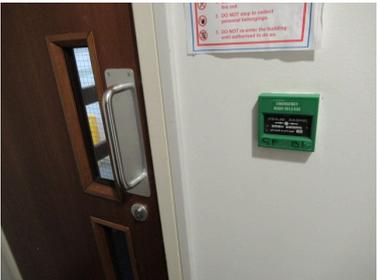
- Known	3			
- Potential	3			
Priority	R	Due Date: N/A	Client Status: Assigned	
		Review Status: Unresolved		
Question	K.7	<p>Comment: Green break glasses have been actuated in a number of instances and/or doors separating clusters have been forced open causing the doors/frames to become faulty/damaged and in some cases resulting in the doors not being a good fit into the frame.</p>

Section	Means of Escape			
Action ID	303950			
Quantity		<p>Recommendation: Management should undertake a programme to regularly check the doors separating cluster accommodations to ensure/confirm the doors are in a satisfactory condition and the door/lock are effective.</p>

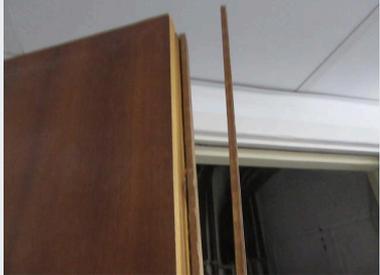
- Potential	N/A		
Priority	A	Due Date: 30/12/2020	Client Status: Assigned
		Review Status: Unresolved	
Question	M.2	<p>Comment: The top floor heating equipment cupboard door has been forced causing damage and large gaps between the door styles. Excessive gap between the top floor staircase door to cluster 307-312 and the 2nd floor lift lobby door. The door style lip to the ground floor cupboard door AO14 and the 2nd floor heating equipment cupboard door has become detached from the door.</p>

- Known	1	<p>Recommendation: Minor joinery repairs are required to the door(s)/frame(s) noted - The door style lip to the ground floor cupboard door AO14 and the 2nd floor heating cupboard door has become detached from the door.</p>

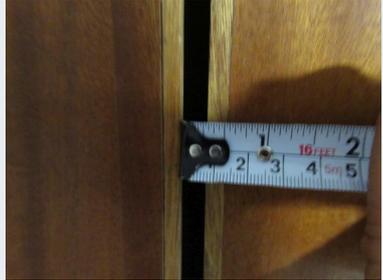
Question	M.2	<p>Comment: The top floor heating equipment cupboard door has been forced causing damage and large gaps between the door styles. Service cupboard A26 has excessive gaps. Excessive gaps to the bottom of cluster doors 101-106, 107-112 &amp; 201-206.. The door style lip to the ground floor cupboard door AO4 and the 2nd-floor heating equipment cupboard door A23 has become detached from the door. The frame to service cupboard door A30 is damaged.</p> <p>Recommendation: The fire doors noted (A33 &amp; A26) should be repaired (or if necessary replaced) to reduce the perimeter gap between the door and frame to a maximum of 3mm.</p>

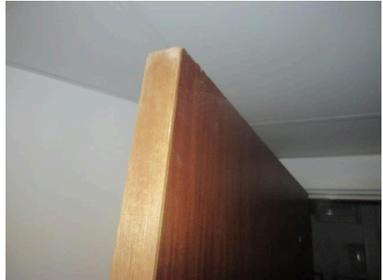
- Known	1		
- Potential	1		
Priority	C	Due Date: 30/03/2022	Client Status: Assigned
		Review Status: Unresolved	
Question	M.6	<p>Comment: The double doors to service/store cupboards appear not to have intumescent strips and cold smoke seals to the meeting stiles of the doors. The 1st and 2nd floor cupboard doors A11, A12, A21 and A22 have smoke seals missing. The 2nd floor lift lobby door frame has smoke seals missing.</p> <p>Recommendation: Common area fire doors as noted should be fitted with intumescent strips and smoke seals.</p>

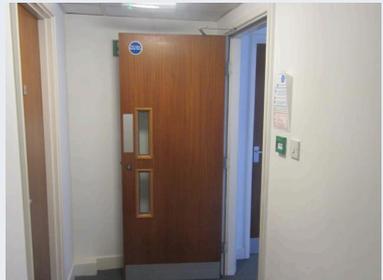
- Known	5		
- Potential	N/A		
Priority	C	Due Date: 30/03/2022	Client Status: Assigned
		Review Status: Unresolved	
Question	M.7	<p>Comment: The 2nd floor staircase/lift lobby door is wedged on the carpet and not effectively self closing.</p> <p>Recommendation: Recommend the door is eased to allow effective self closing of the door into its frame.</p>

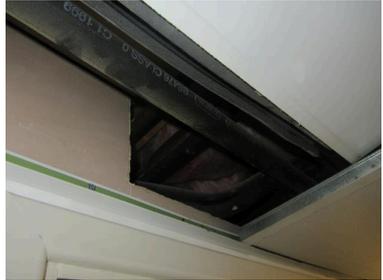
- Potential	1		
Priority	B	Due Date: 30/09/2021	Client Status: Assigned
		Review Status: Unresolved	
Question	Q.2	<p>Comment: As per previous FRA comments a number of service penetrations between riser cupboards and the common parts were identified above the false ceilings across all floors.</p>

- Known	N/A	<p>Recommendation: Management should undertake an intrusive inspection of the hidden voids noted to confirm/ ensure that compartmentation within is adequate.</p>
