# Fire Risk Assessment

Property assessed: Kodak Court C Nightingale Avenue  
London HA1 3GN

Client: Network Homes Ltd

Document Print Date: 21/04/2021

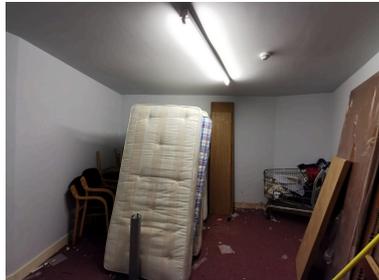
Details		Comments/recommendations	Photo
Question	G.2	<p>Comment: Combustible items were noted close to an ignition source. There were stored combustible materials including broken chairs and mattresses kept within the electrical intake cupboard (C06) There were plastic bags noted within bedroom riser cupboards within (018-024) within 123 and 225 bedroom riser cupboards. This issue should be dealt with as soon as possible.</p> <p>Recommendation: All combustible items should be removed from the electrical intake cupboard as soon as possible and the door kept locked.</p>

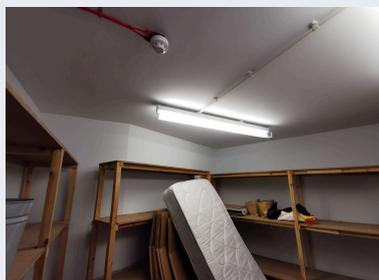
- Known	N/A		
- Potential	N/A		
Priority	Man1		
Question	G.6	<p>Comment: Some accessed storerooms had considered high fire loading due to apparent discarded combustibles - (C16)</p> <p>Recommendation: Recommend that all store cupboards are accessed and discarded/unwanted items disposed to reduce the current considered high fire load.</p>

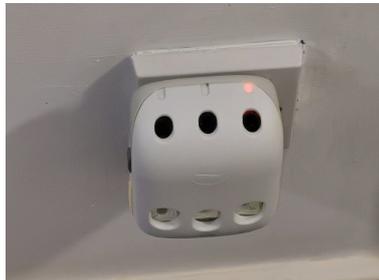
- Known	1		
- Potential	1		
Priority	Man1		
Question	J.1	<p>Comment: Other fire hazard issues noted at the time of inspection include - There was a plug-in air freshener noted within the cluster lobby 025-028. This should be removed.</p> <p>Recommendation: Management should ensure that the air freshener is removed from the cluster communal lobby area. Personal electrical items should not be located within the communal areas at any time.</p>

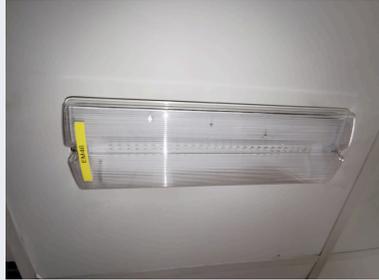
- Known	1		
- Potential	1		
Priority	Man1		
Question	N.2	<p>Comment: Some of the emergency lighting units did not appear to have a visible charging indicator - Second-floor (EML46)</p> <p>Recommendation: The emergency lighting system should be checked by the maintenance engineer to confirm that it is serviceable.</p>

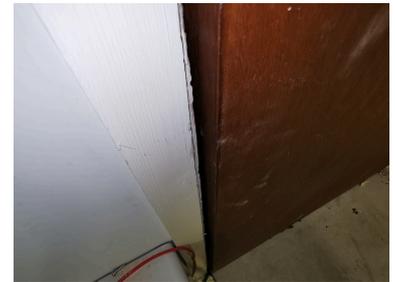
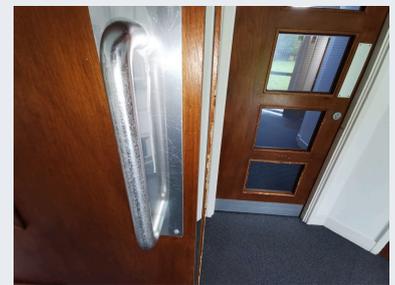
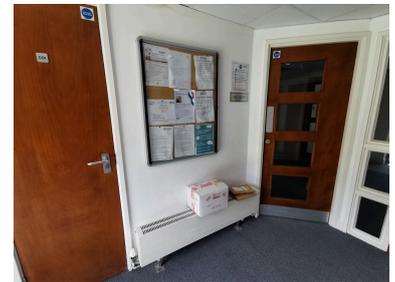
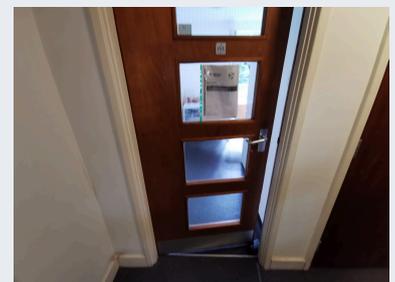
Question	M.5	<p>Comment: The cluster kitchen doors on the first floor (153), the 2nd floor (253) and the 3rd floor (354) are an ill fit in their frames and not effectively self-closing. See M2. In addition to the above doors noted in M2 - The electrical intake cupboard C06 and ground-floor stairwell doors are not fully closing into the frames. Management has confirmed that there is an ongoing programme of routine inspection being undertaken to all doors fitted within self-closing devices.</p>	
Section	Common Area Fire Doors		
Action ID	544383		
Quantity		<p>Recommendation: The self-closing device should be repaired or an effective self-closing device should be fitted to the doors as noted.</p>

- Known	2		
- Potential	2		
Priority	A	Due Date: 21/01/2021	Client Status: Assigned
Question	M.7	<p>Comment: Other common area fire door issues noted at the time of inspection include - There was damage noted to the ground-floor stairwell door to the stile which was delaminated. The first-floor link door stile is damaged. The lobby door leading to 125-129 - damage to the stile. C07 and C08 - damage to stiles. Third-floor, C21 - holes to the face of the door.</p>	
Section	Common Area Fire Doors		
Action ID	544385		
Quantity		<p>Recommendation: Minor joinery repairs are required to the door/frame as noted - Damage to the fire door stiles and hole to the door as noted to be repaired by a competent fire door contractor.</p>

- Known	6		
- Potential	6		
Priority	A	Due Date: 21/01/2021	Client Status: Assigned
Question	G.3	<p>Comment: Discarded and uncollected mail and junk mail noted on top of the communal post-box and boxes noted on the common radiator within the entrance lobby.</p>	
Section	House-Keeping		
Action ID	544391		
Quantity		<p>Recommendation: Management should contact residents to advise that the common area/escape routes should be kept free from all combustibles and/or trip hazards. A programme of regular checks should be put in place to ensure that the common area is kept clear.</p>

- Known	N/A		
- Potential	N/A		
Priority	Man2	Due Date: 21/01/2021	Client Status: Approved
Question	M.8	<p>Comment: Common area fire doors were noted being wedged open or otherwise obstructed at the time of inspection. Cluster kitchen 153. The wedges/obstructions were removed by or for the assessor at the time of inspection.</p>	
Section	Common Area Fire Doors		
Action ID	544392		
Quantity		<p>Recommendation: Management should inform/remind all staff and/or residents that self-closing fire doors must not be wedged open or otherwise obstructed. A programme of regular checks should be put in place to ensure that the fire doors remain unobstructed.</p>

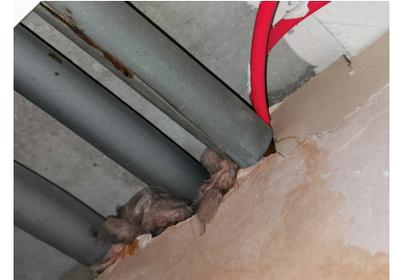
Question	Q.2	<p>Comment: There were various compartmentation breaches noted throughout the escape route above the suspended ceilings adjacent to the bedroom riser cupboards. As previously recommended - an intrusive inspection should be undertaken throughout the communal areas (above suspended ceilings) and noted breaches fire-stopped to provide 60 minutes of fire-resistance. Breaches were noted above the suspended ceiling adjacent to the bedroom service riser cupboards on the ground floor within the lobby 018-024 and above 027's bedroom riser cupboard. First-floor: 119-124 - above bedroom riser cupboard 123. Second-floor: 219-224 - Above middle bedroom riser cupboards.</p>
Section	Limiting Fire Spread	
Action ID	544388	
Quantity		<p>Recommendation: The compartmentation breaches noted within the voids above the false ceilings should be made good with appropriate fire-resisting materials/ construction. Period of fire resistance required is 60 minutes.</p>

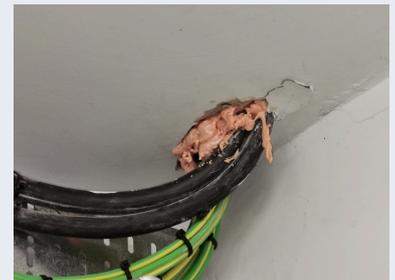
Question	Q.3	<p>Comment: The bedroom service riser cupboards on the ground, first and second-floors appear to have no internal lining provided within the cupboards and above the door. Network Homes confirmed previous recommendation is complete; to check all risers are suitably fire stopped - (All bedroom riser cupboards have been fire-stopped to the floor) The top floor bedroom riser cupboards have been fire stopped to the ceiling and above the door (Internally) to an adequate standard. There were also breaches noted within the electrical intake cupboard C06 and C11 - store cupboard.</p>	
Section	Limiting Fire Spread		
Action ID	544389		
Quantity		<p>Recommendation: The holes noted should be sealed with a suitable fire-stopping material such as an intumescent paste. Period of fire resistance required is 60 minutes.</p>

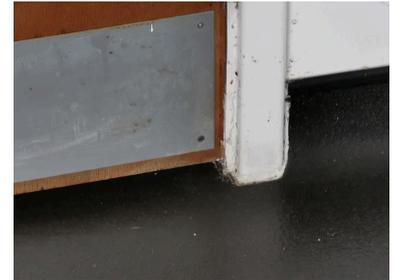
Question	M.2	<p>Comment: Previous comment - The cluster kitchen doors on the first floor (153), the 2nd floor (253) and the 3rd floor (354) are an ill fit in their frames and not effectively self-closing. There were also excessive gaps noted to the following common fire doors which will not stop the spread of smoke in the event of a fire. Gaps noted are over 3mm to the sides and tops and over 6mm to the bottom where specified, they are as follows: Ground-floor: 018-024 lobby door - top gap. 054 cluster kitchen - top gap. 025-028 - top and leading-edge gaps. C04 - leading-edge gap. Link door to block D - top and leading-edge gaps. 053 cluster kitchen - top gap. First-floor: 119-124 lobby door - top gap. Link door - leading-edge gap. 154 cluster kitchen - top and leading-edge gaps. 125-129 - top and leading-edge gaps. Link door to block D - leading-edge, inside edge, and top gaps. 153 cluster kitchen - bottom gap. Second-floor: 219-224 - lobby door - top gap. Link door - leading-edge and top gaps. C13 - middle gap. 254 - cluster kitchen - leading-edge and top gaps. 253 - cluster kitchen - bottom gap. C12 - top gap. Third-floor: 319-324 - Leading edge and top gaps. Link door - top and leading-edge gaps. C18 - top gap. 354 - Leading-edge and top gaps. C20 - Leading-edge gaps.</p>

Section	Common Area Fire Doors		
Action ID	544381		
Quantity		<p>Recommendation: The common area doors noted should be repaired (or if necessary replaced) to reduce the threshold gap to a maximum of 6mm. Alternatively, a threshold seal capable of resisting cold smoke should be fitted.</p>

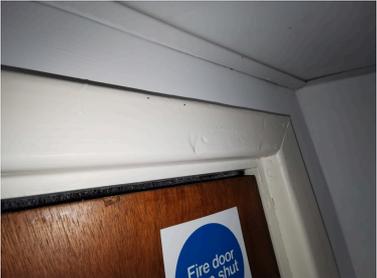
Question	M.2	<p>Comment: Previous comment - The cluster kitchen doors on the first floor (153), the 2nd floor (253) and the 3rd floor (354) are an ill fit in their frames and not effectively self-closing. There were also excessive gaps noted to the following common fire doors which will not stop the spread of smoke in the event of a fire. Gaps noted are over 3mm to the sides and tops and over 6mm to the bottom where specified, they are as follows: Ground-floor: 018-024 lobby door - top gap. 054 cluster kitchen - top gap. 025-028 - top and leading-edge gaps. C04 - leading-edge gap. Link door to block D - top and leading-edge gaps. 053 cluster kitchen - top gap. First-floor: 119-124 lobby door - top gap. Link door - leading-edge gap. 154 cluster kitchen - top and leading-edge gaps. 125-129 - top and leading-edge gaps. Link door to block D - leading-edge, inside edge, and top gaps. 153 cluster kitchen - bottom gap. Second-floor: 219-224 - lobby door - top gap. Link door - leading-edge and top gaps. C13 - middle gap. 254 - cluster kitchen - leading-edge and top gaps. 253 - cluster kitchen - bottom gap. C12 - top gap. Third-floor: 319-324 - Leading edge and top gaps. Link door - top and leading-edge gaps. C18 - top gap. 354 - Leading-edge and top gaps. C20 - Leading-edge gaps.</p>

Section	Common Area Fire Doors		
Action ID	544382		
Quantity		<p>Recommendation: The fire doors noted should be repaired (or if necessary replaced) to reduce the perimeter gap between the door and frame to a maximum of 3mm.</p>

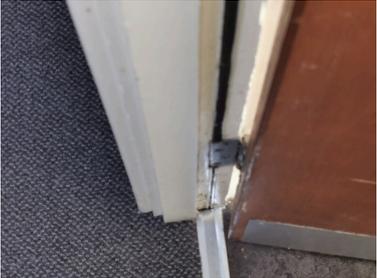
- Known	15		
- Potential	15		
Priority	C	Due Date: 21/04/2022	Client Status: Assigned
Question	M.6	<p>Comment: The double doors to service/store cupboards appear not to have intumescent strips and cold smoke seals to the meeting stiles of the doors. Smoke seals missing from the 1st floor riser cupboard (CO7) and 2nd floor riser cupboard (C13), a section of smoke seal was noted as missing from the 3rd floor riser cupboard door (C18) In addition to the above fire doors, 053 and 353 cluster kitchen doors</p>

Section	Common Area Fire Doors		
Action ID	544384		
Quantity		<p>Recommendation: Common area fire doors as noted should be fitted with intumescent strips and smoke seals.</p>

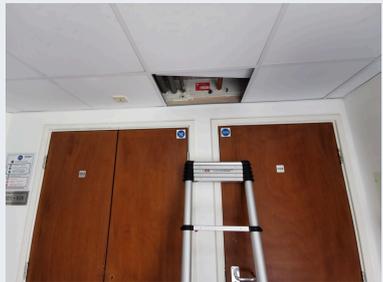
Question	O.2	<p>Comment: Previous comment - Fire door signage missing from the face of a ground floor riser/plant cupboard door (CO6) In addition to the above comment - the following doors were noted to have no fire door signage / incorrect fire door signage. C01, C02, C04, C10, C15, C20 - The fire door signage in situ should be replaced with 'Fire door keep locked' signage. C03, C06, C08, C07, C13, C12, C18, C17 - No fire door signage provided. 'Fire door keep locked' signage required.</p>

Section	Fire Safety Signs and Notices		
Action ID	544387		
Quantity		<p>Recommendation: Provide 'Fire door keep locked' notices to common area fire doors as noted - (each openable fire door requires fire door signage)</p>	
- Known	14		
- Potential	14		
Priority	C	Due Date: 21/04/2022	Client Status: Assigned

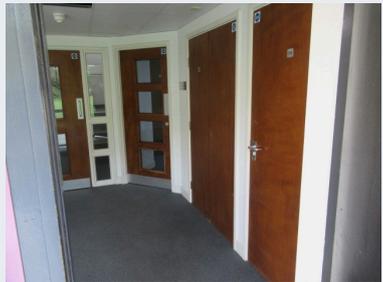
- Known	N/A		
- Potential	1		
Priority	Man2	Due Date: 31/03/2020	Client Status: Approved
		Review Status: Unresolved	
Question	B.4	<p>Comment: No signage was seen in the common area to advise that smoking is prohibited as required by the Smoke-free (Premises and Enforcement) Regulations 2006.</p>

Section	Smoking Policies		
Action ID	304089		
Quantity		<p>Recommendation: 'No Smoking' signage should be provided in the common area.</p>

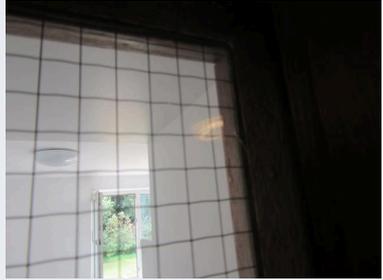
Question	M.2	Comment: The cluster kitchen doors on the first floor (153), the 2nd floor (253) and the 3rd floor (354) are an ill fit in their frames and not effectively self closing.

Section	Common Area Fire Doors		
Action ID	130668		
Quantity		Recommendation: The noted cluster kitchen doors should be repaired/adjusted to provide a close fit in their frames and achieve effective self closing.

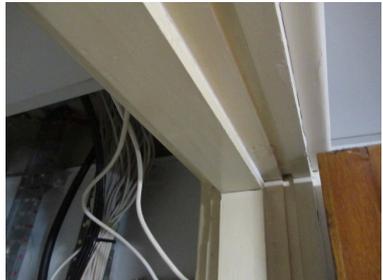
- Known	3		
- Potential	N/A		
Priority	A	Due Date: 30/12/2020	Client Status: Assigned
		Review Status: Unresolved	
Question	M.6	Comment: The double doors to service/store cupboards appear not to have intumescent strips and cold smoke seals to the meeting stiles of the doors. Smoke seals missing from the 1st floor riser cupboard (CO7) and 2nd floor riser cupboard (C13), a section of smoke seal was noted as missing from the 3rd floor riser cupboard door (C18)

Section	Common Area Fire Doors		
Action ID	304096		
Quantity		Recommendation: Common area fire doors as noted should be fitted with intumescent strips and smoke seals.

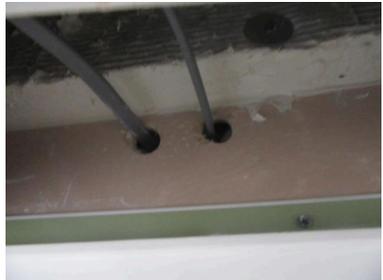
- Known	1		
- Potential	1		
Priority	B	Due Date: 30/09/2021	Client Status: Assigned
		Review Status: Unresolved	
Question	Q.2	Comment: Small breaches in compartmentation noted above the false ceiling where cables/services enter bedsits near 025-028 and above the riser cupboard door into the false ceiling area next to room 221.

Section	Limiting Fire Spread		
Action ID	130677		
Quantity		Recommendation: Recommend the noted breaches are sealed with a suitable fire stopping material to achieve a minimum of 30 minutes fire resistance.

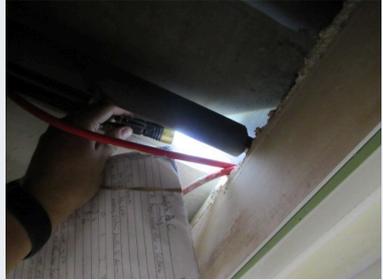
Question	Q.3	<p>Comment: As noted in previous FRA, the top floor bedroom service riser cupboards have not been adequately separated from the roof void at ceiling level with fire-rated material. All the bedroom service riser cupboards appear not to be fire-stopped between the top of the cupboard and the communal corridor where services pass through. The same cupboards also appear to have no internal lining provided to the cupboards, above the door. Previous recommendation to check dropped ceilings and other voids confirmed as complete but issues still noted throughout.</p>

Section	Limiting Fire Spread			
Action ID	304101			
Quantity		<p>Recommendation: The bedroom service riser cupboards as noted should be fire-stopped at ceiling level between the cupboards and the roof void. The bedroom service riser cupboards should be fire-stopped above the inside of the doors where services pass between the common corridor and the cupboard. Also to these cupboards, a fire rated lining should be provided to the inside of the cupboards above the door to achieve a minimum of 60 mins fire separation.</p>

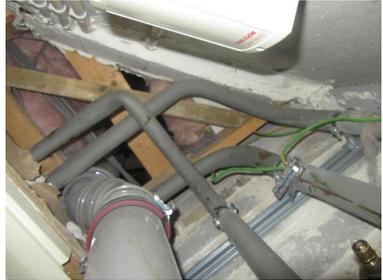
- Known	44			
- Potential	44			
Priority	B	<p>Due Date: 30/09/2021</p> <p>Client Status: Assigned</p> <p>Review Status: Unresolved</p>		
Question	Q.4	<p>Comment: In conjunction with Q3, intumescent collars should be fitted to plastic soil pipes as they enter the roof space at the head of each top floor riser cupboard.</p>

Section	Limiting Fire Spread			
Action ID	131477			
Quantity		<p>Recommendation: A 60 minutes fire rated collar should be fitted around the non fire rated service pipe or duct up to 200mm diameter as noted.</p>

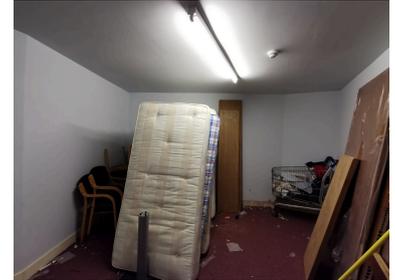
Comment: Combustible items were noted close to an ignition source. There were stored combustible materials including broken chairs and mattresses kept within the electrical intake cupboard (C06) There were plastic bags noted within bedroom riser cupboards within (018-024) within 123 and 225 bedroom riser cupboards. This issue should be dealt with as soon as possible.

Recommendation: All combustible items should be removed from the electrical intake cupboard as soon as possible and the door kept locked.

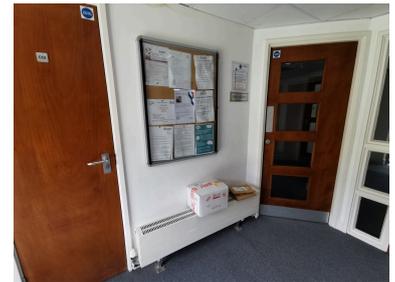
Comment: Discarded and uncollected mail and junk mail noted on top of the communal post-box and boxes noted on the common radiator within the entrance lobby.

Recommendation: Management should contact residents to advise that the common area/escape routes should be kept free from all combustibles and/or trip hazards. A programme of regular checks should be put in place to ensure that the common area is kept clear.

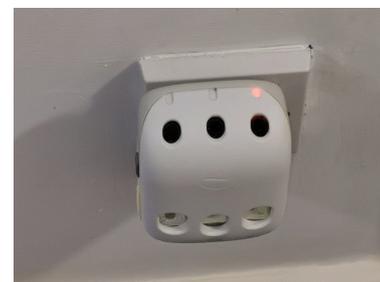
Comment: Other fire hazard issues noted at the time of inspection include - There was a plug-in air freshener noted within the cluster lobby 025-028. This should be removed.

Recommendation: Management should ensure that the air freshener is removed from the cluster communal lobby area. Personal electrical items should not be located within the communal areas at any time.
