Fire Risk Assessment

Property assessed: B Lister Court Nightingale Avenue
London HA1 3GX

Client: Network Homes Ltd

FRA Inspection Date: 04/09/2020
FRA Issued to Client: 21/10/2020
FRA valid to: 21/10/2021
FRA completed by: Savills (UK) Ltd,
33 Margaret Street, London W1G 0JD
T: 020 7409 8737
E: fireriskhousing@savills.com

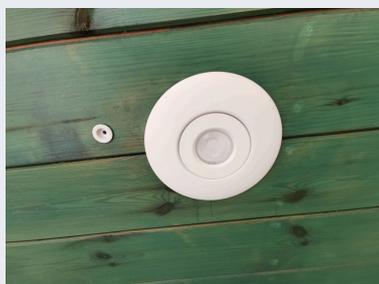
- Known	N/A		
- Potential	N/A		
Priority	Man1	Due Date: 21/11/2020	Client Status: Approved
Question	N.2	<p>Comment: Some of the emergency lighting units did not appear to have a visible charging indicator, they are as follows: External emergency light adjacent to the front entry door. EML 18 - Cluster lobby 119-124.</p>

Section	Emergency Lighting		
Action ID	544315		
Quantity		<p>Recommendation: The emergency lighting system should be checked by the maintenance engineer to confirm that it is serviceable.</p>

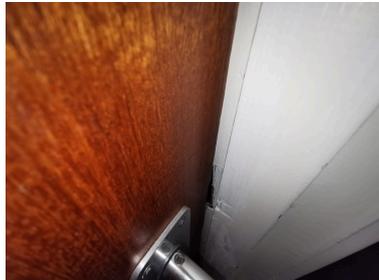
- Known	N/A		
- Potential	N/A		
Priority	Man1	Due Date: 21/11/2020	Client Status: Approved
Question	M.5	<p>Comment: Previous comment - Not all self-closing devices fitted to common area fire doors (where required) are considered adequate. The ground floor alternative stair door was not fully closing into the frame with the aid of the self-closing device. In addition to the above comment - the following fire doors were not fully self-closing: 142 - Cluster kitchen. First-floor link door. 242 - Cluster kitchen. Second-floor lift lobby door.</p>

Section	Common Area Fire Doors		
Action ID	544326		
Quantity		<p>Recommendation: The self-closing device should be repaired or an effective self-closing device should be fitted to the doors as noted.</p>

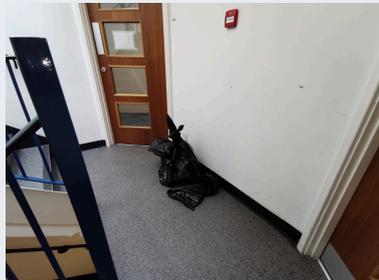
- Known	4		
- Potential	4		
Priority	A	Due Date: 21/01/2021	Client Status: Assigned
Question	G.3	<p>Comment: There were combustible items or waste materials in the escape routes. There were rubbish bags noted on the second-floor landing and a fabric suitcase and shopping trolley adjacent to bedroom 222. As the quantity involved is relatively minor this can be dealt with via written contact with the residents.</p>

Section	House-Keeping		
Action ID	544313		
Quantity		<p>Recommendation: Management should contact residents to advise that the common area/escape routes should be kept free from all combustibles and/or trip hazards. A programme of regular checks should be put in place to ensure that the common area is kept clear.</p>

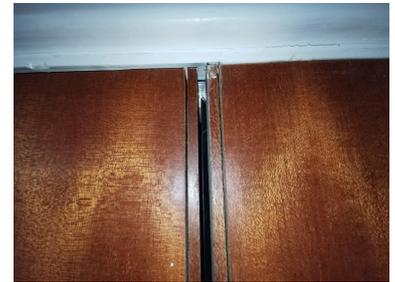
Question	M.2	<p>Comment: Previous comment - The following doors were noted as defective and in need of repair/adjustment: The 2nd-floor lift lobby door is catching on the floor covering and not effectively self-closing into its frame. The second-floor cross-cluster circulation door is an ill fit in its frame and not effectively self-closing into its frame. The side stile lip is coming away from the door to the 2nd-floor heating cupboard door (C23), the frame to the 3rd floor stair door to the alternative stair was damaged. In addition to the above. The following common fire doors were noted to have excessive gaps between the door and frame which will not stop the spread of smoke in the event of fire. They are as follows: (Excessive gaps 3mm and over to the sides/top - 6mm to the bottom of the door) Ground-floor: C04 - middle gaps. 013 - 018 Cluster lobby door - top and leading-edge gaps. 043 - Cluster kitchen door - leading-edge and top gaps. 019 - 023 Cluster lobby door - top gap. C05 - leading-edge gap. 042 - Cluster kitchen door - top, leading-edge and bottom gaps. First-floor: 113 - 118 Cluster lobby door - leading-edge and top gaps. Link door - top gap. 143 - Cluster kitchen door - leading-edge and top gaps. 119 - 124 Cluster lobby door - leading-edge and to gaps. C13 - Middle gap. Alternative exit/escape stairs door - leading-edge. B11 - top gap. Second-floor: 213 - 218 Cluster lobby door - top gap. 219 - 224 Cluster lobby door - top gap. C24/C23 - middle gap. Alternative exit/escape stairs door - leading-edge. Third-floor: 319 - 324 Cluster lobby door - bottom and leading-edge. A34 - leading-edge. 342 - Cluster kitchen - leading-edge. C33 - middle and top gaps. Link door - bottom, inside-edge and top gaps. 313 - 318 Cluster lobby door - bottom and leading-edge. C32/ C31 - middle gap. 343 - Cluster kitchen door - leading-edge gap. Damage was noted to the following doors: C13 - Door stiles delaminating. C33 - Door stiles / middle, delamination.</p>

Section	Common Area Fire Doors		
Action ID	544323		
Quantity		Recommendation: Minor joinery repairs are required to the door/frame as noted - C13/C33.	
- Known	4

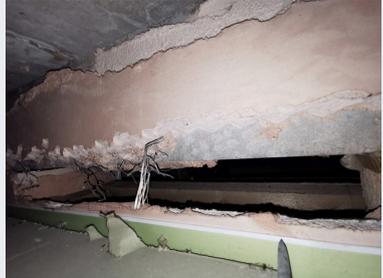
Question	Q.2	<p>Comment: Compartmentation would not appear to be adequate. There were various compartmentation breaches noted throughout the escape route above the suspended ceilings adjacent to the bedroom riser cupboards. As previously recommended - an intrusive inspection should be undertaken throughout the communal areas (above suspended ceilings) and noted breaches fire-stopped to provide 60 minutes of fire-resistance. Breaches were noted above the suspended ceiling within the following areas: 013-018, above bedroom riser cupboards. 019-023, above bedroom riser cupboards. 113-118, above alternative escape route lobby door. 113-118, above bedroom riser cupboards. 119-124, above bedroom riser cupboards. 319-324, above bedroom riser cupboards. 313-318, to ceiling into the void space above. Second-floor lift lobby area above the ceiling adjacent to the lift access.</p>

Action ID	544322		
Quantity		<p>Recommendation: The compartmentation breaches noted within the voids above the false ceilings should be made good with appropriate fire-resisting materials/ construction. Period of fire resistance required is 60 minutes.</p>

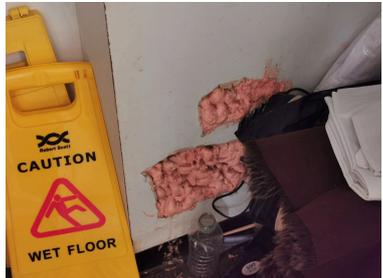
- Known	26		
- Potential	26		
Priority	B	Due Date: 21/10/2021	Client Status: Assigned
Question	Q.3	<p>Comment: The bedroom service riser cupboards on the ground, first and second-floors appear to have no internal lining provided within the cupboards and above the door. Network Homes confirmed previous recommendation is complete; to check all risers are suitably fire stopped - (All bedroom riser cupboards have been fire-stopped to the floor) The top floor bedroom riser cupboards have been fire stopped to the ceiling and above the door (Internally) to an adequate standard. Breaches were noted within the following cupboards at the time of the assessment: C02 - Hole to the boxing - excessive intumescent foam. B01 - breaches to wall at high level. C05 - Damage to boxing. B11 - breaches to ceiling around pipe egress.</p>

Section	Limiting Fire Spread		
Action ID	544320		
Quantity		<p>Recommendation: The casings/boxings noted should be repaired/replaced to provide 30 minutes fire resistance.</p>

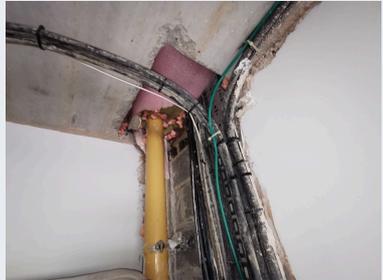
Question	Q.3	<p>Comment: The bedroom service riser cupboards on the ground, first and second-floors appear to have no internal lining provided within the cupboards and above the door. Network Homes confirmed previous recommendation is complete; to check all risers are suitably fire stopped - (All bedroom riser cupboards have been fire-stopped to the floor) The top floor bedroom riser cupboards have been fire stopped to the ceiling and above the door (Internally) to an adequate standard. Breaches were noted within the following cupboards at the time of the assessment: C02 - Hole to the boxing - excessive intumescent foam. B01 - breaches to wall at high level. C05 - Damage to boxing. B11 - breaches to ceiling around pipe egress.</p>

Section	Limiting Fire Spread		
Action ID	544321		
Quantity		<p>Recommendation: The holes noted should be sealed with a suitable fire-stopping material such as an intumescent paste. Period of fire resistance required is 60 minutes.</p>

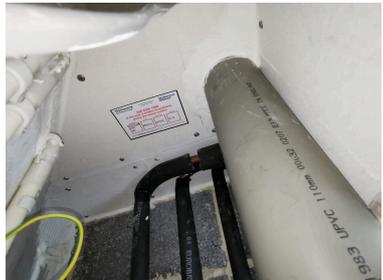
- Known	6		
- Potential	6		
Priority	B	Due Date: 21/10/2021	Client Status: Assigned
Question	Q.4	<p>Comment: There was evidence that fire-stopping works have been undertaken within the bedroom riser cupboards on the top floor. However, not all soil-pipes which enter the roof void have been provided with Intumescent collars. Bedroom riser cupboard 321 has not been provided with a fire-rated collar.</p>

Section	Limiting Fire Spread		
Action ID	544319		
Quantity		<p>Recommendation: A 60 minutes fire rated collar should be fitted around the non fire rated service pipe or duct up to 200mm diameter as noted.</p>

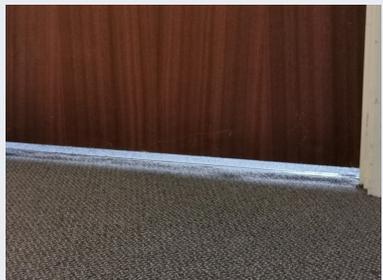
- Known	1		
- Potential	1		
Priority	B	Due Date: 21/10/2021	Client Status: Assigned
Question	L.2	<p>Comment: There is an excessive gap underneath bedroom 318's door noted at the time of the assessment.</p>

Section	Flat Entrance/Residents' Bedroom/Bedsit Doors		
Action ID	544327		
Quantity		<p>Recommendation: The bedroom door noted should be repaired (or if necessary replaced) to reduce the threshold gap to a maximum of 6mm. Alternatively, a threshold seal capable of resisting cold smoke should be fitted.</p>

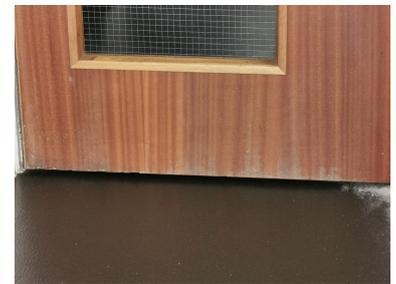
Question	M.2	<p>Comment: Previous comment - The following doors were noted as defective and in need of repair/adjustment: The 2nd-floor lift lobby door is catching on the floor covering and not effectively self-closing into its frame. The second-floor cross-cluster circulation door is an ill fit in its frame and not effectively self-closing into its frame. The side stile lip is coming away from the door to the 2nd-floor heating cupboard door (C23), the frame to the 3rd floor stair door to the alternative stair was damaged. In addition to the above. The following common fire doors were noted to have excessive gaps between the door and frame which will not stop the spread of smoke in the event of fire. They are as follows: (Excessive gaps 3mm and over to the sides/top - 6mm to the bottom of the door) Ground-floor: C04 - middle gaps. 013 - 018 Cluster lobby door - top and leading-edge gaps. 043 - Cluster kitchen door - leading-edge and top gaps. 019 - 023 Cluster lobby door - top gap. C05 - leading-edge gap. 042 - Cluster kitchen door - top, leading-edge and bottom gaps. First-floor: 113 - 118 Cluster lobby door - leading-edge and top gaps. Link door - top gap. 143 - Cluster kitchen door - leading-edge and top gaps. 119 - 124 Cluster lobby door - leading-edge and to gaps. C13 - Middle gap. Alternative exit/escape stairs door - leading-edge. B11 - top gap. Second-floor: 213 - 218 Cluster lobby door - top gap. 219 - 224 Cluster lobby door - top gap. C24/C23 - middle gap. Alternative exit/escape stairs door - leading-edge. Third-floor: 319 - 324 Cluster lobby door - bottom and leading-edge. A34 - leading-edge. 342 - Cluster kitchen - leading-edge. C33 - middle and top gaps. Link door - bottom, inside-edge and top gaps. 313 - 318 Cluster lobby door - bottom and leading-edge. C32/ C31 - middle gap. 343 - Cluster kitchen door - leading-edge gap. Damage was noted to the following doors: C13 - Door stiles delaminating. C33 - Door stiles / middle, delamination.</p>

Section	Common Area Fire Doors		
Action ID	544325		
Quantity		<p>Recommendation: The fire doors noted should be repaired (or if necessary replaced) to reduce the perimeter gap between the door and frame to a maximum of 3mm.</p>

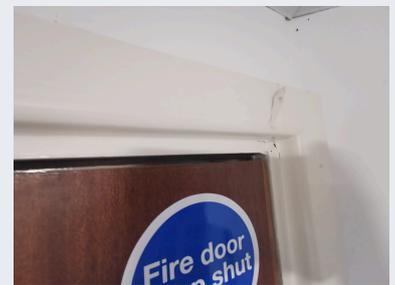
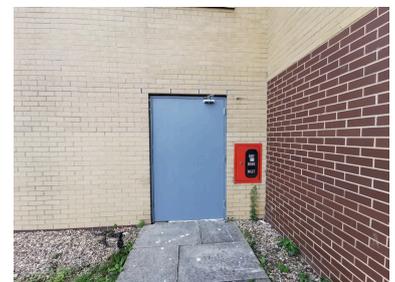
- Known	25		
- Potential	25		
Priority	C	Due Date: 21/04/2022	Client Status: Assigned
Question	N.3	<p>Comment: The coverage of the emergency lighting provided is not considered adequate - emergency lighting should be provided externally adjacent to the alternative exit/fire exit door.</p>	
Section	Emergency Lighting		
Action ID	544316		
Quantity		<p>Recommendation: Additional emergency lighting units should be provided to the areas noted in accordance with BS 5266-1:2016 and BS 5266-8:2004.</p>

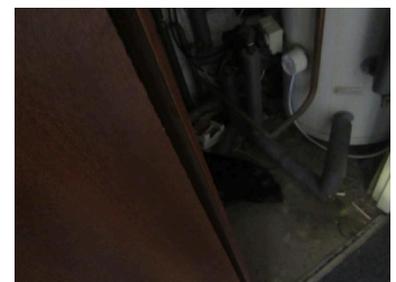
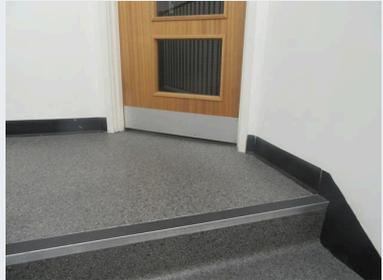
Question	M.2	<p>Comment: The following doors were noted as defective and in need of repair/adjustment: The 2nd floor lift lobby door is catching on the floor covering and not effectively self closing into its frame. The second-floor cross-cluster circulation door is an ill fit in its frame and not effectively self closing into its frame. The side stile lip is coming away from the door to the 2nd-floor heating cupboard door (C23). Excessive gaps noted to the bottom of the top floor staircase door and top floor cross-cluster circulation door. An excessive gap between the door stiles of 033.</p>

- Known	2	<p>Recommendation: The common area doors noted should be repaired (or if necessary replaced) to reduce the threshold gap to a maximum of 6mm. Alternatively, a threshold seal capable of resisting cold smoke should be fitted.</p>

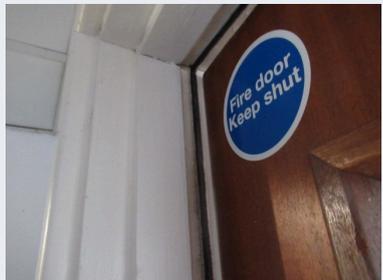
- Potential	9				
Priority	C			Due Date: 30/03/2022	Client Status: Assigned
				Review Status: Unresolved	
Question	M.5	<p>Comment: Not all self-closing devices fitted to common area fire doors (where required) are considered adequate. The ground floor alternative stair door was not fully closing into the frame with the aid of the self-closing device.</p>

- Known	1	<p>Recommendation: The self-closing device should be repaired or an effective self-closing device should be fitted to the doors as noted.</p>

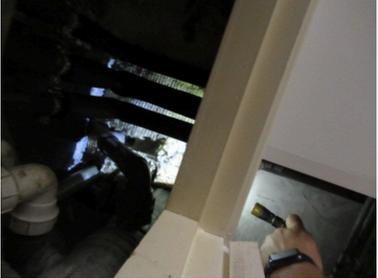
Question	Q.3	<p>Comment: A large hole was noted at the top of a shaft in the top floor staircase lobby. The top floor bedroom service riser cupboards have not been adequately separated from the roof void at ceiling level with fire-rated material. All the bedroom service riser cupboards appear not to be fire-stopped between the top of the cupboard and the communal corridor where services pass through. The same cupboards also appear to have no internal lining provided to the cupboards, above the door.</p>

Section	Limiting Fire Spread		
Action ID	303963		
Quantity		<p>Recommendation: The bedroom service riser cupboards as noted should be fire-stopped at ceiling level between the cupboards and the roof void. The bedroom service riser cupboards should be fire-stopped above the inside of the doors where services pass between the common corridor and the cupboard. Also to these cupboards, a fire rated lining should be provided to the inside of the cupboards above the door to achieve a minimum of 60 mins fire separation.</p>

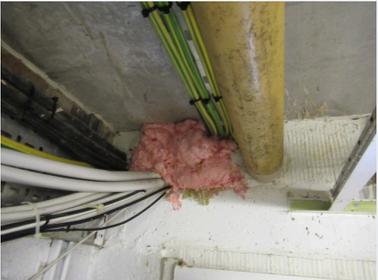
- Known	N/A		
- Potential	1		
Priority	Man1	Due Date: 01/12/2019	Client Status: Assigned
		Review Status: Unresolved	
Question	Q.7	<p>Comment: Inappropriate/excessive use has been made of fire rated expanding foam as a fire-stopping material. This product is only suitable for narrow linear gaps. Where services pass through the wall above the door to the electrical intake cupboard.</p>

Section	Limiting Fire Spread		
Action ID	303964		
Quantity		<p>Recommendation: The fire rated expanding foam used inappropriately to firestop/seal fire resisting construction as noted should be removed and replaced with a suitable product.</p>
