Fire Risk Assessment

Property assessed: B Pasteur Court Nightingale
Avenue London HA1 3GX

Client: Network Homes Ltd

FRA Inspection Date: 20/08/2020
FRA Issued to Client: 21/10/2020
FRA valid to: 21/10/2021
FRA completed by: Savills (UK) Ltd,
33 Margaret Street, London W1G 0JD
T: 020 7409 8737
E: fireriskhousing@savills.com

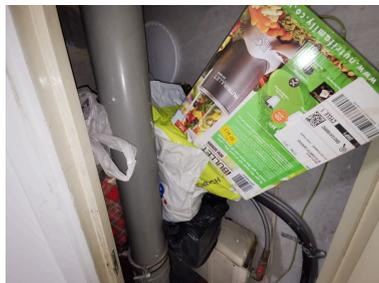
Details		Comments/recommendations	Photo
Question	G.2	<p>Comment: Stored combustible items were noted within A07 (Mattress and wooden ladder) B15 - stored timber panels adjacent to electrical installations. Bedroom riser cupboard - 324.</p> <p>Recommendation: All combustible items should be removed from the electrical intake cupboard as soon as possible and the door kept locked.</p>

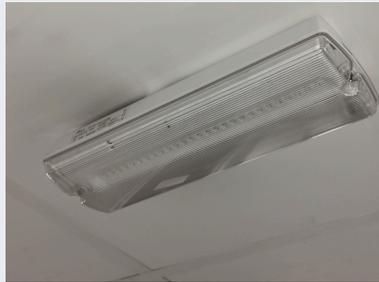
- Known	N/A		
- Potential	N/A		
Question	N.2	<p>Comment: Some of the emergency lighting units did not appear to have a visible charging indicator. Emergency lighting adjacent to the cluster lobby doors 319-324 and 219-224 did not show any signs of power.</p> <p>Recommendation: The emergency lighting system should be checked by the maintenance engineer to confirm that it is serviceable.</p>

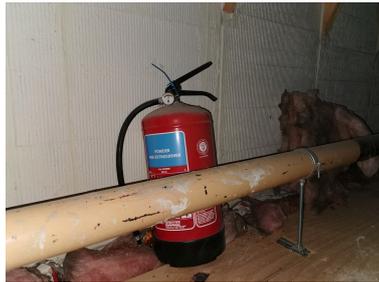
- Known	N/A		
- Potential	N/A		
Question	R.3	<p>Comment: Dry powder type fire extinguishers are installed. A redundant unit noted within the roof void. This type of fire extinguisher is not considered to be suitable for indoor use and should be removed.</p> <p>Recommendation: The noted redundant fire extinguisher should be removed as not required within this property type.</p>

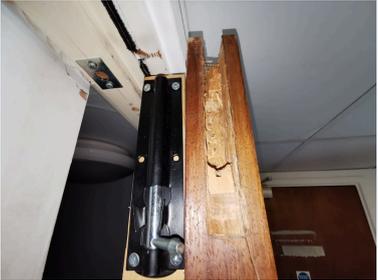
Question	M.2	<p>Comment: Previous comment - The following common area doors were noted as damaged and in need of repair or replacement: The 1st-floor service cupboard door (B08) is damaged at the top of the door. The top floor staircase door to cluster 313-318 has an excessive gap at the bottom of the door. The top floor alternative fire exit door is a bad fit in its frame (daylight visible between the door and frame). In addition to the above comment, the following doors were noted as having excessive gaps between the door and door-frames over 3mm (sides/top) and 6mm (bottom/threshold) Ground-floor: 019-024 Cluster lobby door - top and leading-edge gaps. 014-018 Cluster lobby door - top gap. B04 - leading-edge gap. 042 - Cluster kitchen - leading-edge and top gaps. Alternative exit stairwell door - top and leading-edge gaps. Alternative exit lobby door - leading-edge and top gaps. First-floor: 113-118 Cluster lobby door - top and leading-edge gaps. 142 Cluster kitchen top gap. 119-124 Cluster lobby door - top gap. Link door - leading-edge gaps. A13 - top gap. Second-floor: 213-218 Cluster lobby door - top gap. 242 Cluster kitchen - top and leading-edge gaps. B13 - Leading-edge gap. 219-224 Cluster lobby door - top and leading-edge gaps. Link door to alternative exit - top gap. Third-floor: 313-318 Cluster lobby door - top gap. Damage was noted to the following fire doors: B03 - delaminated stiles to the leading edge of both doors. B11 - appears to be split on the inside edge. B15 - damage to the top of the door. Cluster kitchen - 243 was not accessible at the time of the assessment.</p>

Section	Common Area Fire Doors		
Action ID	544293		
Quantity		<p>Recommendation: Common area doors and frames as noted should be replaced with FD30S lockable fire door sets, installed strictly in accordance with the manufacturer's test certification, including appropriate 'Fire door keep locked' signage to the outer face.</p>

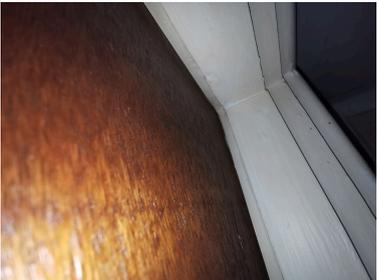
- Known	2		
- Potential	2		
Priority	A	Due Date: 21/01/2021	Client Status: Assigned
Question	M.5	<p>Comment: Previous comment - Not all self-closing devices fitted to common area fire doors (where required) are considered adequate. The 1st-floor kitchen door is not fully closing into the frame with the aid of the self-closing device. Network Homes confirmed previous recommendation is complete; to check all communal fire doors on a regular basis. In addition to the above comment - The ground floor door leading to the alternative exit lobby and cluster kitchen doors 243 and 242 were not fitting flush into the doorframes.</p>

Section	Common Area Fire Doors		
Action ID	544296		
Quantity		<p>Recommendation: The self-closing device should be repaired or an effective self-closing device should be fitted to the doors as noted.</p>

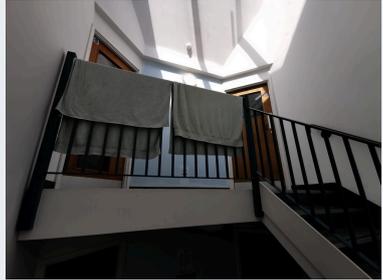
Question	G.3	<p>Comment: There were combustible items or waste materials in the escape routes. Towels were noted on the third-floor landing at the time of the assessment. As the quantity involved is relatively minor this can be dealt with via written contact with the residents.</p> <p>Recommendation: Management should contact residents to advise that the common area/escape routes should be kept free from all combustibles and/or trip hazards. A programme of regular checks should be put in place to ensure that the common area is kept clear.</p>

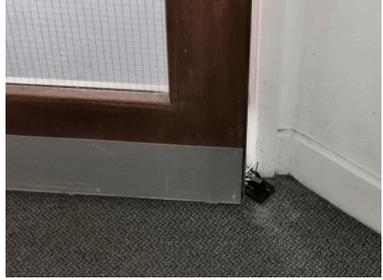
- Known	N/A			
- Potential	N/A			
Priority	Man2	Due Date: 21/01/2021	Client Status: Approved	
Question	M.7	<p>Comment: Common area fire doors were noted being wedged open or otherwise obstructed at the time of inspection. Cluster kitchen 343 was being wedged open at the time of the assessment. The wedges/obstructions were removed by or for the assessor at the time of inspection.</p> <p>Recommendation: Management should inform/remind all staff and/or residents that self-closing fire doors must not be wedged open or otherwise obstructed. A programme of regular checks should be put in place to ensure that the fire doors remain unobstructed.</p>

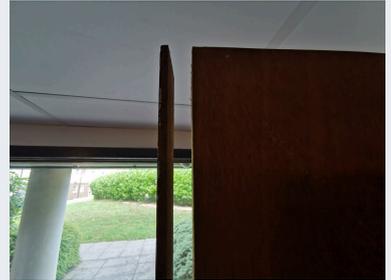
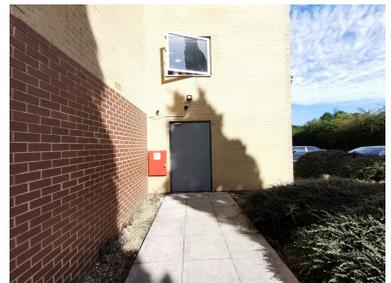
- Potential	3		
Priority	B	Due Date: 21/10/2021	Client Status: Assigned
Question	O.3	<p>Comment: Directional and exit signage is not considered adequate. The fire exit door requires the 'Fire exit' signage to be positioned above the associated exit door.</p>	
Section	Fire Safety Signs and Notices		
Action ID	544289		
Quantity		<p>Recommendation: Provide adequate signage, bespoke, as noted in the FRA comment.</p>

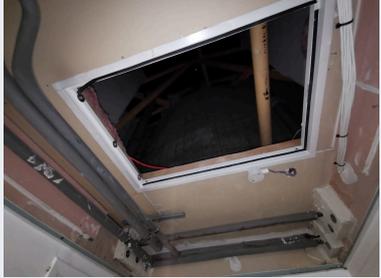
Question	Q.2	<p>Comment: There were various compartmentation breaches noted throughout the escape route above the suspended ceilings adjacent to the bedroom riser cupboards. As previously recommended - an intrusive inspection should be undertaken throughout the communal areas (above suspended ceilings) and noted breaches fire-stopped to provide 60 minutes of fire-resistance. Breaches were noted above the suspended ceiling within the following areas: Ground-floor: 019-024 Cluster lobby area above bedroom riser cupboard doors. Above the exit door leading to the alternative escape route, A. 014-018 Cluster lobby area above bedroom riser cupboard doors. First-floor: 113-118 Cluster lobby area above bedroom riser cupboards. Above bedroom riser cupboard 121. Third-floor: 319-324 Cluster lobby area various holes to the ceiling. No roof void access panel.</p>

Quantity		<p>Recommendation: The open roof void access point should be secured with a fire-rated hatch which affords 60 minutes of fire protection.</p>

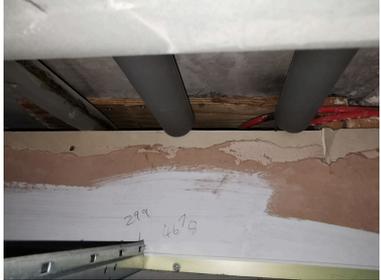
- Known	1		
- Potential	1		
Priority	B	Due Date: 21/10/2021	Client Status: Assigned
Question	Q.2	<p>Comment: There were various compartmentation breaches noted throughout the escape route above the suspended ceilings adjacent to the bedroom riser cupboards. As previously recommended - an intrusive inspection should be undertaken throughout the communal areas (above suspended ceilings) and noted breaches fire-stopped to provide 60 minutes of fire-resistance. Breaches were noted above the suspended ceiling within the following areas: Ground-floor: 019-024 Cluster lobby area above bedroom riser cupboard doors. Above the exit door leading to the alternative escape route, A. 014-018 Cluster lobby area above bedroom riser cupboard doors. First-floor: 113-118 Cluster lobby area above bedroom riser cupboards. Above bedroom riser cupboard 121. Third-floor: 319-324 Cluster lobby area various holes to the ceiling. No roof void access panel.</p>

Section	Limiting Fire Spread		
Action ID	544301		
Quantity		<p>Recommendation: The compartmentation breaches noted within the voids above the false ceilings should be made good with appropriate fire-resisting materials/ construction. Period of fire resistance required is 60 minutes.</p>

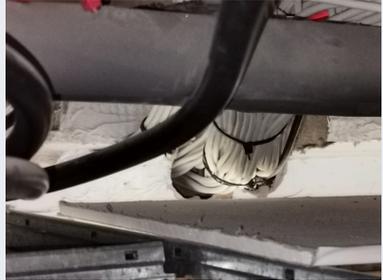
Question	Q.3	<p>Comment: The bedroom service riser cupboards on the ground, first and second-floors appear to have no internal lining provided within the cupboards and above the door. Network Homes confirmed previous recommendation is complete; to check all risers are suitably fire stopped - (All bedroom riser cupboards have been fire-stopped to the floor) The top floor bedroom riser cupboards have been fire stopped to the ceiling and above the door (Internally) to an adequate standard. There were various breaches noted within the electrical intake cupboard A07.</p>

Section	Limiting Fire Spread		
Action ID	544302		
Quantity		<p>Recommendation: The holes noted should be sealed with a suitable fire-stopping material such as an intumescent paste. Period of fire resistance required is 60 minutes.</p>

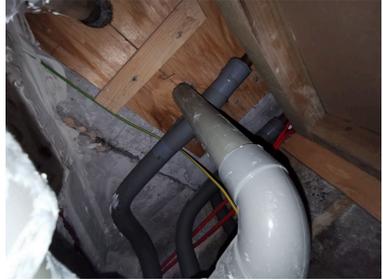
- Known	4		
- Potential	4		
Priority	B	Due Date: 21/10/2021	Client Status: Assigned
Question	Q.3	<p>Comment: The bedroom service riser cupboards on the ground, first and second-floors appear to have no internal lining provided within the cupboards and above the door. Network Homes confirmed previous recommendation is complete; to check all risers are suitably fire stopped - (All bedroom riser cupboards have been fire-stopped to the floor) The top floor bedroom riser cupboards have been fire stopped to the ceiling and above the door (Internally) to an adequate standard. There were various breaches noted within the electrical intake cupboard A07.</p>

Section	Limiting Fire Spread		
Action ID	544303		
Quantity		<p>Recommendation: The plasterboard panels and sections above/either side of the bedroom riser doors (Internally) where pipework and cables run to be fire stopped using fire-resisting materials to ensure 60 minutes of fire resistance between the cupboard and communal areas. Any fire-stopping works to be undertaken by a competent passive fire engineer.</p>

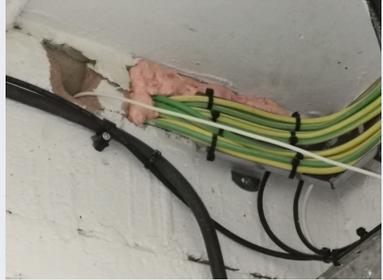
- Known	33		
- Potential	33		
Priority	B	Due Date: 21/10/2021	Client Status: Assigned
Question	Q.3	<p>Comment: The bedroom service riser cupboards on the ground, first and second-floors appear to have no internal lining provided within the cupboards and above the door. Network Homes confirmed previous recommendation is complete; to check all risers are suitably fire stopped - (All bedroom riser cupboards have been fire-stopped to the floor) The top floor bedroom riser cupboards have been fire stopped to the ceiling and above the door (Internally) to an adequate standard. There were various breaches noted within the electrical intake cupboard A07.</p>

Section	Limiting Fire Spread		
Action ID	544304		
Quantity		<p>Recommendation: The fire-rated expanding foam used inappropriately (noted within A07) to firestop/seal fire-resisting construction as noted should be removed and replaced with a suitable product (unless the existing installation can be confirmed as complying with an appropriate fire test certificate).</p>

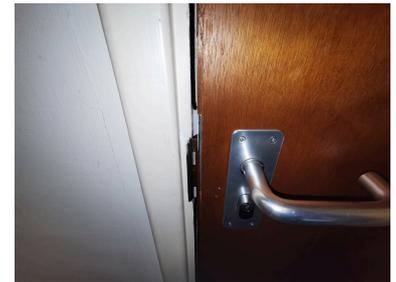
Question	M.2	<p>Comment: Previous comment - The following common area doors were noted as damaged and in need of repair or replacement: The 1st-floor service cupboard door (B08) is damaged at the top of the door. The top floor staircase door to cluster 313-318 has an excessive gap at the bottom of the door. The top floor alternative fire exit door is a bad fit in its frame (daylight visible between the door and frame). In addition to the above comment, the following doors were noted as having excessive gaps between the door and door-frames over 3mm (sides/top) and 6mm (bottom/threshold) Ground-floor: 019-024 Cluster lobby door - top and leading-edge gaps. 014-018 Cluster lobby door - top gap. B04 - leading-edge gap. 042 - Cluster kitchen - leading-edge and top gaps. Alternative exit stairwell door - top and leading-edge gaps. Alternative exit lobby door - leading-edge and top gaps. First-floor: 113-118 Cluster lobby door - top and leading-edge gaps. 142 Cluster kitchen top gap. 119-124 Cluster lobby door - top gap. Link door - leading-edge gaps. A13 - top gap. Second-floor: 213-218 Cluster lobby door - top gap. 242 Cluster kitchen - top and leading-edge gaps. B13 - Leading-edge gap. 219-224 CLuster lobby door - top and leading-edge gaps. Link door to alternative exit - top gap. Third-floor: 313-318 CLuster lobby door - top gap. Damage was noted to the following fire doors: B03 - delaminated stiles to the leading edge of both doors. B11 - appears to be split on the inside edge. B15 - damage to the top of the door. Cluster kitchen - 243 was not accessible at the time of the assessment.</p>

Quantity		<p>Recommendation: The fire doors noted should be repaired (or if necessary replaced) to reduce the perimeter gap between the door and frame to a maximum of 3mm.</p>
- Known	17	
- Potential	17

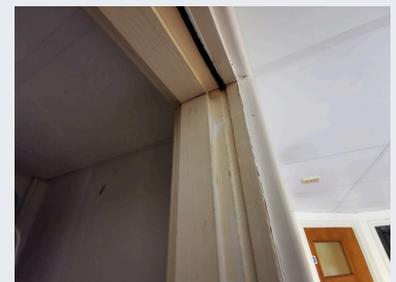
Question	M.6	<p>Comment: There were various common fire doors which have defective/damaged or missing combined intumescent strips and cold smoke seals, they are as follows: B02, B08, 143, A13, Link door to block C, 219-224 lobby door, 342 -cluster kitchen door - excessive paint. 319-324 link door, third-floor alternative exit lobby door. All double door riser cupboards noted will required combined intumescent strips and cold smoke seals to the middle of the door set (one side)</p>
Section	Common Area Fire Doors	
Action ID	544297

Quantity		<p>Recommendation: Common area fire doors as noted should be fitted with intumescent strips and smoke seals.</p>
- Known	21	
- Potential	21

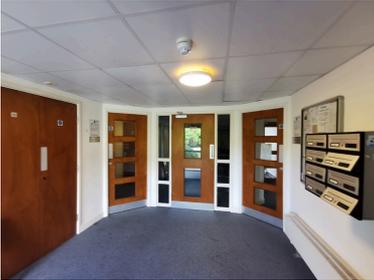
Question	O.2	<p>Comment: Previous comment - Fire door signage is not considered adequate. No fire door sign is provided to the ground floor stair door. In addition to the above, the following is required: The following fire doors are provided with the wrong signage: B07, B11, B15. - The fire door signage in situ should be replaced with 'Fire door keep locked' signage. The following fire doors require 'Fire door keep locked' signage: B03, B08, B12, B16, B17, A07. (Both openable doors within the double door cupboards will require adequate fire door signage)</p> <p>Recommendation: Provide 'Fire door keep locked' notices to common area fire doors as noted.</p>

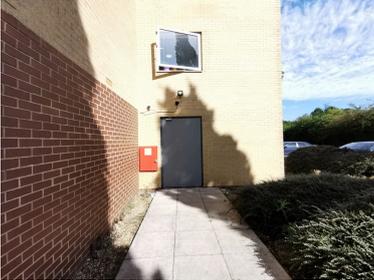
- Known	9			
- Potential	9			
Priority	C	Due Date: 21/04/2022	Client Status: Assigned	
Question	O.4	<p>Comment: Previous comment - No fire exit door signage provided to the exterior side of the ground floor alternate fire exit door. Do not use lift signage missing from the 2nd-floor lift lobby. In addition to the above comment - signage was also missing to the dry riser inlet.</p> <p>Recommendation: Provide adequate signage, bespoke, as noted in the FRA comment.</p>

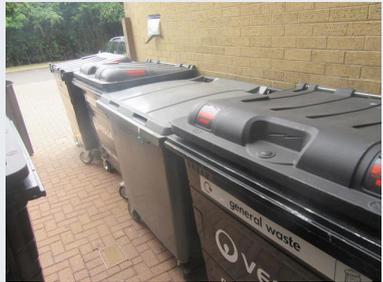
- Known	N/A		
- Potential	1		
Priority	Man2	<p>Due Date: 31/03/2020</p> <p>Client Status: Approved</p> <p>Review Status: Unresolved</p>	
Question	C.2	<p>Comment: There was no designated bin storage area for the Paladin/Wheelie bins resulting in them being stored in inappropriate locations.</p>

Section	Arson		
Action ID	130930		
Quantity		<p>Recommendation: A suitable bin storage area should be provided at a safe distance from the building including any necessary hard standing, fencing and security arrangements.</p>

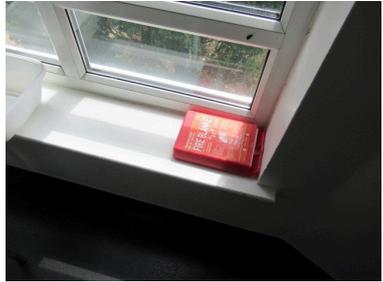
- Known	1		
- Potential	N/A		
Priority	C	<p>Due Date: 30/03/2022</p> <p>Client Status: Assigned</p> <p>Review Status: Unresolved</p>	
Question	E.4	<p>Comment: There was one fire blanket only, in a 2nd-floor kitchen but this was not within the annual service date or fixed to the wall.</p>

Section	Cooking		
Action ID	304122		
Quantity		<p>Recommendation: The fire blanket as noted should be fixed to the wall in an appropriate position</p>

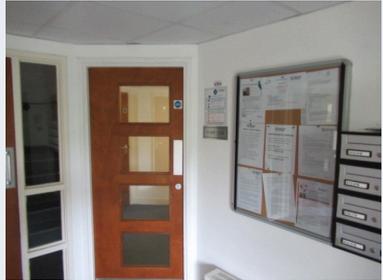
Question	K.1	<p>Comment: Previous FRA comment. BS9991 - 9.8.1 recommends; The cluster should be lobbied from any staircases serving the building (i.e. a protected lobby should be formed between the cluster front entrance door and the stair door). There is no lobby separating the stairway and cluster entrance doors on the 1st, 2nd and 3rd floors off the stairway from entrance A. Lobby protection is provided to the stairs at ground floor level separating the cluster corridor from the stairway. Lobby protection is provided to the alternative rear corner stairway on all levels separating the cluster corridor from the stairway. Bedrooms discharge directly into a protected corridor leading to a protected stairway or stair lobby for ground floor flats. There is one cluster per level with a single direction of travel of 9m from the furthest bedrooms to the lobby. Other cluster bedrooms have a choice of direction to the protected stairway or to the shared interlinked lift lobby of block B. Stairways discharge at ground floor level to the outside and away from the building. Previous recommendation of a C priority not considered suitable so completed and this recommendation with an R priority used.</p>

Section	Means of Escape			
Action ID	304126			
Quantity		<p>Recommendation: When the buildings are next refurbished the cluster should be lobbied from any staircases serving the building (i.e. a protected lobby should be formed between the cluster front entrance door and the stair door) as recommended by BS 9991 - 9.8.1.</p>

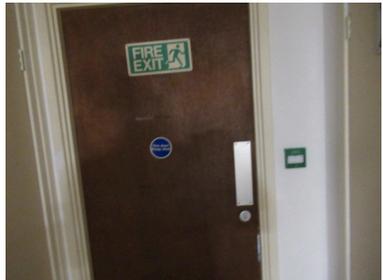
- Known	3			
- Potential	3			
Priority	R	Due Date: N/A	Client Status: Assigned	
		Review Status: Unresolved		
Question	K.7	<p>Comment: Green break glasses have been actuated in a number of instances and/or doors separating clusters have been forced open causing the doors/frames to become faulty/damaged and in some cases resulting in the doors not being a good fit into the frame.</p>

Section	Means of Escape			
Action ID	304138			
Quantity		<p>Recommendation: Management should undertake a programme to regularly check the doors separating cluster accommodations to ensure/confirm the doors are in a satisfactory condition and the door/lock are effective.</p>

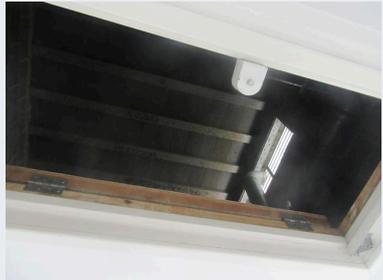
- Known	1			
- Potential	1			
Priority	Man2	Due Date: 31/03/2020	Client Status: Approved	
		Review Status: Unresolved		
Question	K.15	<p>Comment: An AOV positioned above an alternative staircase appears to have been de-commissioned. An operational AOV (assumed) was noted at the head of the main staircase.</p>

Section	Means of Escape			
Action ID	130992			
Quantity		<p>Recommendation: Recommend the decommissioned AOV at the head of the alternate staircase is reinstated.</p>

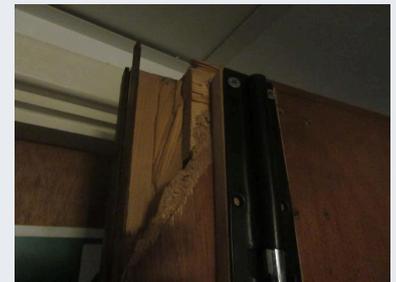
- Potential	N/A		
Priority	A	Due Date: 30/12/2020	Client Status: Assigned
		Review Status: Unresolved	
Question	M.2	<p>Comment: The following common area doors were noted as damaged and in need of repair or replacement: The ground floor cleaners cupboard door stile has delaminated from the side of the door. The 1st-floor service cupboard door (BO8) is damaged at the top of the door. The door to the alternate fire exit door next to bedroom 121 is an ill fit and not closing into the door frame. The 1st-floor cluster kitchen door (143) is an ill fit and not closing into the door frame. The second-floor cluster kitchen door (242) is an ill fit in its frame. The top floor staircase door to cluster 313-318 has an excessive gap at the bottom of the door. The top floor alternative fire exit door is a bad fit in its frame (daylight visible between the door and frame). The ground floor and 2nd-floor cluster kitchen doors (043, 243) are not effectively self-closing into their door frames.</p>

Section	Common Area Fire Doors		
Action ID	130936		
Quantity			
- Known	2	<p>Recommendation: The common area fire door(s) as noted should be replaced with an FD30S lockable fire door: 1st floor service cupboard door BO8. The top floor alternate fire exit door (next to bedroom 322)</p>

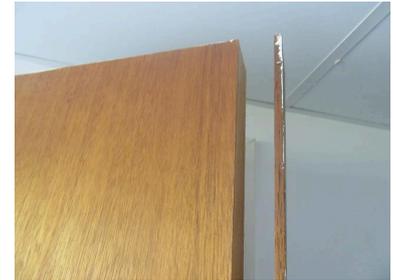
Question	M.2	<p>Comment: The following common area doors were noted as damaged and in need of repair or replacement: The ground floor cleaners cupboard door stile has delaminated from the side of the door. The 1st-floor service cupboard door (BO8) is damaged at the top of the door. The door to the alternate fire exit door next to bedroom 121 is an ill fit and not closing into the door frame. The 1st-floor cluster kitchen door (143) is an ill fit and not closing into the door frame. The second-floor cluster kitchen door (242) is an ill fit in its frame. The top floor staircase door to cluster 313-318 has an excessive gap at the bottom of the door. The top floor alternative fire exit door is a bad fit in its frame (daylight visible between the door and frame). The ground floor and 2nd-floor cluster kitchen doors (043, 243) are not effectively self-closing into their door frames.</p>
Section	Common Area Fire Doors

Action ID	130937	
Quantity		<p>Recommendation: Minor joinery repairs are required to the door(s)/frame(s) noted - The ground floor cleaners cupboard door should be repaired to refix the door stile strip. Ill-fitting doors provided to the 1st-floor alternate fire exit door, 1st and 2nd-floor cluster kitchen doors 143 and 242 should be repaired/adjusted to reinstate a good fit within their door frames or the doors replaced with FD30s doors.</p>

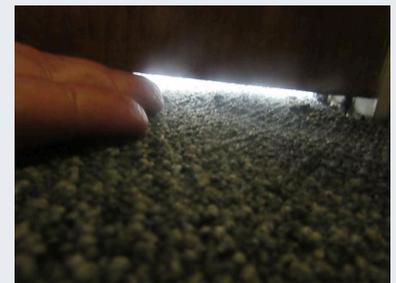
Question	M.2	<p>Comment: The following common area doors were noted as damaged and in need of repair or replacement: The 1st-floor service cupboard door (BO8) is damaged at the top of the door. The top floor staircase door to cluster 313-318 has an excessive gap at the bottom of the door. The top floor alternative fire exit door is a bad fit in its frame (daylight visible between the door and frame).</p>	
Section	Common Area Fire Doors		
Action ID	304130		
Quantity		<p>Recommendation: Common area doors and frames as noted should be replaced with FD30S lockable fire door sets, installed strictly in accordance with the manufacturer's test certification, including appropriate 'Fire door keep locked' signage to the outer face.</p>	
- Known	2		
- Potential	2		
Priority	A	Due Date: 30/12/2020	Client Status: Assigned
		Review Status: Unresolved

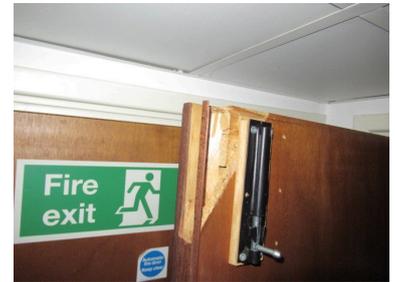
Question	M.2	<p>Comment: The following common area doors were noted as damaged and in need of repair or replacement: The 1st-floor service cupboard door (BO8) is damaged at the top of the door. The top floor staircase door to cluster 313-318 has an excessive gap at the bottom of the door. The top floor alternative fire exit door is a bad fit in its frame (daylight visible between the door and frame).</p>	
Section	Common Area Fire Doors		
Action ID	304131		
Quantity		<p>Recommendation: The common area doors noted should be repaired (or if necessary replaced) to reduce the threshold gap to a maximum of 6mm. Alternatively, a threshold seal capable of resisting cold smoke should be fitted.</p>	
- Known	1		
- Potential	1		
Priority	C	Due Date: 30/03/2022	Client Status: Assigned
		Review Status: Unresolved

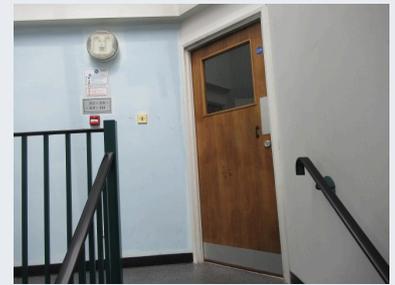
Question	M.5	<p>Comment: Not all self-closing devices fitted to common area fire doors (where required) are considered adequate. The 1st-floor kitchen door is not fully closing into the frame with the aid of the self-closing device. Network Homes confirmed previous recommendation is complete; to check all communal fire doors on a regular basis.</p>	
Section	Common Area Fire Doors		
Action ID	304132		
Quantity		<p>Recommendation: The self-closing device should be repaired or an effective self-closing device should be fitted to the doors as noted.</p>	
- Known	1		
- Potential	1		
Priority	A	Due Date: 30/12/2020	Client Status: Assigned
		Review Status: Unresolved

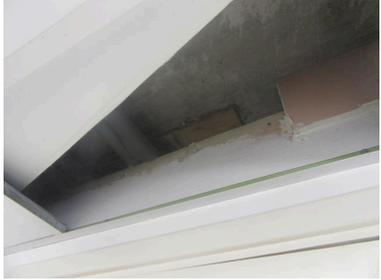
Question	Q.2	Comment: Voids were noted above some sampled sections of the false ceilings where services pass between the riser shafts and common parts.

Section	Limiting Fire Spread		
Action ID	130953		
Quantity		Recommendation: Management should undertake an intrusive inspection of the hidden voids above the false ceilings to confirm/ensure that compartmentation within is adequate between the riser shafts and common parts.

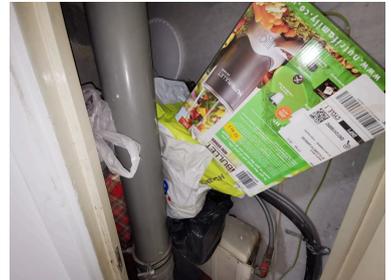
Comment: Stored combustible items were noted within A07 (Mattress and wooden ladder) B15 - stored timber panels adjacent to electrical installations. Bedroom riser cupboard - 324.

Recommendation: All combustible items should be removed from the electrical intake cupboard as soon as possible and the door kept locked.

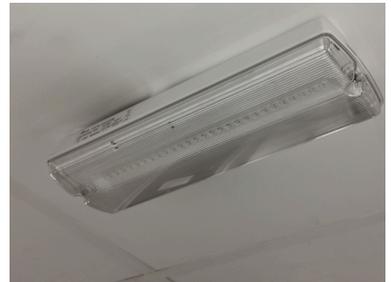
Question - N.3: From visual inspection, does the coverage of the emergency lighting system provided appear to be adequate? (Internal and external)	No
Comment: The coverage of the emergency lighting provided is not considered adequate. No external emergency light provided over the alternative exit door.
