Fire Risk Assessment

Property assessed: C Pasteur Court Nightingale Avenue London HA1 3GX
Client: Network Homes Ltd
UPRN: PAST0000-3
Property Classification: Level 1
Document Print Date: 21/04/2021

FRA Inspection Date: 20/08/2020
FRA Issued to Client: 21/10/2020
FRA valid to: 21/10/2021
FRA completed by: Savills (UK) Ltd,
33 Margaret Street, London W1G 0JD
T: 020 7409 8737
E: fireriskhousing@savills.com

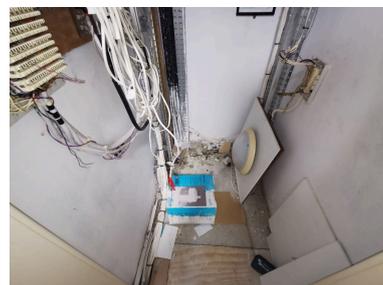
Details		Comments/recommendations	Photo
Question	G.2	<p>Comment: Previous recommendation - Discarded combustibles noted within a ground floor service cupboard CO5 and 2nd-floor service cupboard CO10 containing fixed electrical equipment.</p> <p>Recommendation: All combustible items should be removed from the electrical intake cupboard as soon as possible and the door kept locked.</p>

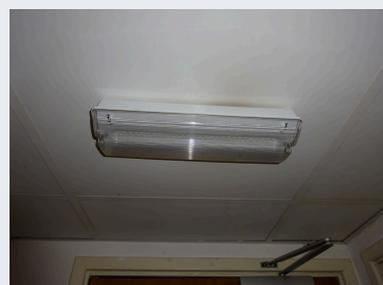
- Known	N/A		
- Potential	N/A		
Priority	Man1		
Question	N.2	<p>Comment: Some of the emergency lighting units did not appear to have a visible charging indicator. The emergency light adjacent to the cluster lobby door 101-106 shows no sign of power. The unit adjacent to the link door leading to block B within cluster 107-112 shows no signs of power.</p> <p>Recommendation: The emergency lighting system should be checked by the maintenance engineer to confirm that it is serviceable.</p>

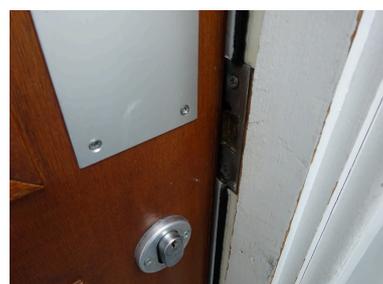
- Known	N/A		
- Potential	N/A		
Priority	Man1		
Question	M.5	<p>Comment: Previous comment - Not all self-closing devices fitted to common area fire doors (where required) are considered adequate. Cluster kitchen 041 and cluster lobby door 301-306 do not fully close into the frame.</p> <p>Recommendation: The self-closing device should be repaired or an effective self-closing device should be fitted to the doors as noted.</p>

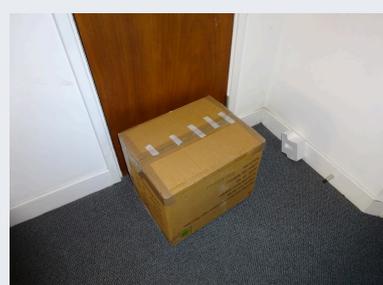
- Known	2		
- Potential	2		
Priority	A		
Question	G.3	<p>Comment: There were combustible items or waste materials in the escape routes. There was a cardboard box noted adjacent to C17. As the quantity involved is relatively minor this can be dealt with via written contact with the residents.</p> <p>Recommendation: Management should contact residents to advise that the common area/escape routes should be kept free from all combustibles and/or trip hazards. A programme of regular checks should be put in place to ensure that the common area is kept clear.</p>

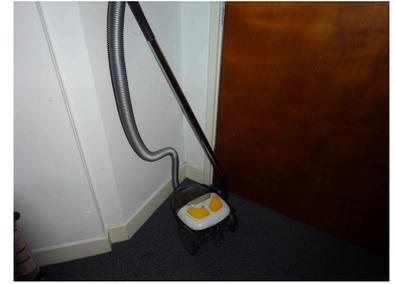
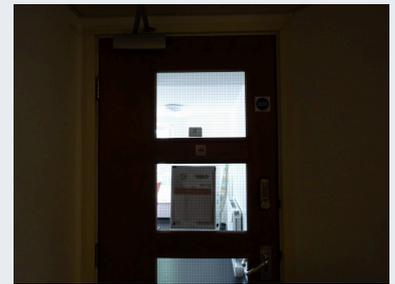
- Known	N/A		
- Potential	N/A		
Priority	Man2	Due Date: 21/01/2021	Client Status: Approved
Question	M.6	Comment: The double doors to service/store cupboards do not have intumescent strips and cold smoke seals to the meeting stiles of the doors. Missing combined intumescent strips and cold smoke seals were also noted to 014 - Cluster kitchen door, 107-112 - Link door to Block B, 207-212 - Link door to block B and cluster kitchen 341. Cluster kitchens 340 and 141 were not accessible at the time of the assessment due to there being coded locks.	
Section	Common Area Fire Doors		
Action ID	544226		
Quantity		Recommendation: The locked riser/cupboard doors as noted should be checked to confirm that adequate intumescent strips and smoke seals are fitted.

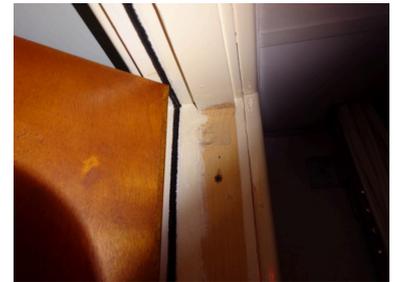
Question	M.2	<p>Comment: The following common area fire doors were noted as damaged and require replacing: The ground floor heating cupboard door and the top floor service cupboard door (opposite cluster kitchen 341) are damaged at the top of the doors where locks have been removed, the 1st floor heating cupboard door (C08) has been damaged and split on the inner face of the door, 1st floor service cupboard door (CO7) appears to be delaminating on the inside of the door. In addition to the above, the door stops were missing to C10/C11. The second-floor link door to Block B's leading-edge/ stile is broken. The following doors were noted as having excessive gaps between the door/door frames which will not resist the spread of smoke into throughout the escape route. They are as follows:- Ground-floor: C02 - top gap. 007-012, Cluster lobby door - top, leading-edge and bottom gaps. Link door to block B - top gap. 041 - Cluster kitchen - leading-edge gap. 002-006, Cluster lobby door - top and leading-edge gaps. 040 - Cluster kitchen - top gap. Stairwell door - leading-edge and top gaps. First-floor: 101-006, Cluster lobby door - top and leading-edge gaps. 140 - Cluster kitchen - inside-edge and top gaps. 107-112, Cluster lobby door - leading-edge gap. Link door - inside-edge and top gaps. Link door to block B - top gap. Second-floor: 201-206, Cluster lobby door - top gap. 240 - Cluster kitchen - leading-edge gap. C13 - Leading-edge gap. 207-212, Cluster lobby door - top and leading-edge gap. 241 - Cluster kitchen - top gap. Link door to block B - top and leading-edge gaps. Third-floor: 301-306, Cluster lobby door - top and leading-edge gaps. 307-312, Cluster lobby door - top and leading-edge gaps. C17 - leading-edge gap. Link door - leading edge gap.</p>

Quantity		<p>Recommendation: Minor joinery repairs are required to the door/frame as noted - Replace missing door-stops to C10/C11</p>
- Known	2	
- Potential	2

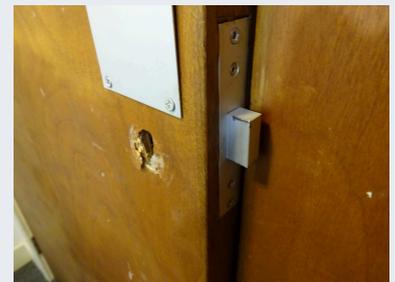
Question	M.8	<p>Comment: Fire doors to services risers/cupboards were found to be unlocked at the time of inspection. It appeared that the riser cupboard C06's lock was faulty at the time of the assessment.</p>
Section	Common Area Fire Doors	
Action ID	544230

Quantity		<p>Recommendation: The doors noted should be provided with a suitable locking device.</p>
- Known	1	
- Potential	1

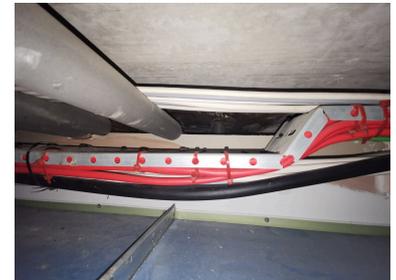
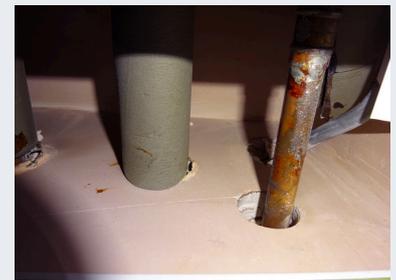
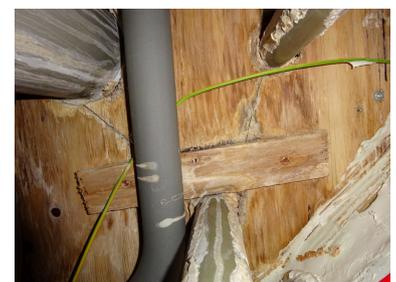
Question	Q.2	<p>Comment: There were various compartmentation breaches noted throughout the escape route above the suspended ceilings adjacent to the bedroom riser cupboards. As previously recommended - an intrusive inspection should be undertaken throughout the communal areas (above suspended ceilings) and noted breaches fire-stopped to provide 60 minutes of fire-resistance. Breaches were noted above the suspended ceiling adjacent to the bedroom service riser cupboards on the ground floor within the bedroom lobbies 007-012 and 002-006 and lobby door. The first floor (107-112) above the suspended ceiling adjacent to all bedroom riser cupboards. Third-floor, above 301-306 cluster entry door and adjacent to the middle bedroom riser cupboards to the ceiling.</p>	
Section	Limiting Fire Spread		
Action ID	544220		
Quantity		<p>Recommendation: The compartmentation breaches noted within the voids above the false ceilings should be made good with appropriate fire-resisting materials/ construction. Period of fire resistance required is 60 minutes.</p>

- Known	23		
- Potential	23		
Priority	B	Due Date: 21/10/2021	Client Status: Assigned
Question	Q.3	<p>Comment: The bedroom service riser cupboards on the ground, first and second-floors appear to have no internal lining provided within the cupboards and above the door. Network Homes confirmed previous recommendation is complete; to check all risers are suitably fire stopped - (All bedroom riser cupboards have been fire-stopped to the floor) The top floor bedroom riser cupboards have been fire stopped to the ceiling and above the door (Internally) to an adequate standard. Breaches were noted within the third-floor electrical cupboard (righthand side cupboard) to the wall to pipe egress.</p>	
Section	Limiting Fire Spread		
Action ID	544221		
Quantity		<p>Recommendation: The holes noted should be sealed with a suitable fire-stopping material such as an intumescent paste. Period of fire resistance required is 60 minutes.</p>

- Known	3		
- Potential	3		
Priority	B	Due Date: 21/10/2021	Client Status: Assigned
Question	Q.3	<p>Comment: The bedroom service riser cupboards on the ground, first and second-floors appear to have no internal lining provided within the cupboards and above the door. Network Homes confirmed previous recommendation is complete; to check all risers are suitably fire stopped - (All bedroom riser cupboards have been fire-stopped to the floor) The top floor bedroom riser cupboards have been fire stopped to the ceiling and above the door (Internally) to an adequate standard. Breaches were noted within the third-floor electrical cupboard (righthand side cupboard) to the wall to pipe egress.</p>	
Section	Limiting Fire Spread		
Action ID	544222		
Quantity		<p>Recommendation: The plasterboard panels and sections above/either side of the bedroom riser doors (Internally) where pipework and cables run to be fire stopped using fire-resisting materials to ensure 60 minutes of fire resistance between the cupboard and communal areas. Any fire-stopping works to be undertaken by a competent passive fire engineer.</p>

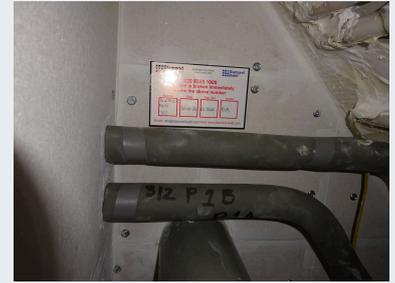
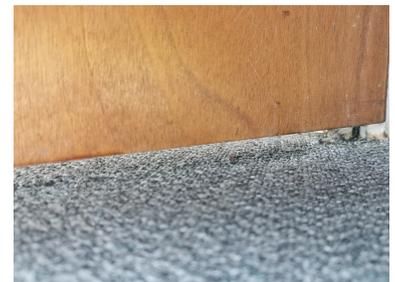
- Known	3		
- Potential	3		
Priority	B	Due Date: 21/10/2021	Client Status: Assigned
Question	M.2	<p>Comment: The following common area fire doors were noted as damaged and require replacing: The ground floor heating cupboard door and the top floor service cupboard door (opposite cluster kitchen 341) are damaged at the top of the doors where locks have been removed, the 1st floor heating cupboard door (C08) has been damaged and split on the inner face of the door, 1st floor service cupboard door (CO7) appears to be delaminating on the inside of the door. In addition to the above, the door stops were missing to C10/C11. The second-floor link door to Block B's leading-edge/ stile is broken. The following doors were noted as having excessive gaps between the door/door frames which will not resist the spread of smoke into throughout the escape route. They are as follows:- Ground-floor: C02 - top gap. 007-012, Cluster lobby door - top, leading-edge and bottom gaps. Link door to block B - top gap. 041 - Cluster kitchen - leading-edge gap. 002-006, Cluster lobby door - top and leading-edge gaps. 040 - Cluster kitchen - top gap. Stairwell door - leading-edge and top gaps. First-floor: 101-006, Cluster lobby door - top and leading-edge gaps. 140 - Cluster kitchen - inside-edge and top gaps. 107-112, Cluster lobby door - leading-edge gap. Link door - inside-edge and top gaps. Link door to block B - top gap. Second-floor: 201-206, Cluster lobby door - top gap. 240 - Cluster kitchen - leading-edge gap. C13 - Leading-edge gap. 207-212, Cluster lobby door - top and leading-edge gap. 241 - Cluster kitchen - top gap. Link door to block B - top and leading-edge gaps. Third-floor: 301-306, Cluster lobby door - top and leading-edge gaps. 307-312, Cluster lobby door - top and leading-edge gaps. C17 - leading-edge gap. Link door - leading edge gap.</p>

Section	Common Area Fire Doors		
Action ID	544228		
Quantity		<p>Recommendation: The common area doors noted should be repaired (or if necessary replaced) to reduce the threshold gap to a maximum of 6mm. Alternatively, a threshold seal capable of resisting cold smoke should be fitted.</p>

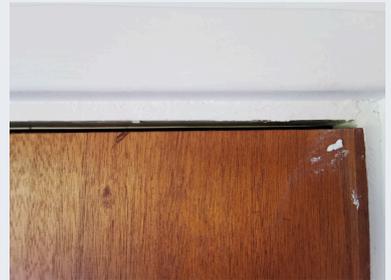
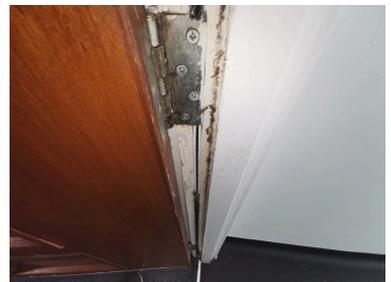
- Potential	22		
Priority	C	Due Date: 21/04/2022	Client Status: Assigned
Question	M.6	<p>Comment: The double doors to service/store cupboards do not have intumescent strips and cold smoke seals to the meeting stiles of the doors. Missing combined intumescent strips and cold smoke seals were also noted to 014 - Cluster kitchen door, 107-112 - Link door to Block B, 207-212 - Link door to block B and cluster kitchen 341. Cluster kitchens 340 and 141 were not accessible at the time of the assessment due to there being coded locks.</p>	
Section	Common Area Fire Doors		
Action ID	544225		
Quantity

- Known	15	<p>Recommendation: Common area fire doors as noted should be fitted with intumescent strips and smoke seals.</p>	
- Potential	15		
Priority	C	Due Date: 21/04/2022	Client Status: Assigned

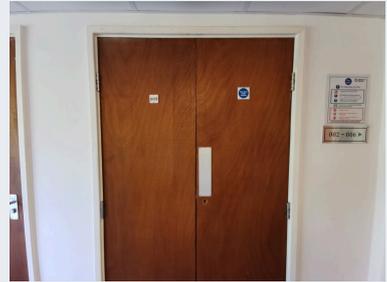
Question	O.2	<p>Comment: Fire door signage is not considered adequate. The following fire doors are provided with the wrong signage: C06, C10, C17, 307-312 (Electrical cupboard). - The fire door signage in situ should be replaced with 'Fire door keep locked' signage. The following fire door requires 'Fire door keep locked' signage: C03, C08, C12, C13, C16. (Both openable doors within the double door cupboards will require adequate fire door signage)</p> <p>Recommendation: Provide 'Fire door keep locked' notices to common area fire doors as noted.</p>

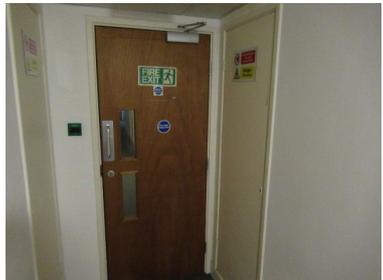
- Known	3		
- Potential	3		
Priority	R	Due Date: N/A	Client Status: Assigned
		Review Status: Unresolved	
Question	K.7	<p>Comment: Green break glasses have been actuated in a number of instances and/or doors separating clusters have been forced open causing the doors/frames to become faulty/damaged and in some cases resulting in the doors not being a good fit into the frame.</p>

Section	Means of Escape		
Action ID	304149		
Quantity		<p>Recommendation: Management should undertake a programme to regularly check the doors separating cluster accommodations to ensure/confirm the doors are in a satisfactory condition and the door/lock are effective.</p>

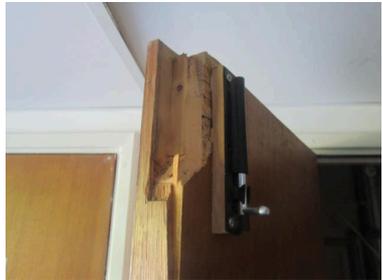
Question	M.2	<p>Comment: The following common area fire doors were noted as damaged and require replacing: The ground floor heating cupboard door and the top floor service cupboard door (opposite cluster kitchen 341) are damaged at the top of the doors where locks have been removed, the 1st floor heating cupboard door (C08) has been damaged and split on the inner face of the door, 1st floor service cupboard door (CO7) appears to be delaminating on the inside of the door,</p> <p>Recommendation: The common area fire door(s) as noted should be replaced with an FD30S lockable fire door.</p>

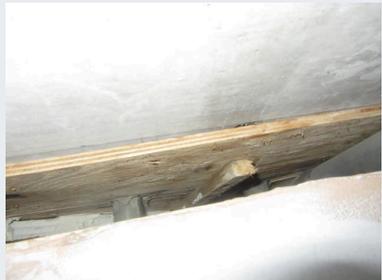
- Known	1		
- Potential	N/A		
Priority	R	Due Date: N/A	Client Status: Assigned
		Review Status: Unresolved	
Question	Q.2	<p>Comment: Voids were noted above some sampled sections of the false ceilings where services pass between the riser shafts and common parts.</p> <p>Recommendation: Management should undertake an intrusive inspection of the hidden voids above the false ceilings to confirm/ensure that compartmentation within is adequate between the riser shafts and common parts.</p>

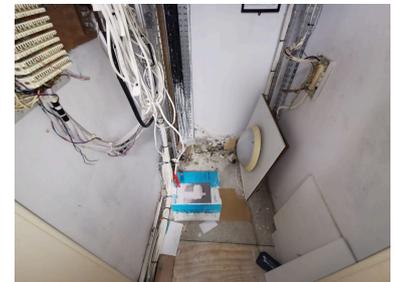
Comment: Previous recommendation - Discarded combustibles noted within a ground floor service cupboard CO5 and 2nd-floor service cupboard CO10 containing fixed electrical equipment.

Recommendation: All combustible items should be removed from the electrical intake cupboard as soon as possible and the door kept locked.

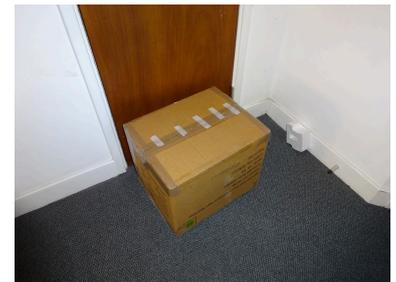
Comment: There were combustible items or waste materials in the escape routes. There was a cardboard box noted adjacent to C17. As the quantity involved is relatively minor this can be dealt with via written contact with the residents.

Recommendation: Management should contact residents to advise that the common area/escape routes should be kept free from all combustibles and/or trip hazards. A programme of regular checks should be put in place to ensure that the common area is kept clear.

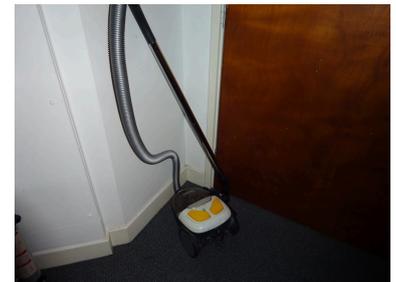
Comment: Previous recommendation - Discarded hoovers and ironing boards identified within the common circulation routes.

Recommendation: Management should contact residents to advise that the common area/escape routes should be kept free from all combustibles and/or trip hazards. A programme of regular checks should be put in place to ensure that the common area is kept clear.
