Fire Risk Assessment

Property assessed: B Lister Court Nightingale Avenue
London HA1 3GX

Client: Network Homes Ltd

FRA Inspection Date: 03/11/2021
FRA Issued to Client: 17/11/2021
FRA valid to: 17/11/2022
FRA completed by: Savills (UK) Ltd,
33 Margaret Street, London W1G 0JD
T: 020 7409 8737
E: fireriskhousing@savills.com

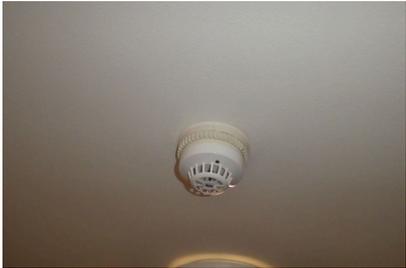
Question	P.9	<p>Comment: The security officer is the only member of staff on site at night. The housing manager advised that the security officer is not currently permitted to silence or reset the fire alarm system. It is therefore not immediately clear who will reset the fire alarm system if the system is falsely activated during the hours when the security officer is the only member of staff on site.</p>

Section	Means of Giving Warning in Case of Fire		
Action ID	730125		
Quantity		<p>Recommendation: A suitable protocol for the operation/ silencing/resetting of the panel should be introduced.</p>

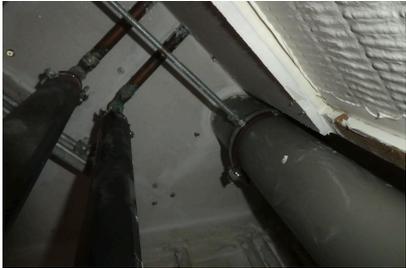
- Known	0		
- Potential	1		
Priority	Man2	Due Date: 17/02/2022	Client Status: Assigned
Question	Q.4	<p>Comment: There was evidence that fire-stopping works have been undertaken within the bedroom riser cupboards on the top floor. However, not all soil-pipes which enter the roof void have been provided with Intumescent collars. A number of bedroom riser cupboard have not been provided with a fire-rated collar (eg sample riser adjacent bedroom 318). .</p>

Section	Limiting Fire Spread		
Action ID	730122		
Quantity		<p>Recommendation: All top floor bedroom riser cupboards should be checked and a 60 minutes fire rated collar should be fitted around the non fire rated service pipe or duct up to 200mm diameter where they are found to be missing.</p>

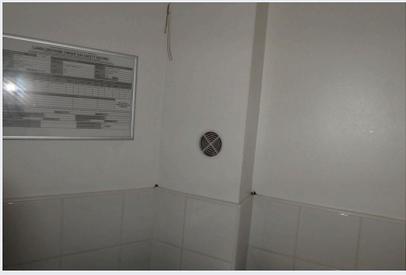
Question	Q.9	Comment: There are ventilation openings present in the wall of each kitchen. It is unclear if the presence of these ventilation openings compromise compartmentation at the premises.

Section	Limiting Fire Spread		
Action ID	730123		
Quantity		Recommendation: A check should be made to ensure that ventilation openings noted in each of the kitchens do not compromise compartmentation at the property.

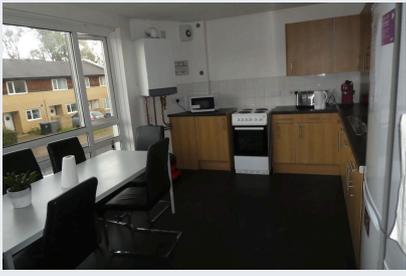
- Known	0		
- Potential	1		
Priority	Man2	Due Date: 17/02/2022	Client Status: Assigned
Question	E.4	Comment: No fire blanket is provided in the common kitchen.

Section	Cooking		
Action ID	730112		
Quantity		Recommendation: A fire blanket should be provided within each kitchen.

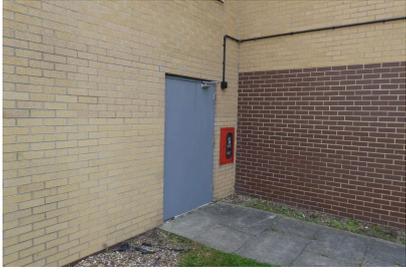
- Known	8		
- Potential	8		
Priority	B	Due Date: 17/11/2022	Client Status: Assigned
Question	O.4	Comment: Other fire safety signs issues noted include:- No fire exit keep clear signage fixed to the exit side of the final exit from the alternative staircase.

Section	Fire Safety Signs and Notices		
Action ID	730118		
Quantity		Recommendation: Fire exit keep clear signage should be fixed to the exit side of the final exit as noted.

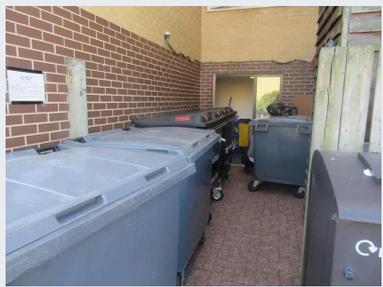
- Known	N/A			
- Potential	1			
Priority	Man2	Due Date: 31/03/2020	Client Status: Approved	
Question	C.2	<p>Comment: There was no designated bin storage area for the Paladin/Wheelie bins resulting in them being stored in inappropriate locations, close to the building.</p>

Section	Arson			
Action ID	130843			
Quantity		<p>Recommendation: As per previous recommendation, a suitable bin storage area should be provided at a safe distance from the building including any necessary hard standing, fencing and security arrangements.</p>

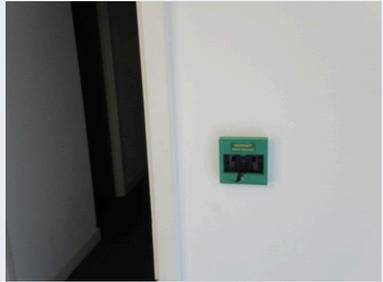
Question	K.7	Comment: Green break glasses have been actuated in a number of instances and/or doors separating clusters have been forced open causing the doors/frames to become faulty/damaged and in some cases resulting in the doors not being a good fit into the frame.

Section	Means of Escape		
Action ID	303965		
Quantity		Recommendation: Management should undertake a programme to regularly check the doors separating cluster accommodations to ensure/confirm the doors are in a satisfactory condition and the door/lock are effective.

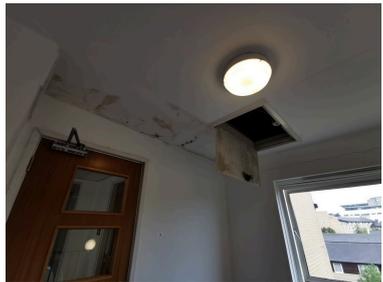
- Known	1		
- Potential	1		
Priority	Man2	Due Date: 31/03/2020	Client Status: Approved
Question	K.17	Comment: Other means of escape issues noted at the time of inspection include - The noted vents are not operational. The vent noted within the alternative escape stairs has been actuated but not retracted. The manual operation button for the skylight vent is not operational within the main stairwell.

Section	Means of Escape		
Action ID	544314		
Quantity		Recommendation: Management should arrange for the defects noted to the automatic smoke ventilation system to be rectified by the service engineer and the system to be confirmed as fully operational.

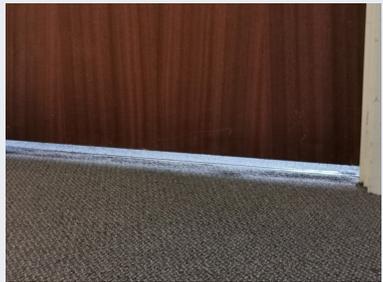
- Known	N/A		
- Potential	N/A		
Priority	Man1	Due Date: 21/11/2020	Client Status: Approved
Question	L.2	Comment: There is an excessive gap underneath bedroom 318's door noted at the time of the assessment.

Section	Flat Entrance/Residents' Bedroom/Bedsit Doors		
Action ID	544327		
Quantity		Recommendation: The bedroom door noted should be repaired (or if necessary replaced) to reduce the threshold gap to a maximum of 6mm. Alternatively, a threshold seal capable of resisting cold smoke should be fitted.

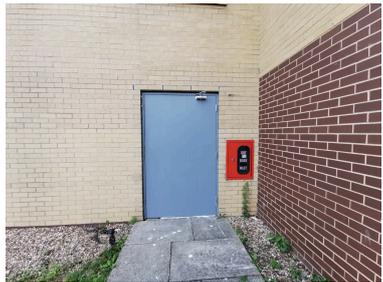
- Known	1		
- Potential	1		
Priority	C	Due Date: 21/04/2022	Client Status: Assigned
Question	N.3	Comment: The coverage of the emergency lighting provided is not considered adequate - emergency lighting should be provided externally adjacent to the alternative exit/fire exit door.

Section	Emergency Lighting		
Action ID	544316		
Quantity		Recommendation: Additional emergency lighting units should be provided to the areas noted in accordance with BS 5266-1:2016 and BS 5266-8:2004.

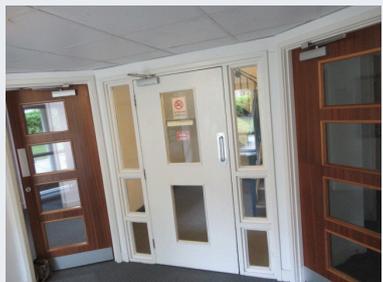
- Known	1		
- Potential	1		
Priority	C	Due Date: 21/04/2022	Client Status: Approved
Question	O.2	Comment: Fire door signage is not considered adequate. Door signage missing from both sides of the alternate ground floor final exit fire door. 'Push to open' signage missing from the ground floor alternate final exit fire door. Ground floor accommodation corridors and stair doors have no fire door signs.

Section	Fire Safety Signs and Notices		
Action ID	303961		
Quantity		Recommendation: Provide 'Fire door keep shut' notices to common area fire doors as noted.

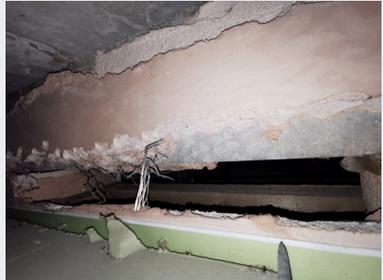
- Known	N/A			
- Potential	1			
Priority	Man2	Due Date: 01/02/2020	Client Status: Approved	
Question	Q.2	Comment: Compartmentation would not appear to be adequate. There were various compartmentation breaches noted throughout the escape route above the suspended ceilings adjacent to the bedroom riser cupboards. As previously recommended - an intrusive inspection should be undertaken throughout the communal areas (above suspended ceilings) and noted breaches fire-stopped to provide 60 minutes of fire-resistance. Breaches were noted above the suspended ceiling within the following areas: 013-018, above bedroom riser cupboards. 019-023, above bedroom riser cupboards. 113-118, above alternative escape route lobby door. 113-118, above bedroom riser cupboards. 119-124, above bedroom riser cupboards. 319-324, above bedroom riser cupboards. 313-318, to ceiling into the void space above. Second-floor lift lobby area above the ceiling adjacent to the lift access.

Section	Limiting Fire Spread			
Action ID	544322			
Quantity		Recommendation: The compartmentation breaches noted within the voids above the false ceilings should be made good with appropriate fire-resisting materials/ construction. Period of fire resistance required is 60 minutes.

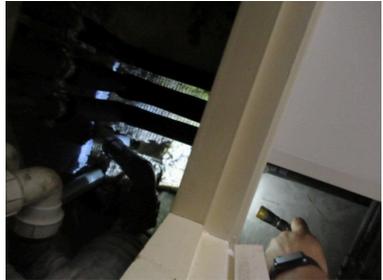
- Known	26			
- Potential	26			
Priority	B	Due Date: 21/10/2022	Client Status: Assigned	
Question	Q.3	Comment: A large hole was noted at the top of a shaft in the top floor staircase lobby. The top floor bedroom service riser cupboards have not been adequately separated from the roof void at ceiling level with fire-rated material. All the bedroom service riser cupboards appear not to be fire-stopped between the top of the cupboard and the communal corridor where services pass through. The same cupboards also appear to have no internal lining provided to the cupboards, above the door.

Section	Limiting Fire Spread			
Action ID	303963			
Quantity		Recommendation: The bedroom service riser cupboards as noted should be fire-stopped at ceiling level between the cupboards and the roof void. The bedroom service riser cupboards should be fire-stopped above the inside of the doors where services pass between the common corridor and the cupboard. Also to these cupboards, a fire rated lining should be provided to the inside of the cupboards above the door to achieve a minimum of 60 mins fire separation.

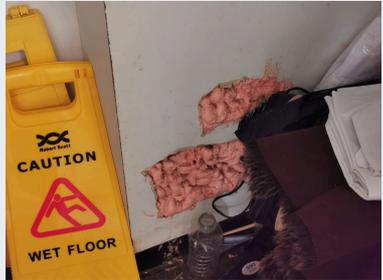
Question	Q.3	<p>Comment: The bedroom service riser cupboards on the ground, first and second-floors appear to have no internal lining provided within the cupboards and above the door. Network Homes confirmed previous recommendation is complete; to check all risers are suitably fire stopped - (All bedroom riser cupboards have been fire-stopped to the floor) The top floor bedroom riser cupboards have been fire stopped to the ceiling and above the door (Internally) to an adequate standard. Breaches were noted within the following cupboards at the time of the assessment: C02 - Hole to the boxing - excessive intumescent foam. B01 - breaches to wall at high level. C05 - Damage to boxing. B11 - breaches to ceiling around pipe egress.</p>

Section	Limiting Fire Spread			
Action ID	544320			
Quantity		<p>Recommendation: The casings/boxings noted should be repaired/replaced to provide 30 minutes fire resistance.</p>

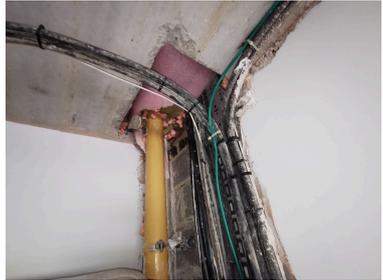
- Known	2			
- Potential	2			
Priority	B	Due Date: 21/10/2022	Client Status: Assigned	
Question	Q.3	<p>Comment: The bedroom service riser cupboards on the ground, first and second-floors appear to have no internal lining provided within the cupboards and above the door. Network Homes confirmed previous recommendation is complete; to check all risers are suitably fire stopped - (All bedroom riser cupboards have been fire-stopped to the floor) The top floor bedroom riser cupboards have been fire stopped to the ceiling and above the door (Internally) to an adequate standard. Breaches were noted within the following cupboards at the time of the assessment: C02 - Hole to the boxing - excessive intumescent foam. B01 - breaches to wall at high level. C05 - Damage to boxing. B11 - breaches to ceiling around pipe egress.</p>

Section	Limiting Fire Spread			
Action ID	544321			
Quantity		<p>Recommendation: The holes noted should be sealed with a suitable fire-stopping material such as an intumescent paste. Period of fire resistance required is 60 minutes.</p>

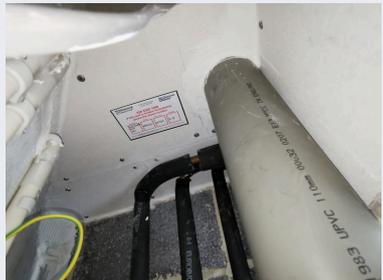
- Known	6			
- Potential	6			
Priority	B	Due Date: 21/10/2022	Client Status: Assigned	
Question	Q.4	<p>Comment: There was evidence that fire-stopping works have been undertaken within the bedroom riser cupboards on the top floor. However, not all soil-pipes which enter the roof void have been provided with Intumescent collars. Bedroom riser cupboard 321 has not been provided with a fire-rated collar.</p>

Section	Limiting Fire Spread			
Action ID	544319			
Quantity		<p>Recommendation: A 60 minutes fire rated collar should be fitted around the non fire rated service pipe or duct up to 200mm diameter as noted.</p>

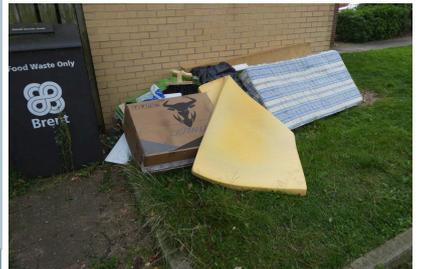
Comment: There was unnecessary fire load noted close to the building at the time of inspection. Items apparently dumped against the building.

Recommendation: The combustible items noted should be disposed of or removed a safe distance away from the exterior walls of the building.

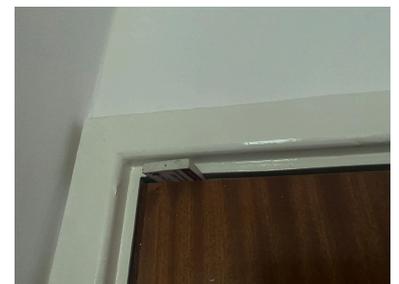
Question	L.2	Comment: An excessive gap was noted between the fire door and frame of the fire doorset to bedroom 213. Furthermore, an excessive threshold gap was noted beneath the door to bedroom 318.	
Section	Flat Entrance/Residents' Bedroom/Bedsit Doors		
Action ID	730114		
Quantity		Recommendation: The bedroom door noted should be repaired (or if necessary replaced) to reduce the perimeter gap between the door and frame to a maximum of 3mm.

Recommendation: The bedroom door noted should be repaired (or if necessary replaced) to reduce the perimeter gap between the door and frame to a maximum of 3mm.

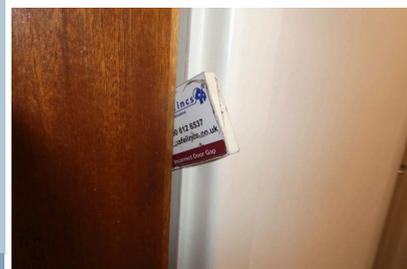
- Known	N/A		
- Potential	N/A		
Priority	Man2		
Question	M.2	<p>Comment: There are a significant number of fire doors at the premises that have excessive perimeter and/or threshold gaps, ineffective self-closing devices, damaged or missing intumescent strips and/or cold smoke seals, or are damaged. Due to the large number of doors that are defective (approximately 37), it is now considered appropriate to supersede the previous recommendations and instead recommend a full fire door survey.</p> <p>Recommendation: A comprehensive survey of all fire doorsets (including frames) should be commissioned using a registered fire door inspector to produce a schedule of works for repairs, upgrading and replacement as necessary (Approximately 37 common area fire doors defective)</p>	
Section	Common Area Fire Doors		
Action ID	730115		
Quantity		<p>Due Date: 17/02/2022</p> <p>Client Status: Assigned</p>

Recommendation: A comprehensive survey of all fire doorsets (including frames) should be commissioned using a registered fire door inspector to produce a schedule of works for repairs, upgrading and replacement as necessary (Approximately 37 common area fire doors defective)

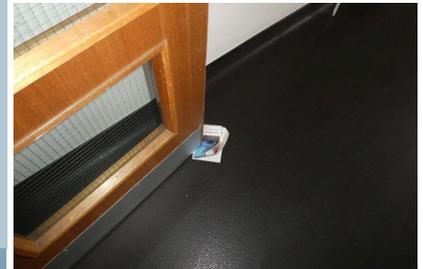
- Known	0		
- Potential	1		
Priority	Man2		
Question	M.7	<p>Comment: Common area fire doors were noted being wedged open or otherwise obstructed at the time of inspection. Door to kitchen 242 (cluster 219-224). The wedges/obstructions were removed by or for the assessor at the time of inspection.</p> <p>Recommendation: Management should inform/remind all staff and/or residents that self-closing fire doors must not be wedged open or otherwise obstructed. A programme of regular checks should be put in place to ensure that the fire doors remain unobstructed.</p>	
Section	Common Area Fire Doors		
Action ID	730116		
Quantity		<p>Due Date: 17/02/2022</p> <p>Client Status: Assigned</p>

Recommendation: Management should inform/remind all staff and/or residents that self-closing fire doors must not be wedged open or otherwise obstructed. A programme of regular checks should be put in place to ensure that the fire doors remain unobstructed.

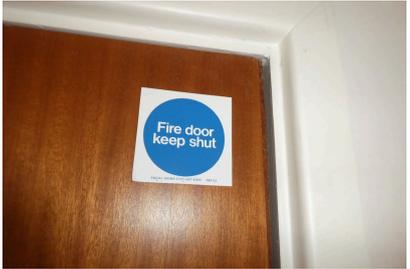
- Known	1		
- Potential	1		
Priority	C	Due Date: 17/05/2023	Client Status: Assigned
Question	O.2	Comment: Fire door signage is not considered adequate - The following fire doors are provided with the wrong signage: C02, C24 - The fire door signage in situ should be replaced with 'Fire door keep locked' signage. The following fire door require 'Fire door keep locked' signage: C04, C12, C14, C13, C22, C23, C33, C32, C31. (Both openable doors within the double door cupboards will require adequate fire door signage) The following fire doors require 'Fire door keep shut' signage to both sides of the doors at eye level: Ground-floor - door to cluster 013-018, door to cluster 019-023, stairwell door.	
Section	Fire Safety Signs and Notices		
Action ID	730117		
Quantity		Recommendation: Provide 'Fire door keep locked' and/or 'Fire door keep shut' notices to common area fire doors as required.

Recommendation: Provide 'Fire door keep locked' and/or 'Fire door keep shut' notices to common area fire doors as required.

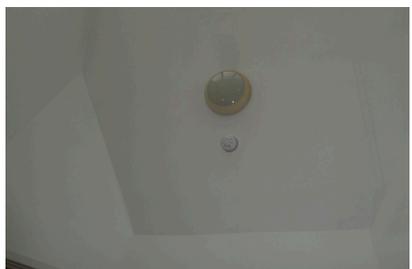
- Known	10		
- Potential	10		
Priority	C	Due Date: 17/05/2023	Client Status: Assigned
Question	P.11	Comment: The smoke head within the staircase is fitted at the lower level of the apex, and not at or near the apex as recommended within BS5839 Part 1.	
Section	Means of Giving Warning in Case of Fire		
Action ID	730121		
Quantity		Recommendation: The smoke head within the staircase should be relocated to the apex or near to the apex as recommended with BS65839 Part 1

Recommendation: The smoke head within the staircase should be relocated to the apex or near to the apex as recommended with BS65839 Part 1
