Fire Risk Assessment

Property assessed: 1-20 72 Cambridge Road London
NW6 5FN

Client: Network Homes Group

FRA Inspection Date: 23/11/2021
FRA Issued to Client: 10/12/2021
FRA valid to: 10/12/2022
FRA completed by: Savills (UK) Ltd,
33 Margaret Street, London W1G 0JD
T: 020 7409 8737
E: fireriskhousing@savills.com

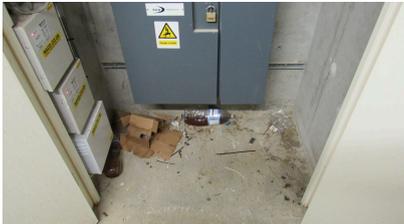
Details		Comments/recommendations	Photo
Question	G.2	<p>Comment: Combustible items were noted close to an ignition source. Basement floor - electrical riser-discarded packaging, Second floor - electrical riser-old service sheets, Sixth floor - electrical riser-discarded packaging. This issue should be dealt with as soon as possible.</p> <p>Recommendation: All combustible items should be removed from the electrical intake and riser cupboards as soon as possible and the door kept locked.</p>

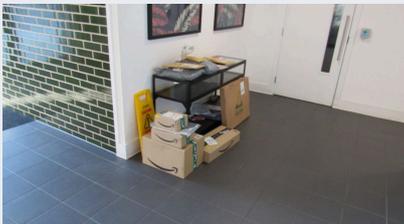
- Known	N/A		
- Potential	N/A		
Priority	Man1	Due Date: 10/01/2022	Client Status: Assigned
Question	G.3	<p>Comment: There were combustible items or waste materials in the escape routes. A large quantity of parcels in the entrance lobby, shoes, a scooter and a pushchair by flat 14, shoes by flat 6, shoes, a pushchair, a scooter and boxes by flat 8, shoes by flat 7, and a scooter, shoes and a pushchair by flat 3. Given the type and/or substantial quantity involved these should be cleared as soon as possible.</p> <p>Recommendation: The significant combustible items noted should be removed from the common area as soon as possible and a programme of regular checks put in place to ensure that the common area is kept clear.</p>

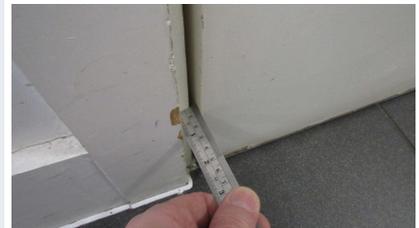
Question	M.2	<p>Comment: Excessive gaps were noted under some common area fire doors which will not resist the passage of cold smoke, Basement floor - store cupboard (under stairs)-18mm, store cupboard-13mm, single riser-19mm, electrical riser-18mm, water riser-19mm, duct riser-19mm, car par/lift lobby door-13mm, car park door-17mm, Ground floor - bicycle store door-20mm, bicycle lobby door-7mm, water riser-17mm, duct riser-6mm, stairs to basement lobby door-10mm, First floor - lobby-8mm, Second floor - lobby-13mm, electrical riser-13mm, water riser-13mm, Third floor - lobby-12mm, electrical riser-12mm, water riser-10mm, duct riser-6mm, Fourth floor - lobby-14mm, electrical riser-14mm, water riser-12mm, duct riser-9mm, Fifth floor - lobby-11mm, electrical riser-8mm, water riser-9mm, Sixth floor - lobby-8mm, electrical riser-10mm, water riser-9mm, duct riser-8mm, controls cupboard-10mm. Also it was noted some of the common fire doors have excessive perimeter gaps, Basement floor - single storage cupboard-6mm side, electrical riser-7mm centre gap, water riser-6mm centre gap, duct riser-5mm side, Ground floor - bicycle looy-6mm side, bicycle store-5mm side, duct riser-6mm top, basement access lobby door-6mm top, First floor - lobby-5mm top, water-8mm centre and 5mm top, duct riser-6mm top, Second floor - lobby-5mm top, electrical riser-5mm centre, duct riser-6mm top, Third floor - lobby-7mm top, electrical-7mm centre, water-5mm centre, duct-7mm top, Fourth floor - lobby-5mm top, Fifth floor - lobby-7mm top, electrical-6mm centre, water-7mm centre, duct-8mm top, Sixth floor - water-5mm centre, duct-7mm side, controls cupboard-6mm centre. Also the ground floor stairs lobby door is warped and not sitting into the frame.</p>

Quantity		<p>Recommendation: Common area doors and frames as noted should be replaced with E30S (FD30S) self-closing fire door sets, installed strictly in accordance with the manufacturer's test certification, including appropriate 'Fire door keep shut' signage to both sides. Ground floor stairs lobby door is warped and not sitting into the frame.</p>
- Known	1	
- Potential	1

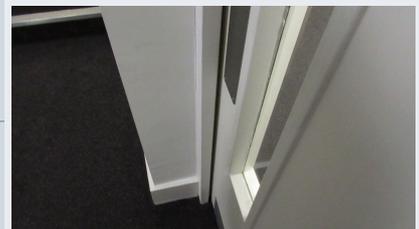
Question	M.5	<p>Comment: Not all self-closing devices fitted to common area fire doors (where required) are considered adequate, Second floor - lobby door. It was also noted that the bicycle store door is missing an adequate self closer.</p>
Section	Common Area Fire Doors	
Action ID	741817

Quantity		<p>Recommendation: The self-closing device should be repaired or an effective self-closing device should be fitted to the doors as noted. Second floor - lobby door.</p>
- Known	1	
- Potential	1

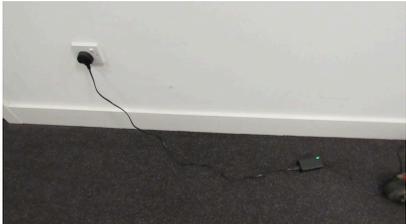
Question	A.5	Comment: Use of personal portable electrical appliances is prohibited within the common areas but this policy was not being adhered to. A scooter charging outside flat 14.

Section	Electrical Ignition Sources			
Action ID	741811			
Quantity		Recommendation: Management should confirm/ensure that the policy regarding use of personal portable electrical appliances within the common areas is enforced.

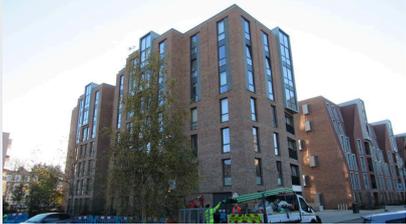
- Known	N/A			
- Potential	N/A			
Priority	Man2	Due Date: 10/03/2022	Client Status: Assigned	
Question	T.11	Comment: It is not known if routine fire safety checks are being carried out.

Section	Procedures and Arrangements			
Action ID	741820			
Quantity		Recommendation: Management should confirm/ensure that routine in-house fire safety checks are carried out on a regular basis (daily or weekly depending on building usage) and records kept on-site or in a central database.

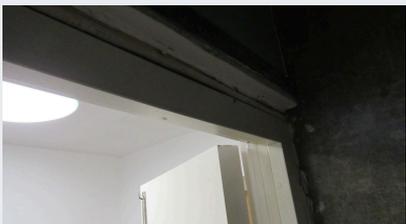
- Known	N/A			
- Potential	N/A			
Priority	Man2	Due Date: 10/03/2022	Client Status: Approved	
Question	M.8	Comment: Firestopping was missing or inadequate to the back of the frame of common area fire doors as noted:- Sixth floor - water riser is not adequately firestopped.

Section	Common Area Fire Doors			
Action ID	741818			
Quantity		Recommendation: Adequate firestopping should be provided/replaced to the back of the frame of the common area fire door set as noted using a suitable material such as an intumescent paste to ensure 30 minutes fire resistance is achieved.

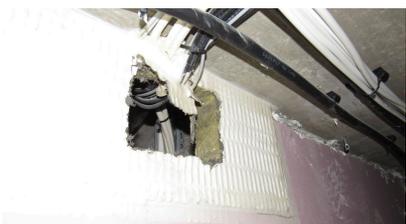
- Known	1			
- Potential	1			
Priority	B	Due Date: 10/12/2022	Client Status: Assigned	
Question	Q.2	Comment: Compartmentation breaches were noted from sample inspection of the voids above the false ceiling. Second floor - above the electrical riser door is a hole that has not been firestopped. Also the pipe exiting the refuse bin store does not appear to be adequately firestopped.

Section	Limiting Fire Spread			
Action ID	741822			
Quantity		Recommendation: The compartmentation breaches noted within the voids above the false ceilings should be made good with appropriate fire-resisting materials/ construction. The minimum period of fire resistance required is 60 minutes.

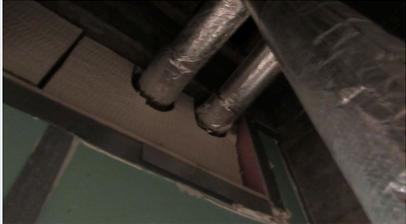
Question	Q.3	Comment: The services riser/cupboards sampled did not appear to be adequately fire resisting and/or fire-stopped. Firestopping was not adequately sealed within some of the service riser cupboards, Second floor - water riser, Sixth floor - water riser.

Section	Limiting Fire Spread			
Action ID	741819			
Quantity		Recommendation: The firestopping noted should be sealed with a suitable fire-stopping material such as an intumescent paste. The minimum period of fire resistance required is 60 minutes.

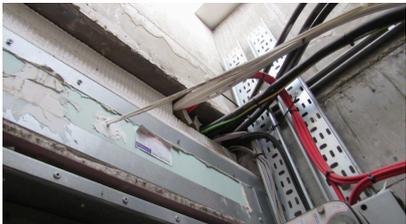
- Known	2			
- Potential	2			
Priority	B	Due Date: 10/12/2022	Client Status: Assigned	
Question	Q.4	Comment: Firestopping around services exiting the risers/ cupboards sampled would not appear to be adequate. Ground floor - electrical riser, water riser, First floor - electrical riser, water riser, Second floor - electrical riser, water riser, Third floor - electrical riser, water riser, Fourth floor - electrical riser, Fifth floor - electrical riser, water riser, Sixth floor - electrical riser, water riser and controls cupboard. The compartmentation above the car park access door does not appear adequately sealed.

Section	Limiting Fire Spread			
Action ID	741824			
Quantity		Recommendation: Firestopping around the service cable, pipe or duct (as noted) should be provided. The minimum period of fire resistance required is 60 minutes. Ground floor - electrical riser, water riser, First floor - electrical riser, water riser, Second floor - electrical riser, water riser, Third floor - electrical riser, water riser, Fourth floor - electrical riser, Fifth floor - electrical riser, water riser, Sixth floor - water riser and controls cupboard. The compartmentation above the car park access door does not appear adequately sealed.

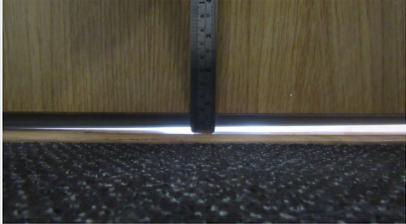
- Known	15			
- Potential	15			
Priority	B	Due Date: 10/12/2022	Client Status: Assigned	
Question	L.2	Comment: Excessive gaps were noted under some flat entrance doors which will not resist the passage of cold smoke. Flat 1-15mm, flat 2-13mm, flat 4-7mm, flat 5-7mm, flat 6-8mm, flat 7-12mm, flat 8-8mm, flat 11-8mm, flat 13-15mm, flat 15-5mm, flat 16-8mm, flat 17-8mm, flat 19-10mm, flat 20-5mm.

Section	Flat Entrance/Residents' Bedroom/Bedsit Doors			
Action ID	741813			
Quantity		Recommendation: The flat entrance doors noted should be repaired (or if necessary replaced) to reduce the threshold gap to a maximum of 3mm. Alternatively, a threshold seal capable of resisting cold smoke should be fitted.

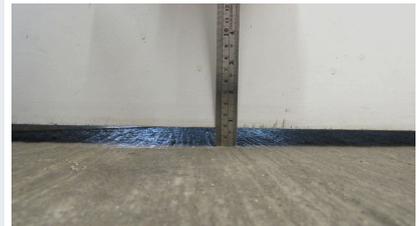
Question	M.2	Comment: Excessive gaps were noted under some common area fire doors which will not resist the passage of cold smoke, Basement floor - store cupboard (under stairs)-18mm, store cupboard-13mm, single riser-19mm, electrical riser-18mm, water riser-19mm, duct riser-19mm, car par/lift lobby door-13mm, car park door-17mm, Ground floor - bicycle store door-20mm, bicycle lobby door-7mm, water riser-17mm, duct riser-6mm, stairs to basement lobby door-10mm, First floor - lobby-8mm, Second floor - lobby-13mm, electrical riser-13mm, water riser-13mm, Third floor - lobby-12mm, electrical riser-12mm, water riser-10mm, duct riser-6mm, Fourth floor - lobby-14mm, electrical riser-14mm, water riser-12mm, duct riser-9mm, Fifth floor - lobby-11mm, electrical riser-8mm, water riser-9mm, Sixth floor - lobby-8mm, electrical riser-10mm, water riser-9mm, duct riser-8mm, controls cupboard-10mm. Also it was noted some of the common fire doors have excessive perimeter gaps, Basement floor - single storage cupboard-6mm side, electrical riser-7mm centre gap, water riser-6mm centre gap, duct riser-5mm side, Ground floor - bicycle looy-6mm side, bicycle store-5mm side, duct riser-6mm top, basement access lobby door-6mm top, First floor - lobby-5mm top, water-8mm centre and 5mm top, duct riser-6mm top, Second floor - lobby-5mm top, electrical riser-5mm centre, duct riser-6mm top, Third floor - lobby-7mm top, electrical-7mm centre, water-5mm centre, duct-7mm top, Fourth floor - lobby-5mm top, Fifth floor - lobby-7mm top, electrical-6mm centre, water-7mm centre, duct-8mm top, Sixth floor - water-5mm centre, duct-7mm side, controls cupboard-6mm centre. Also the ground floor stairs lobby door is warped and not sitting into the frame.

Section	Common Area Fire Doors		
Action ID	741814		
Quantity		Recommendation: The common area doors noted should be repaired (or if necessary replaced) to reduce the threshold gap to a maximum of 3mm. Alternatively, a threshold seal capable of resisting cold smoke should be fitted. Basement floor - store cupboard (under stairs)-18mm, store cupboard-13mm, single riser-19mm, electrical riser-18mm, water riser-19mm, duct riser-19mm, car par/lift lobby door-13mm, car park door-17mm, Ground floor - bicycle store door-20mm, bicycle lobby door-7mm, water riser-17mm, duct riser-6mm, stairs to basement lobby door-10mm, First floor - lobby-8mm, Second floor - lobby-13mm, electrical riser-13mm, water riser-13mm, Third floor - lobby-12mm, electrical riser-12mm, water riser-10mm, duct riser-6mm, Fourth floor - lobby-14mm, electrical riser-14mm, water riser-12mm, duct riser-9mm, Fifth floor - lobby-11mm, electrical riser-8mm, water riser-9mm, Sixth floor - lobby-8mm, electrical riser-10mm, water riser-9mm, duct riser-8mm, controls cupboard-10mm.

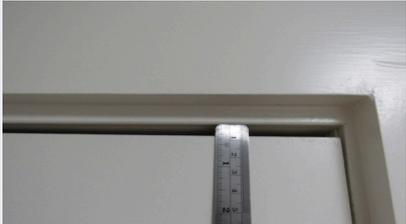
Question	M.2	<p>Comment: Excessive gaps were noted under some common area fire doors which will not resist the passage of cold smoke, Basement floor - store cupboard (under stairs)-18mm, store cupboard-13mm, single riser-19mm, electrical riser-18mm, water riser-19mm, duct riser-19mm, car par/lift lobby door-13mm, car park door-17mm, Ground floor - bicycle store door-20mm, bicycle lobby door-7mm, water riser-17mm, duct riser-6mm, stairs to basement lobby door-10mm, First floor - lobby-8mm, Second floor - lobby-13mm, electrical riser-13mm, water riser-13mm, Third floor - lobby-12mm, electrical riser-12mm, water riser-10mm, duct riser-6mm, Fourth floor - lobby-14mm, electrical riser-14mm, water riser-12mm, duct riser-9mm, Fifth floor - lobby-11mm, electrical riser-8mm, water riser-9mm, Sixth floor - lobby-8mm, electrical riser-10mm, water riser-9mm, duct riser-8mm, controls cupboard-10mm. Also it was noted some of the common fire doors have excessive perimeter gaps, Basement floor - single storage cupboard-6mm side, electrical riser-7mm centre gap, water riser-6mm centre gap, duct riser-5mm side, Ground floor - bicycle looy-6mm side, bicycle store-5mm side, duct riser-6mm top, basement access lobby door-6mm top, First floor - lobby-5mm top, water-8mm centre and 5mm top, duct riser-6mm top, Second floor - lobby-5mm top, electrical riser-5mm centre, duct riser-6mm top, Third floor - lobby-7mm top, electrical-7mm centre, water-5mm centre, duct-7mm top, Fourth floor - lobby-5mm top, Fifth floor - lobby-7mm top, electrical-6mm centre, water-7mm centre, duct-8mm top, Sixth floor - water-5mm centre, duct-7mm side, controls cupboard-6mm centre. Also the ground floor stairs lobby door is warped and not sitting into the frame.</p>

Section	Common Area Fire Doors		
Action ID	741815		
Quantity		<p>Recommendation: The fire doors noted should be repaired (or if necessary replaced) to reduce the perimeter gap between the door and frame to a maximum of 3mm. Basement floor - single storage cupboard-6mm side, electrical riser-7mm centre gap, water riser-6mm centre gap, duct riser-5mm side, Ground floor - bicycle looy-6mm side, bicycle store-5mm side, duct riser-6mm top, basement access lobby door-6mm top, First floor - lobby-5mm top, water-8mm centre and 5mm top, duct riser-6mm top, Second floor - lobby-5mm top, electrical riser-5mm centre, duct riser-6mm top, Third floor - lobby-7mm top, electrical-7mm centre, water-5mm centre, duct-7mm top, Fourth floor - lobby-5mm top, Fifth floor - lobby-7mm top, electrical-6mm centre, water-7mm centre, duct-8mm top, Sixth floor - water-5mm centre, duct-7mm side, controls cupboard-6mm centre.</p>

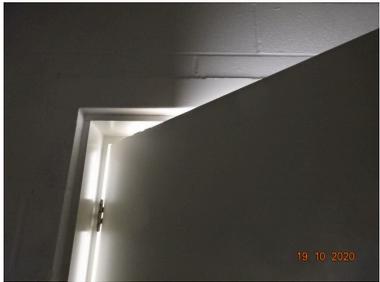
Question	M.5	Comment: Common area fire doors are generally fitted with adequate self-closing devices or are kept locked shut, however, the door into the bicycle store was not self-closing at the time of the assessment.

Section	Common Area Fire Doors			
Action ID	563225			
Quantity		Recommendation: An effective self-closing device should be fitted to the common area doors as noted.

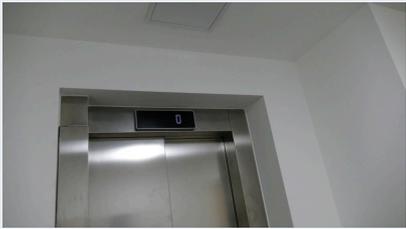
- Known	1			
- Potential	1			
Priority	A	Due Date: 26/02/2021	Client Status: No Access	
Question	O.4	Comment: 'In event of fire do not use lifts' signage has not been provided adjacent to the doors to the lift at each floor level.

Section	Fire Safety Signs and Notices			
Action ID	131973			
Quantity		Recommendation: Provide 'In event of fire do not use lifts' signage adjacent to the doors to the lift at each floor level.

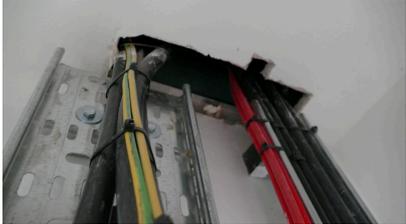
- Known	8			
- Potential	N/A			
Priority	C	Due Date: 30/03/2022	Client Status: No Access	
Question	Q.4	Comment: Suitable fire-stopping around services exiting the service riser cupboard located on the sixth floor stairway landing would not appear to be adequate.

Section	Limiting Fire Spread			
Action ID	131975			
Quantity		Recommendation: Suitable fire-stopping around the service cables and pipes within the service riser cupboard should be fitted to provide 60 minutes fire rating as noted.

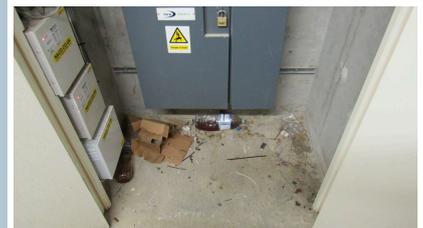
Comment: Combustible items were noted close to an ignition source. Basement floor - electrical riser-discarded packaging, Second floor - electrical riser-old service sheets, Sixth floor - electrical riser-discarded packaging. This issue should be dealt with as soon as possible.

Recommendation: All combustible items should be removed from the electrical intake and riser cupboards as soon as possible and the door kept locked.

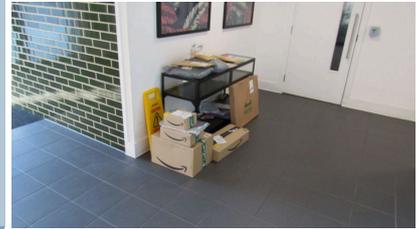
Question - G.3: Are escape routes kept clear of combustible items or waste materials?				No
Comment: There were combustible items or waste materials in the escape routes. A large quantity of parcels in the entrance lobby, shoes, a scooter and a pushchair by flat 14, shoes by flat 6, shoes, a pushchair, a scooter and boxes by flat 8, shoes by flat 7, and a scooter, shoes and a pushchair by flat 3. Given the type and/or substantial quantity involved these should be cleared as soon as possible.				
Recommendation: The significant combustible items noted should be removed from the common area as soon as possible and a programme of regular checks put in place to ensure that the common area is kept clear.				
Priority: Man1	Known Quantity: N/A	Potential Quantity: N/A	Action ID: 741823

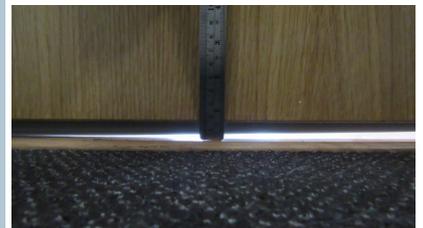
Comment: Excessive gaps were noted under some flat entrance doors which will not resist the passage of cold smoke. Flat 1-15mm, flat 2-13mm, flat 4-7mm, flat 5-7mm, flat 6-8mm, flat 7-12mm, flat 8-8mm, flat 11-8mm, flat 13-15mm, flat 15-5mm, flat 16-8mm, flat 17-8mm, flat 19-10mm, flat 20-5mm.

Recommendation: The flat entrance doors noted should be repaired (or if necessary replaced) to reduce the threshold gap to a maximum of 3mm. Alternatively, a threshold seal capable of resisting cold smoke should be fitted.

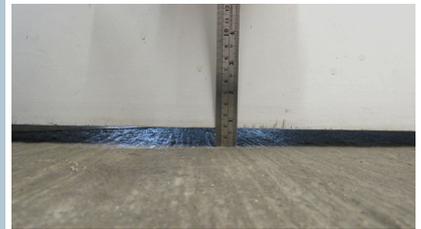
Comment: Excessive gaps were noted under some common area fire doors which will not resist the passage of cold smoke, Basement floor - store cupboard (under stairs)-18mm, store cupboard-13mm, single riser-19mm, electrical riser-18mm, water riser-19mm, duct riser-19mm, car par/lift lobby door-13mm, car park door-17mm, Ground floor - bicycle store door-20mm, bicycle lobby door-7mm, water riser-17mm, duct riser-6mm, stairs to basement lobby door-10mm, First floor - lobby-8mm, Second floor - lobby-13mm, electrical riser-13mm, water riser-13mm, Third floor - lobby-12mm, electrical riser-12mm, water riser-10mm, duct riser-6mm, Fourth floor - lobby-14mm, electrical riser-14mm, water riser-12mm, duct riser-9mm, Fifth floor - lobby-11mm, electrical riser-8mm, water riser-9mm, Sixth floor - lobby-8mm, electrical riser-10mm, water riser-9mm, duct riser-8mm, controls cupboard-10mm. Also it was noted some of the common fire doors have excessive perimeter gaps, Basement floor - single storage cupboard-6mm side, electrical riser-7mm centre gap, water riser-6mm centre gap, duct riser-5mm side, Ground floor - bicycle looy-6mm side, bicycle store-5mm side, duct riser-6mm top, basement access lobby door-6mm top, First floor - lobby-5mm top, water-8mm centre and 5mm top, duct riser-6mm top, Second floor - lobby-5mm top, electrical riser-5mm centre, duct riser-6mm top, Third floor - lobby-7mm top, electrical-7mm centre, water-5mm centre, duct-7mm top, Fourth floor - lobby-5mm top, Fifth floor - lobby-7mm top, electrical-6mm centre, water-7mm centre, duct-8mm top, Sixth floor - water-5mm centre, duct-7mm side, controls cupboard-6mm centre. Also the ground floor stairs lobby door is warped and not sitting into the frame.

Recommendation: The common area doors noted should be repaired (or if necessary replaced) to reduce the threshold gap to a maximum of 3mm. Alternatively, a threshold seal capable of resisting cold smoke should be fitted. Basement floor - store cupboard (under stairs)-18mm, store cupboard-13mm, single riser-19mm, electrical riser-18mm, water riser-19mm, duct riser-19mm, car par/lift lobby door-13mm, car park door-17mm, Ground floor - bicycle store door-20mm, bicycle lobby door-7mm, water riser-17mm, duct riser-6mm, stairs to basement lobby door-10mm, First floor - lobby-8mm, Second floor - lobby-13mm, electrical riser-13mm, water riser-13mm, Third floor - lobby-12mm, electrical riser-12mm, water riser-10mm, duct riser-6mm, Fourth floor - lobby-14mm, electrical riser-14mm, water riser-12mm, duct riser-9mm, Fifth floor - lobby-11mm, electrical riser-8mm, water riser-9mm, Sixth floor - lobby-8mm, electrical riser-10mm, water riser-9mm, duct riser-8mm, controls cupboard-10mm.

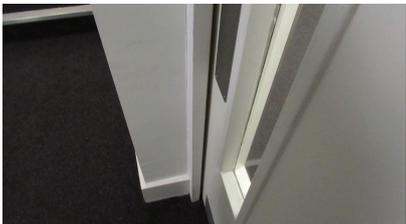
Comment: Not all self-closing devices fitted to common area fire doors (where required) are considered adequate, Second floor - lobby door. It was also noted that the bicycle store door is missing an adequate self closer.

Recommendation: The self-closing device should be repaired or an effective self-closing device should be fitted to the doors as noted. Second floor - lobby door.

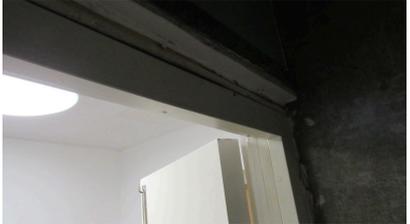
Question - M.8: Are all other common area fire door issues satisfactory?			No
Comment: Firestopping was missing or inadequate to the back of the frame of common area fire doors as noted:- Sixth floor - water riser is not adequately firestopped.			
Recommendation: Adequate firestopping should be provided/replaced to the back of the frame of the common area fire door set as noted using a suitable material such as an intumescent paste to ensure 30 minutes fire resistance is achieved.

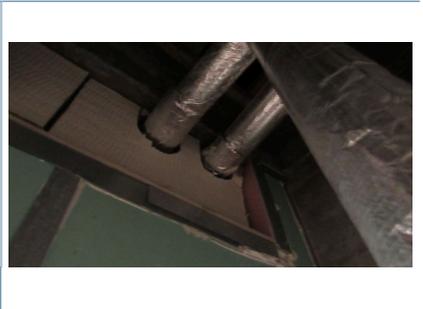
Question - Q.3: Are services risers, shafts, ducts and cupboards in the common area appropriately enclosed with fire resisting construction and adequately fire-stopped?	No
Comment: The services riser/cupboards sampled did not appear to be adequately fire resisting and/or fire-stopped. Firestopping was not adequately sealed within some of the service riser cupboards, Second floor - water riser, Sixth floor - water riser.

Recommendation: The firestopping noted should be sealed with a suitable fire-stopping material such as an intumescent paste. The minimum period of fire resistance required is 60 minutes.			
Priority: B	Known Quantity: 2	Potential Quantity: 2	Action ID: 741819

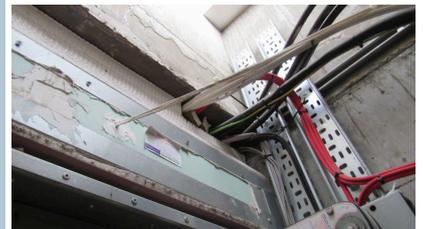
Question - Q.4: Are pipes and other services provided with adequate fire-stopping measures as required where they pass through fire resisting construction? (Consider fire collars etc) No

Recommendation: Firestopping around the service cable, pipe or duct (as noted) should be provided. The minimum period of fire resistance required is 60 minutes. Ground floor - electrical riser, water riser, First floor - electrical riser, water riser, Second floor - electrical riser, water riser, Third floor - electrical riser, water riser, Fourth floor - electrical riser, Fifth floor - electrical riser, water riser, Sixth floor - water riser and controls cupboard. The compartmentation above the car park access door does not appear adequately sealed.
