Fire Risk Assessment

Property assessed: 1-140 Avery Court 40, 41 & 45
Capitol Way London NW9 0AU

Client: Network Homes Group

FRA Inspection Date: 20/06/2022
FRA Issued to Client: 28/06/2022
FRA valid to: 28/06/2023
FRA completed by: Savills (UK) Ltd,
33 Margaret Street, London W1G 0JD
T: 020 7409 8737
E: fireriskhousing@savills.com

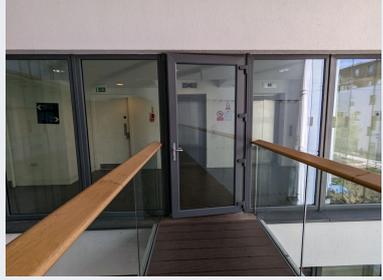
Question	K.5	<p>Comment: Some doors along the escape routes are fitted with locks which require the use of a key to open them and may not be suitable for means of escape - the door along the link balcony leading into the 3rd floor lift lobby of 1 - 62 Avery Court; the 2 doors on the 5th floor (106 - 140 Avery Court) which lead from the external balcony approach of Flats 138 & 139 into the main building.</p>

Section	Means of Escape		
Action ID	844109		
Quantity		<p>Recommendation: The locking devices fitted to the doors along escape routes (as noted) should be removed or replaced with locks which can be easily opened without the use of a key.</p>

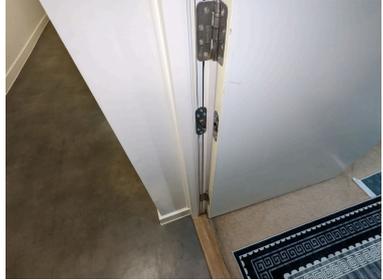
- Known	3		
- Potential	3		
Priority	A	Due Date: 28/09/2022	Client Status: Assigned
Question	L.6	<p>Comment: Network Homes advises that flat entrance doors are checked for adequacy (including self-closers and intumescent strips and smoke seals) as part of a rolling programme. The self closing mechanism fitted to the flat entrance door to Flat 5 (sampled flat) was damaged/disconnected from the door. The self closing mechanism fitted to the flat entrance door to Flat 87 requires adjustment as the door slams shut (which may lead to damaged to the door/frame). All other flat entrance doors sampled at the time of my inspection were fitted with adequate self closing mechanisms (Flats 7, 67, 83, 84, 110, 111, 115, 121 & 130). No access to other flats.</p>

Section	Flat Entrance/Residents' Bedroom/Bedsit Doors		
Action ID	844111		
Quantity		<p>Recommendation: An effective self-closing device should be fitted to the flat entrance door to Flat 5 as noted.</p>

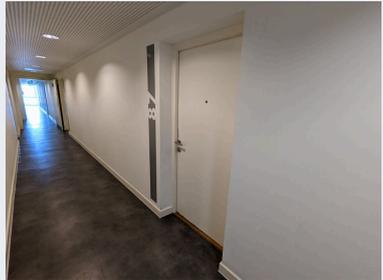
- Known	1		
- Potential	1		
Priority	A	Due Date: 28/09/2022	Client Status: Assigned
Question	L.6	<p>Comment: Network Homes advises that flat entrance doors are checked for adequacy (including self-closers and intumescent strips and smoke seals) as part of a rolling programme. The self closing mechanism fitted to the flat entrance door to Flat 5 (sampled flat) was damaged/disconnected from the door. The self closing mechanism fitted to the flat entrance door to Flat 87 requires adjustment as the door slams shut (which may lead to damaged to the door/frame). All other flat entrance doors sampled at the time of my inspection were fitted with adequate self closing mechanisms (Flats 7, 67, 83, 84, 110, 111, 115, 121 & 130). No access to other flats.</p>

Section	Flat Entrance/Residents' Bedroom/Bedsit Doors		
Action ID	844112		
Quantity		<p>Recommendation: The self-closing device fitted to the flat entrance door to Flat 87 as noted should be repaired or adjusted to ensure the door closes fully from all angles and does not slam shut.</p>

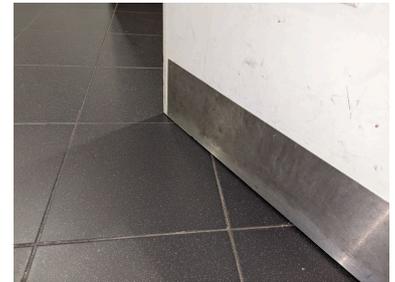
Question	M.2	<p>Comment: The following issues were noted to common area fire doors: - Excessive perimeter and/or threshold gaps were noted to a large number of common area fire doors throughout the building including stairwell doors, electrical riser cupboard doors, cross corridor doors, etc. It was evident at the time of my inspection that the issues identified within the previous report had not been rectified and additional issues were also noted. Management confirmed that they were aware the issues noted and that a full fire door survey is being carried out to identify/rectify all defects to common area fire doors.</p> <p>- The management office door (mezzanine level within 1-62 Avery Court) did not fully self close into the frame as the base of the door become wedged open on the tiled floor. - The 3rd floor stairwell door (106 - 140 Avery Court) was misaligned with the frame and could not close flush into the frame.</p>

Section	Common Area Fire Doors		
Action ID	844125		
Quantity		<p>Recommendation: Minor joinery repairs are required to the door/frame as noted - The management office door (mezzanine level within 1-62 Avery Court) should be trimmed/adjusted so that the base of the door does not become wedged on the flooring and the door is able to fully self close into the frame.</p>

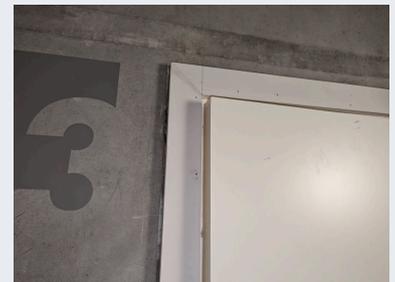
Question	M.2	<p>Comment: The following issues were noted to common area fire doors: - Excessive perimeter and/or threshold gaps were noted to a large number of common area fire doors throughout the building including stairwell doors, electrical riser cupboard doors, cross corridor doors, etc. It was evident at the time of my inspection that the issues identified within the previous report had not been rectified and additional issues were also noted. Management confirmed that they were aware the issues noted and that a full fire door survey is being carried out to identify/rectify all defects to common area fire doors.</p> <p>- The management office door (mezzanine level within 1-62 Avery Court) did not fully self close into the frame as the base of the door become wedged open on the tiled floor. - The 3rd floor stairwell door (106 - 140 Avery Court) was misaligned with the frame and could not close flush into the frame.</p>

Section	Common Area Fire Doors		
Action ID	844126		
Quantity		<p>Recommendation: Minor joinery repairs are required to the doors/frames as noted - The 3rd floor stairwell door (106 - 140 Avery Court) requires repair/adjustment so that the door can be closed flush into the frame.</p>

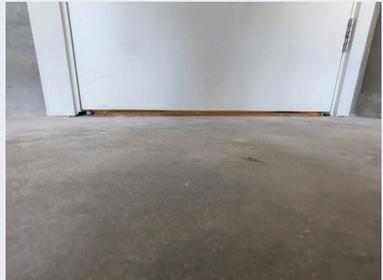
Question	M.2	<p>Comment: The following issues were noted to common area fire doors: - Excessive perimeter and/or threshold gaps were noted to a large number of common area fire doors throughout the building including stairwell doors, electrical riser cupboard doors, cross corridor doors, etc. It was evident at the time of my inspection that the issues identified within the previous report had not been rectified and additional issues were also noted. Management confirmed that they were aware the issues noted and that a full fire door survey is being carried out to identify/rectify all defects to common area fire doors.</p> <p>- The management office door (mezzanine level within 1-62 Avery Court) did not fully self close into the frame as the base of the door become wedged open on the tiled floor. - The 3rd floor stairwell door (106 - 140 Avery Court) was misaligned with the frame and could not close flush into the frame.</p>

Section	Common Area Fire Doors		
Action ID	844113		
Quantity		<p>Recommendation: Management to ensure that a full fire door survey is carried out by an FDIS consultant on the common area fire doors throughout the building in order to identify/rectify all defects.</p>

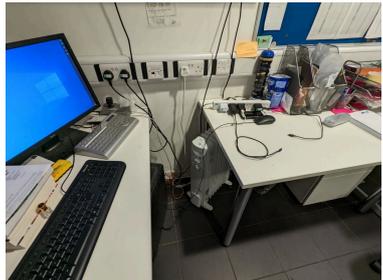
- Known	0		
- Potential	1		
Priority	Man2	Due Date: 28/09/2022	Client Status: Assigned
Question	A.6	<p>Comment: The use of multi-way adaptors and/or extension leads observed during the inspection was not considered acceptable. Multi-way plug adaptors were seen in regular use within the management office.</p>

Section	Electrical Ignition Sources		
Action ID	844105		
Quantity		<p>Recommendation: Additional fixed sockets should be provided in the locations noted within the common areas to limit the use of adaptors and leads.</p>

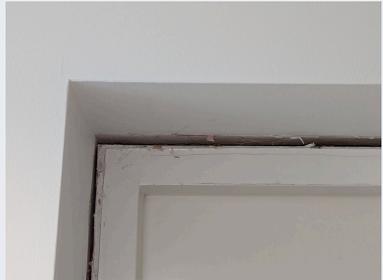
- Known	2		
- Potential	2		
Priority	B	Due Date: 28/06/2023	Client Status: Assigned
Question	L.9	<p>Comment: Firestopping was missing or inadequate around the door frame of Flat 34.</p>

Section	Flat Entrance/Residents' Bedroom/Bedsit Doors		
Action ID	844128		
Quantity		<p>Recommendation: Adequate firestopping should be provided/replaced around the door frame of Flat 34 as noted using a suitable material such as an intumescent paste to ensure 30 minutes fire resistance is achieved.</p>

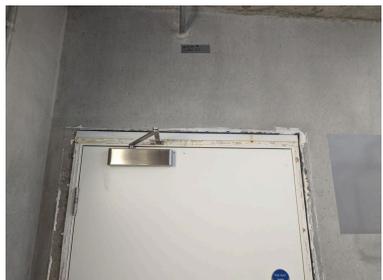
- Known	1		
- Potential	1		
Priority	B	Due Date: 28/06/2023	Client Status: Assigned
Question	M.8	<p>Comment: Firestopping was missing or inadequate to the back of the frame of common area fire doors as noted:- 5th floor stairwell door (adjacent to Flat 140). Management confirms via the Riskhub Client Portal that the previous recommendation is Assigned so this has been marked as Unresolved</p>

Section	Common Area Fire Doors		
Action ID	844127		
Quantity		<p>Recommendation: Adequate firestopping should be provided/replaced to the back of the frame of the common area fire door set as noted using a suitable material such as an intumescent paste to ensure 30 minutes fire resistance is achieved.</p>

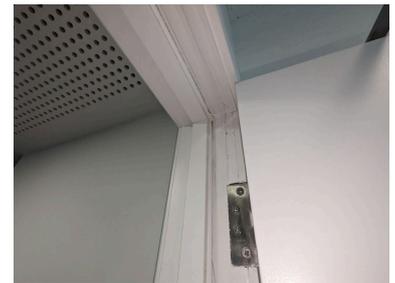
Question	M.6	<p>Comment: Common area fire doors are provided with adequate intumescent strips and smoke seals except for: - Some common area fire doors are fitted with intumescent strips only (no cold smoke seals) - Stairwell doors on the 1st, 2nd, 3rd, 4th and 6th floors (1-62 Avery Court), doors to flat lobbies on the 1st, 2nd, 3rd and 4th floors (1 - 62 Avery Court), electrical intake/meter cupboard doors on the 2nd and 3rd floors (1-62 Avery Court), stairwell door on the 4th floor (adjacent to Flat 133), leading edges of the double doorsets to the balcony/atrium on the 2nd, 3rd and 4th floors (63 - 105 Avery Court). - There was a small section of intumescent strip/cold smoke seal missing from the cross corridor door adjacent to Flat 13. - The cold smoke seal was missing/damaged to the top of the door frame to the 2nd floor double doorset to the balcony/atrium (63 - 105 Avery Court) and the cross corridor door adjacent to Flat 135. Management confirms via the Riskhub Client Portal that the previous recommendations are Assigned so these have been marked as Unresolved</p>

Section	Common Area Fire Doors		
Action ID	844116		
Quantity		<p>Recommendation: The damaged/missing cold smoke seals should be replaced on the doors or frames as noted (top of the door frame to the 2nd floor double doorset to the balcony/atrium (63 - 105 Avery Court) and the cross corridor door adjacent to Flat 135). The strips and seals to all edges should be replaced to ensure that compatibility is maintained.</p>

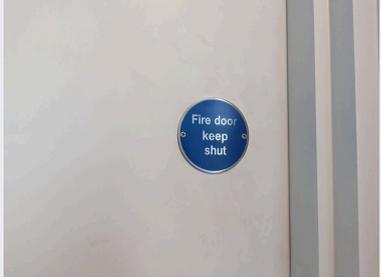
Question	O.2	<p>Comment: Fire door signage is not considered adequate:</p> <ul style="list-style-type: none"> - Some common area fire doors which are fitted with magnetic hold open devices are also fitted with inappropriate 'fire door keep shut' signage. These signs should be replaced with the appropriate 'Automatic fire door keep clear' signage: lobby door leading to Flats 16-18, lobby door leading to Flats 19-20, lobby door leading to Flats 21-23, lobby door leading to Flats 24-25, lobby door leading to Flats 39-41, lobby door leading to Flats 42-43, cross corridor door adjacent to Flat 57, cross corridor door adjacent to Flat 104 and the 2nd floor double doors leading to the balcony/atrium (63 - 105 Avery Court). - All electrical intake/meter cupboards throughout the building were fitted with 'fire door keep shut' signage, however, these should be replaced with 'fire door keep locked shut' signage. - An 'automatic fire door keep clear' sign was fitted to the management office door, however, there is no hold open device fitted to the door and this should be replaced with a 'fire door keep shut' sign. Management confirms via the Riskhub Client Portal that the previous recommendation is Assigned so this has been marked as Unresolved.

Section	Fire Safety Signs and Notices		
Action ID	844119		
Quantity		<p>Recommendation: Replace the incorrect 'fire door keep shut' signage with 'Fire door keep locked' signage to all electrical intake/meter cupboards as noted.</p>

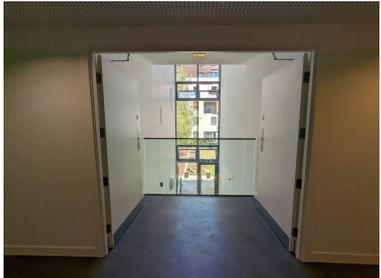
- Known	16		
- Potential	16		
Priority	C	Due Date: 28/12/2023	Client Status: Assigned
Question	O.2	<p>Comment: Fire door signage is not considered adequate:</p> <ul style="list-style-type: none"> - Some common area fire doors which are fitted with magnetic hold open devices are also fitted with inappropriate 'fire door keep shut' signage. These signs should be replaced with the appropriate 'Automatic fire door keep clear' signage: lobby door leading to Flats 16-18, lobby door leading to Flats 19-20, lobby door leading to Flats 21-23, lobby door leading to Flats 24-25, lobby door leading to Flats 39-41, lobby door leading to Flats 42-43, cross corridor door adjacent to Flat 57, cross corridor door adjacent to Flat 104 and the 2nd floor double doors leading to the balcony/atrium (63 - 105 Avery Court). - All electrical intake/meter cupboards throughout the building were fitted with 'fire door keep shut' signage, however, these should be replaced with 'fire door keep locked shut' signage. - An 'automatic fire door keep clear' sign was fitted to the management office door, however, there is no hold open device fitted to the door and this should be replaced with a 'fire door keep shut' sign. Management confirms via the Riskhub Client Portal that the previous recommendation is Assigned so this has been marked as Unresolved.

Section	Fire Safety Signs and Notices		
Action ID	844120		
Quantity		<p>Recommendation: 'Automatic fire door keep clear' signs should be provided to the 2nd floor double doors leading to the balcony/atrium (63-105 Avery Court) as noted.</p>

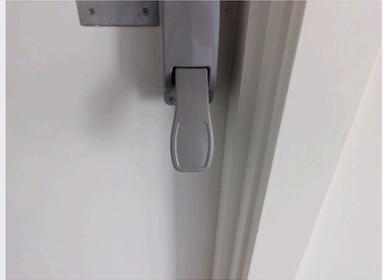
Question	O.4	<p>Comment: Other fire safety signs issues noted include: - The 'push to open' signage is faded/missing from the push pads fitted to stairwell doors throughout the building. This signage is required to illustrate how to open these doors fitted along the means of escape.</p>

Section	Fire Safety Signs and Notices		
Action ID	844124		
Quantity		<p>Recommendation: Provide 'Push to open' signage to the push pads fitted to the stairwell doors in all blocks.</p>

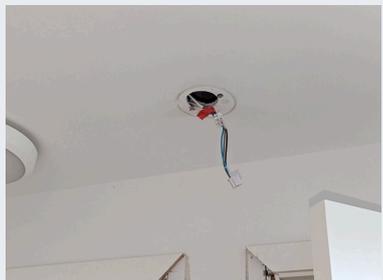
- Known	5		
- Potential	5		
Priority	C	Due Date: 28/12/2023	Client Status: Assigned
Question	P.5	<p>Comment: Network Homes advises that flats are checked for working hard-wired smoke alarms as part of a rolling programme: No suitable Grade D smoke alarm was noted in the entrance hallway of Flat 83. The wiring appears to be present, however, the Grade D alarm has been removed (N.B. - The flat is currently vacant whilst maintenance work is carried out within the flat to resolve a water ingress/damp issue); The Grade D smoke alarm fitted in the entrance hallway of Flat 7 is not securely fixed to the ceiling and some cables/wiring appear to be disconnected; Grade D smoke alarms were noted within the entrance hallways of sampled Flats 5, 67, 84, 87, 110, 111, 115, 1221 & 130); No access to other flats.</p>

Section	Means of Giving Warning in Case of Fire		
Action ID	844122		
Quantity		<p>Recommendation: A Grade D1 LD2 smoke alarm system to BS 5839-6:2019 should be installed in Flat 83 as noted.</p>

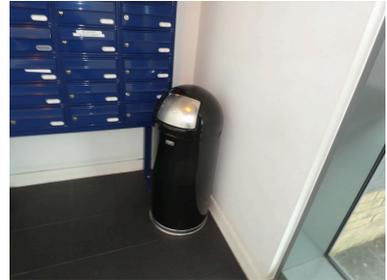
Details		Comments/recommendations	Photo
Question	G.3	<p>Comment: There were combustible items or waste materials in the escape routes. Bins located on the ground floor of all 3 staircases, and an items outside of flat 44. As the quantity involved is relatively minor this can be dealt with via written contact with the residents.</p>

Section	House-Keeping		
Action ID	669537		
Quantity		<p>Recommendation: Management should contact residents to advise that the common area/escape routes should be kept free from all combustibles and/or trip hazards. A programme of regular checks should be put in place to ensure that the common area is kept clear.</p>

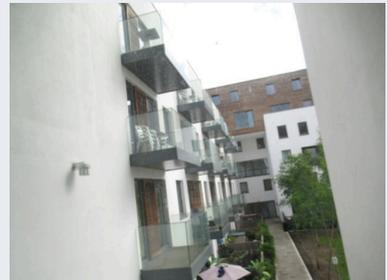
- Known	N/A		
- Potential	N/A		
Priority	Man2	Due Date: 15/09/2021	Client Status: Approved
Question	G.6	<p>Comment: It was noted that private balconies are provided. MHCLG have identified this as an area of risk in their 'Advice Note on Balconies on Residential Buildings'.</p>

Section	House-Keeping		
Action ID	488829		
Quantity		<p>Recommendation: Management should confirm/ensure that a policy is in place and communicated to residents which covers what can and cannot be stored and used on balconies. This should include policy/advice on combustible storage, smoking materials and barbecue use.</p>

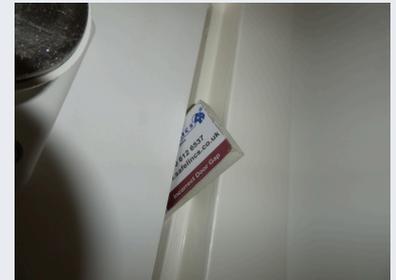
Question	M.2	<p>Comment: All common area fire rated fire doors appear to be in good condition except for the following which have an excessive perimeter gap between the fire door and frame:: Fire door to staircase 1-62 6th floor, door to staircase 1-62 4th floor, door to lobby to 44-46, door to lobby to 42 & 43, door to staircase 1-62 3rd floor, door to lobby to 39-41, cross corridor fire door adjacent to 28, door to the lobby to flats 24 & 25, door to lobby to flats 21-23, door to lobby to 19 & 20, cross corridor door adjacent to flat 13, door to the bin store within staircase 1-62, door to bin store within staircase 63-105, door to service cupboard opposite flat 136, double doorset to balcony atrium 4th floor, cross corridor door adjacent to flat 88, door to the central staircase 3rd floor, door to atrium balcony 3rd floor, cross corridor door adjacent to flat 78, door to services cupboard opposite flat 120, door to atrium balcony 2nd floor, cross corridor door adjacent to flat 76, & door to staircase 62-105 1st floor, Furthermore, the following fire doors were found to have an excessive threshold gap:- door to staircase 1-62 3rd floor, door to the central staircase 2nd floor, door to staircase adjacent to flat 92, and door to the main staircase ground floor.</p>

Quantity		<p>Recommendation: The fire doors noted should be repaired (or if necessary replaced) to reduce the perimeter gap between the door and frame to a maximum of 3mm.</p>
- Known	23	
- Potential	23

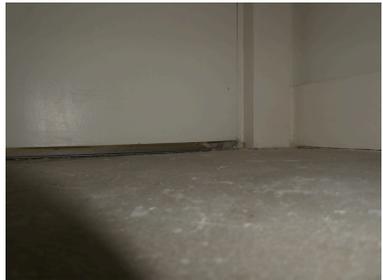
Question	M.2	<p>Comment: All common area fire rated fire doors appear to be in good condition except for the following which have an excessive perimeter gap between the fire door and frame:: Fire door to staircase 1-62 6th floor, door to staircase 1-62 4th floor, door to lobby to 44-46, door to lobby to 42 & 43, door to staircase 1-62 3rd floor, door to lobby to 39-41, cross corridor fire door adjacent to 28, door to the lobby to flats 24 & 25, door to lobby to flats 21-23, door to lobby to 19 & 20, cross corridor door adjacent to flat 13, door to the bin store within staircase 1-62, door to bin store within staircase 63-105, door to service cupboard opposite flat 136, double doorset to balcony atrium 4th floor, cross corridor door adjacent to flat 88, door to the central staircase 3rd floor, door to atrium balcony 3rd floor, cross corridor door adjacent to flat 78, door to services cupboard opposite flat 120, door to atrium balcony 2nd floor, cross corridor door adjacent to flat 76, & door to staircase 62-105 1st floor, Furthermore, the following fire doors were found to have an excessive threshold gap:- door to staircase 1-62 3rd floor, door to the central staircase 2nd floor, door to staircase adjacent to flat 92, and door to the main staircase ground floor.</p>

Section	Common Area Fire Doors		
Action ID	669536		
Quantity		<p>Recommendation: The common area doors noted should be repaired (or if necessary replaced) to reduce the threshold gap to a maximum of 6mm. Alternatively, a threshold seal capable of resisting cold smoke should be fitted.</p>

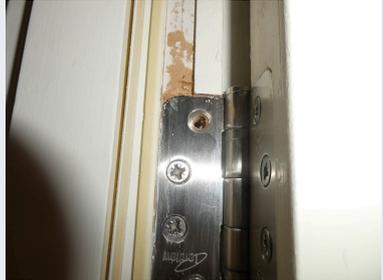
- Known	1		
- Potential	1		
Priority	C	Due Date: 15/12/2022	Client Status: Assigned
Question	M.8	<p>Comment: The fire door to the basement car park at the base of the staircase to flats 1-62 was found being held open on the latch at the time of the fire risk assessment. Furthermore, there was a screw found to be missing from one of the hinges used to hang the cross corridor door adjacent to flat 13</p>

Section	Common Area Fire Doors		
Action ID	669539		
Quantity		<p>Recommendation: The screw missing from the door hinge as noted should be replaced.</p>

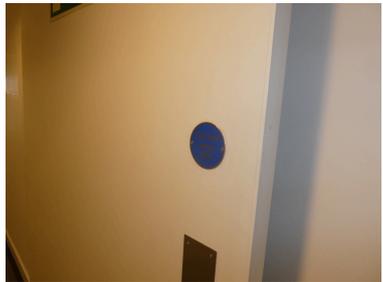
Question	O.2	<p>Comment: Fire door signage is not considered adequate. The following fire doors are not provided with automatic fire door keep clear signs as required:- Cross corridor fire door between flats 57 & 58, door to lobby to flats 44-46, fire door to lobby to flats 42 & 43, door to lobby to flats 39-41, door to lobby to flats 24 & 25, door to lobby to 19 & 20, door to lobby to flats 16 - 18, & cross corridor fire door adjacent to flat 104. These doors are current provided with incorrect fire door signage.</p> <p>Recommendation: An 'Automatic fire door keep clear' sign should be provided to the doors as noted.</p>
