Fire Risk Assessment

Property assessed:	1-156 Park Heights 25 Robsart Street London SW9 0BP
Client:	Network Homes Ltd
UPRN:	ROBA0025
Property Classification:	Level 1
Document Print Date:	18/09/2020

FRA Inspection Date:	14/08/2020
FRA Issued to Client:	18/09/2020
FRA valid to:	18/09/2021
FRA completed by:	Savills (UK) Ltd, 33 Margaret Street, London W1G 0JD T: 020 7409 8737 E: fireriskhousing@savills.com

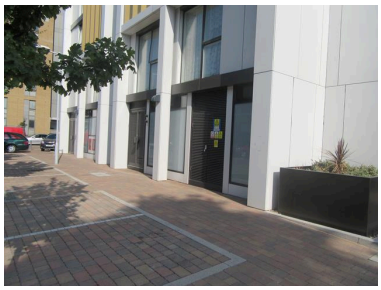
Question	Q.13	Comment: The building has Reynobond ACM rain screen cladding from the second floor upwards, over 130mm Kingspan Kooltherm K15 insulation, according to the specification documents supplied. The lower two storeys have a stone cladding material. The ACM cladding has been tested by BRE and is confirmed as PE. The Kingspan insulation used is not A2 (limited combustibility) and would appear to not have a BS8414 test for the exact system used at Park Heights. Kingspan cite a number of desktop study reports in their literature of systems which utilise their insulation with ACM but the cladding is either FR or A2. The rain screen cladding system will therefore require revision or total replacement but a degree of uncertainty exists around what it should be replaced with until government bring forward any changes to the Building Regulations which will result out of Grenfell. Compliance with current Building Regulations could be achieved by using materials for cladding and insulation which are both A2 and Class 0. Systems which rely on the BR135/BS8414 methodology to justify fire performance are currently in some doubt and it would be risky to adopt any until further clarification on the way forward is forthcoming from the regulators. During the Type 4 inspection the sample location was opened and the insulation depth and type checked to be 130mm Kingspan material. A further panel was opened up which coincided with the line of a compartment floor between flats. It was confirmed that the insulation was interrupted along this line by a stone wool cavity barrier, although it appeared that this would not have been fully in contact with the rear of the ACM cladding leaving a gap of around 20mm in places.

Question - Q.13: Are the external walls of the building satisfactory with regard to fire spread? (Consider combustibility of cladding, external insulation systems, spandrel panels and balconies etc. if provided).	No
Comment: At present cladding is being replaced to the exterior of the building, The upper section of 1-75 Park Heights - cladding has been replaced. Work is ongoing.

Section	Limiting Fire Spread		
Action ID	130507		
Quantity - Known - Potential	 1 N/A	Recommendation: It is recommended that the rain screen cladding system is revised or replaced to meet the requirements of Building Regulations, including any changes to standards which arise as a result of the Grenfell tower fire. Network Homes have stated that they are in the process of arranging for the ACM cladding to the exterior façade be replaced with a suitable alternative.	
Priority	B	Due Date: 18/09/2021 | Client Status: Assigned Review Status: Unresolved
