Fire Risk Assessment

Property assessed:	6-10 The Cedars 30 Lavender Crescent St Albans AL3 5QS
Client:	Network Homes Ltd
UPRN:	CEDE0000-2
Property Classification:	Level 1
Document Print Date:	13/04/2021

FRA Inspection Date:	08/03/2021
FRA Issued to Client:	26/03/2021
FRA valid to:	26/03/2022
FRA completed by:	Savills (UK) Ltd, 33 Margaret Street, London W1G 0JD T: 020 7409 8737 E: fireriskhousing@savills.com

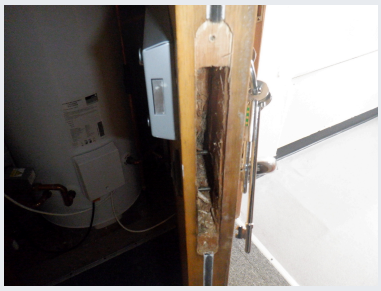
Question	M.2	Comment: Excessive gaps were noted around some common area fire doors which will not resist the passage of cold smoke. These include the second lobby door and the lounge door. The riser door was also damaged at the time of inspection

Question - M.2: Are all common area fire rated fire door sets in good condition - and not in need of repair?	No
Comment: Excessive gaps were noted around some common area fire doors which will not resist the passage of cold smoke. These include the second lobby door and the lounge door. The riser door was also damaged at the time of inspection

Section	Common Area Fire Doors			
Action ID	638282			
Quantity - Known - Potential	 1 1	Recommendation: Common area doors and frames as noted should be replaced with FD30S lockable fire door sets, installed strictly in accordance with the manufacturer's test certification, including appropriate 'Fire door keep locked' signage to the outer face.		
Priority	A	Due Date: 26/06/2021	Client Status: Unassigned

Recommendation: Common area doors and frames as noted should be replaced with FD30S lockable fire door sets, installed strictly in accordance with the manufacturer's test certification, including appropriate 'Fire door keep locked' signage to the outer face.

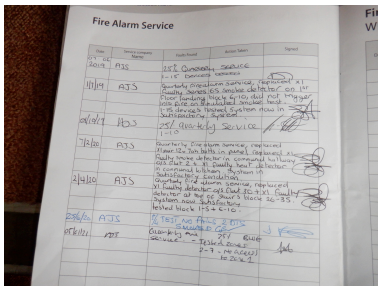
Question	V.1	Comment: No evidence was available on-site to confirm that regular inspection, testing and servicing of the system/equipment is being carried out. Servicing records were noted however evidence of weekly testing was not seen.

Section	Testing and Maintenance			
Action ID	638288			
Quantity - Known - Potential	 N/A N/A	Recommendation: Management should confirm/ensure that the automatic fire detection/fire alarm system is tested weekly and serviced six-monthly in accordance with BS 5839-1 and records kept on-site or in a central database.		
Priority	Man2	Due Date: 26/06/2021	Client Status: Assigned

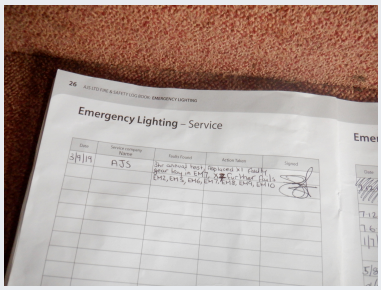
Question	V.2	Comment: No evidence was available on-site to confirm that regular inspection, testing and servicing of the system/equipment is being carried out. Log book was present but last recorded servicing details were 2019. However evidence of monthly testing was available.

Section	Testing and Maintenance			
Action ID	638286			
Quantity - Known - Potential	 N/A N/A	Recommendation: Management should confirm/ensure that the common area emergency lighting system is tested monthly and serviced annually in accordance with BS 5266-8:2004 and records kept on-site or in a central database.		
Priority	Man2	Due Date: 26/06/2021	Client Status: Assigned

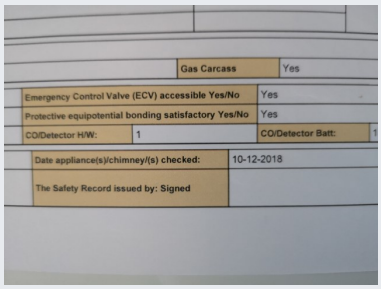
Question	Z.1	Comment: Other issues considered unsatisfactory at the time of inspection include - CP-12 Gas certificate noted witthin the kitchen suggest that Gas testing is overdue 10/12/2018.

Question - Z.1: Are all other issues deemed satisfactory? [1]	No
Comment: Other issues considered unsatisfactory at the time of inspection include - CP-12 Gas certificate noted witthin the kitchen suggest that Gas testing is overdue 10/12/2018.

Section	Other Issues		
Action ID	454247		
Quantity - Known - Potential	 1 1	Recommendation: Management must ensure that the CP-12 Gas certificate is maintained to date and records should be held and made available upon request.	
Priority	Man2	Due Date: 30/03/2021 | Client Status: Assigned Review Status: Unresolved

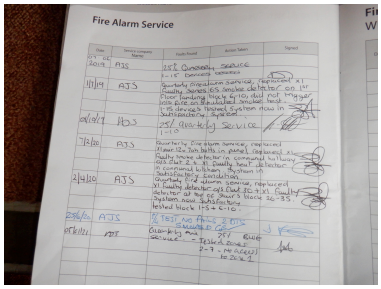
Question - V.1: Is the common area fire detection/alarm system tested and serviced in accordance with relevant guidance?	Not Known
Comment: No evidence was available on-site to confirm that regular inspection, testing and servicing of the system/equipment is being carried out. Servicing records were noted however evidence of weekly testing was not seen.	
Recommendation: Management should confirm/ensure that the automatic fire detection/fire alarm system is tested weekly and serviced six-monthly in accordance with BS 5839-1 and records kept on-site or in a central database.

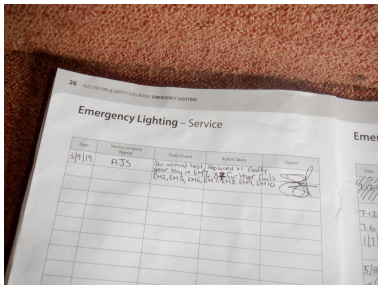
Question - V.2: Is the common area emergency lighting system tested and serviced in accordance with relevant guidance?	Not Known
Comment: No evidence was available on-site to confirm that regular inspection, testing and servicing of the system/equipment is being carried out. Log book was present but last recorded servicing details were 2019. However evidence of monthly testing was available.	
Recommendation: Management should confirm/ensure that the common area emergency lighting system is tested monthly and serviced annually in accordance with BS 5266-8:2004 and records kept on-site or in a central database.
