# Fire Risk Assessment

Property assessed: B Hodgson Court Nightingale  
Avenue London HA1 3GX

Client: Network Homes Ltd

FRA Inspection Date: 01/09/2020  
FRA Issued to Client: 21/10/2020  
FRA valid to: 21/10/2021  
FRA completed by: Savills (UK) Ltd,  
33 Margaret Street, London W1G 0JD  
T: 020 7409 8737  
E: fireriskhousing@savills.com

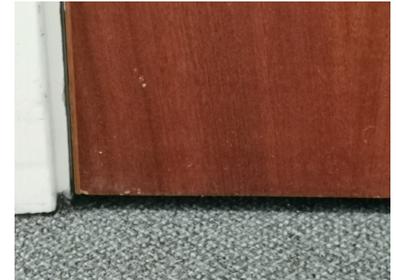
| Question | M.2 | <p>Comment: Excessive gaps were noted to some common area fire doors which will not resist the passage of cold smoke, they are as follows:- (Noted gaps to the sides and tops of the doors are over 3mm and the bottom of the doors over 6mm as specified) Ground-floor:- B04 - leading-edge and top gaps. Stairwell door - leading-edge and top gaps. 024 - Cluster kitchen - leading-edge and top gaps. B03 - Left-hand side door - Internal-edge and top gaps. First-floor:- 113-118 - Landing/lobby door - leading-edge, top and bottom gaps. Link door to Block C - top gap. B12 - middle and top gaps. 163 - Cluster kitchen - leading-edge and top gaps. 107-112 - Landing/ lobby door - leading-edge and top gaps. Link door - bottom and top gaps. 162 - Cluster kitchen - bottom and top gaps. B13 - top and inside-edge gaps. Second-floor:- 213-218 - Landing/lobby door - leading-edge, top, and inside-edge gaps. B22 - middle, top, and inside-edge gaps. 207-212 - Landing/lobby door - leading-edge and top gaps. Link door - top, leading-edge, and bottom gaps. 262 - Cluster kitchen - both sides, top, and bottom gaps. Damage was noted to the following fire doors: Ground-floor: B03 - Delaminated stile to both doors (leading-edge) First-floor: B13 - Delaminated stile. Second-floor: B22 and B23, Damaged/delaminated stiles to doors.</p> | |
