# Fire Risk Assessment

Property assessed: A Lister Court Nightingale Avenue  
London HA1 3GX

Client: Network Homes Ltd

FRA Inspection Date: 04/09/2020  
FRA Issued to Client: 21/10/2020  
FRA valid to: 21/10/2021  
FRA completed by: Savills (UK) Ltd,  
33 Margaret Street, London W1G 0JD  
T: 020 7409 8737  
E: [fireriskhousing@savills.com](mailto:fireriskhousing@savills.com)

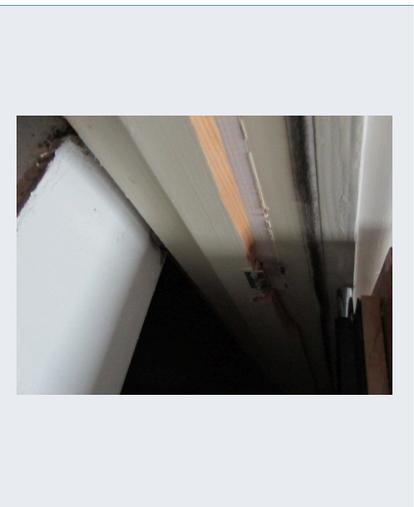
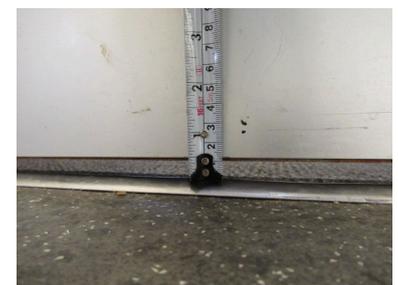
- Known	4	
- Potential	4	
Priority	B	<p>Due Date: 30/09/2021</p> <p>Client Status: Assigned</p> <p>Review Status: Unresolved</p>
Question	M.2	<p>Comment: The top floor heating equipment cupboard door has been forced causing damage and large gaps between the door styles. Service cupboard A26 has excessive gaps. Excessive gaps to the bottom of cluster doors 101-106, 107-112 &amp; 201-206.. The door style lip to the ground floor cupboard door AO4 and the 2nd-floor heating equipment cupboard door A23 has become detached from the door. The frame to service cupboard door A30 is damaged.</p>
Section	Common Area Fire Doors	
Action ID	303946	
Quantity		<p>Recommendation: The common area doors noted (stair doors to 101-106, 107-112 &amp; 201-206) should be repaired (or if necessary replaced) to reduce the threshold gap to a maximum of 6mm. Alternatively, a threshold seal capable of resisting cold smoke should be fitted.</p>

Question	M.2	<p>Comment: The top floor heating equipment cupboard door has been forced causing damage and large gaps between the door styles. Service cupboard A26 has excessive gaps. Excessive gaps to the bottom of cluster doors 101-106, 107-112 &amp; 201-206.. The door style lip to the ground floor cupboard door AO4 and the 2nd-floor heating equipment cupboard door A23 has become detached from the door. The frame to service cupboard door A30 is damaged.</p> <p>Recommendation: The fire doors noted (A33 &amp; A26) should be repaired (or if necessary replaced) to reduce the perimeter gap between the door and frame to a maximum of 3mm.</p>

Section	Common Area Fire Doors		
Action ID	544413		
Quantity		<p>Recommendation: The common area doors noted should be repaired (or if necessary replaced) to reduce the threshold gap to a maximum of 6mm. Alternatively, a threshold seal capable of resisting cold smoke should be fitted.</p>

Section	Common Area Fire Doors		
Action ID	544414		
Quantity		<p>Recommendation: The fire doors noted should be repaired (or if necessary replaced) to reduce the perimeter gap between the door and frame to a maximum of 3mm.</p>

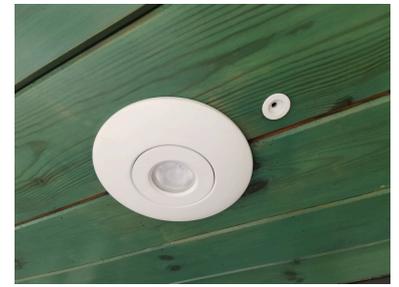
Priority: Man1    Known Quantity: N/A    Potential Quantity: N/A    Action ID: 544409

Comment: Some of the emergency lighting units did not appear to have a visible charging indicator - this was evident to the following units: EML - Adjacent to the front entry door (external) EML - within lobby 101-106.

Recommendation: The emergency lighting system should be checked by the maintenance engineer to confirm that it is serviceable.

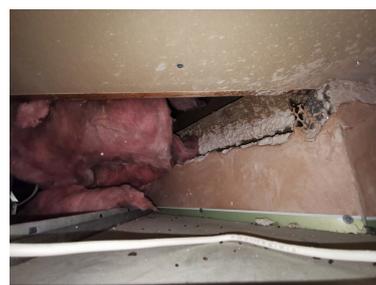
Comment: Compartmentation would not appear to be adequate:- There were various compartmentation breaches noted throughout the escape route above the suspended ceilings adjacent to the bedroom riser cupboards. As previously recommended - an intrusive inspection should be undertaken throughout the communal areas (above suspended ceilings) and noted breaches fire-stopped to provide 60 minutes of fire-resistance. Breaches were noted in the following sampled areas: Ground-floor:- 002-006 - Above the suspended ceiling adjacent to the cluster door. 002-006 Cluster lobby - Above the suspended ceiling adjacent to the bedroom riser cupboards. 007-012 Cluster lobby - Above the suspended ceiling adjacent to the bedroom riser cupboards. First-floor:- 101-106 Cluster lobby - Above the suspended ceiling adjacent to the bedroom riser cupboards and cluster lobby door. A15 breach to wall noted above the suspended ceiling. Third-floor:- 301-306 Cluster lobby - Breach above stairwell door and 039. 307-312 Cluster lobby - breach noted above stairwell/landing door. Lack of compartmentation above the suspended ceiling throughout the third-floor.

Recommendation: The compartmentation breaches noted within the voids above the false ceilings should be made good with appropriate fire-resisting materials/construction. The period of fire resistance required is 60 minutes.

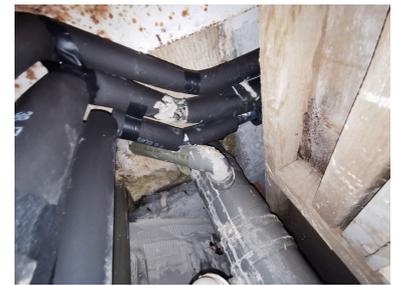
Priority: B      Known Quantity: 19      Potential Quantity: 19      Action ID: 544416

Comment: The bedroom service riser cupboards on the ground, first and second-floors appear to have no internal lining provided within the cupboards and above the door. Network Homes confirmed previous recommendation is complete; to check all risers are suitably fire stopped - (All bedroom riser cupboards have been fire-stopped to the floor) The top floor bedroom riser cupboards have been fire stopped to the ceiling and above the door (Internally) to an adequate standard. Additional compartmentation breaches were noted within the following cupboards at the time of the assessment, they are as follows: Ground-floor: A03 - damage to boxing. Second-floor: A26 - to high-level wall and ceiling around pipe-egress. A05, A15, and the externally accessed bike store should be accessed and inspected for adequate fire-stopping to the walls and ceiling.

Recommendation: The plasterboard panels and sections above/either side of the bedroom riser doors (Internally) where pipework and cables run to be fire stopped using fire-resisting materials to ensure 60 minutes of fire resistance between the cupboard and communal areas. Any fire-stopping works to be undertaken by a competent passive fire engineer.

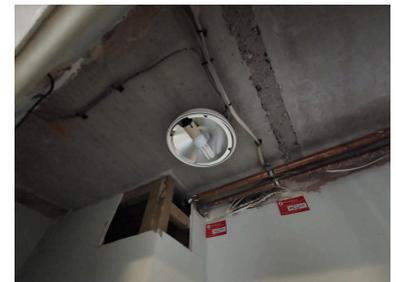
Priority: B      Known Quantity: 1      Potential Quantity: 1      Action ID: 544417

Question	Q.3	<p>Comment: The bedroom service riser cupboards on the ground, first and second-floors appear to have no internal lining provided within the cupboards and above the door. Network Homes confirmed previous recommendation is complete; to check all risers are suitably fire stopped - (All bedroom riser cupboards have been fire-stopped to the floor) The top floor bedroom riser cupboards have been fire stopped to the ceiling and above the door (Internally) to an adequate standard. Additional compartmentation breaches were noted within the following cupboards at the time of the assessment, they are as follows: Ground-floor: A03 - damage to boxing. Second-floor: A26 - to high-level wall and ceiling around pipe-egress. A05, A15, and the externally accessed bike store should be accessed and inspected for adequate fire-stopping to the walls and ceiling.</p>
Section	Limiting Fire Spread	
Action ID	544417

Recommendation: The casings noted should be upgraded/replaced to provide 30 minutes fire resistance.

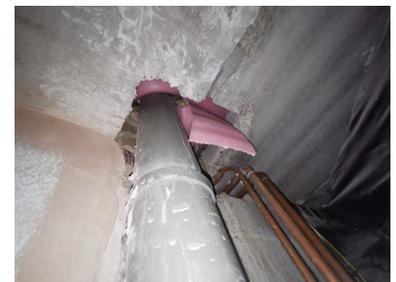
Priority: B      Known Quantity: 1      Potential Quantity: 1      Action ID: 544418

Question	Q.3	<p>Comment: The bedroom service riser cupboards on the ground, first and second-floors appear to have no internal lining provided within the cupboards and above the door. Network Homes confirmed previous recommendation is complete; to check all risers are suitably fire stopped - (All bedroom riser cupboards have been fire-stopped to the floor) The top floor bedroom riser cupboards have been fire stopped to the ceiling and above the door (Internally) to an adequate standard. Additional compartmentation breaches were noted within the following cupboards at the time of the assessment, they are as follows: Ground-floor: A03 - damage to boxing. Second-floor: A26 - to high-level wall and ceiling around pipe-egress. A05, A15, and the externally accessed bike store should be accessed and inspected for adequate fire-stopping to the walls and ceiling.</p>
Section	Limiting Fire Spread	
Action ID	544418

Recommendation: The holes noted should be sealed with a suitable fire-stopping material such as an intumescent paste. The period of fire resistance required is 60 minutes.

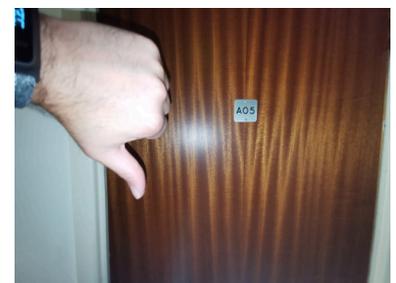
Priority: Man2      Known Quantity: 0      Potential Quantity: 3      Action ID: 544421

- Known	N/A		
- Potential	N/A		
Priority	Man1	Due Date: 21/11/2020	Client Status: Approved
Question	Q.3	Comment: The bedroom service riser cupboards on the ground, first and second-floors appear to have no internal lining provided within the cupboards and above the door. Network Homes confirmed previous recommendation is complete; to check all risers are suitably fire stopped - (All bedroom riser cupboards have been fire-stopped to the floor) The top floor bedroom riser cupboards have been fire stopped to the ceiling and above the door (Internally) to an adequate standard. Additional compartmentation breaches were noted within the following cupboards at the time of the assessment, they are as follows: Ground-floor: A03 - damage to boxing. Second-floor: A26 - to high-level wall and ceiling around pipe-egress. A05, A15, and the externally accessed bike store should be accessed and inspected for adequate fire-stopping to the walls and ceiling.

Recommendation: Management should check within services risers/shafts/ducts/cupboards as noted to confirm that they are appropriately enclosed with fire resisting construction and adequately fire-stopped.

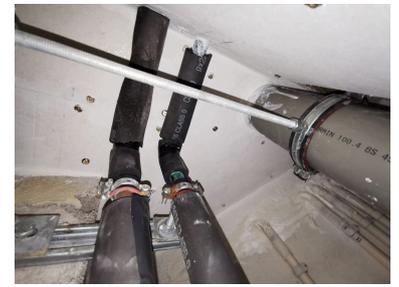
Priority: B      Known Quantity: 2      Potential Quantity: 2      Action ID: 544419

Comment: There was evidence that fire-stopping works have been undertaken within the bedroom riser cupboards on the top floor. However, not all soil-pipes which enter the roof void have been provided with Intumescent collars. They are as follows: 304, 307-308.

Recommendation: A 60 minutes fire rated collar should be fitted around the non fire rated service pipe or duct up to 200mm diameter as noted.
