# Fire Risk Assessment

Property assessed: Kodak Court C Nightingale Avenue  
London HA1 3GN

Client: Network Homes Ltd

Document Print Date: 21/04/2021

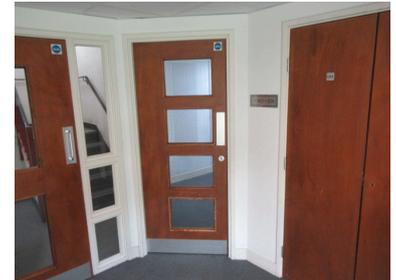
- Known	1		
- Potential	N/A		
Priority	Man2	Due Date: 31/03/2020	Client Status: Approved
		Review Status: Unresolved	
Question	M.1	<p>Comment: Bedroom riser cupboard doors adjacent to bedroom entrance doors are not considered fire rated. Some were identified as damaged due to water ingress. Protected staircase doors, cross-cluster separation doors, main electrical risers, electrical and boiler cupboard, store rooms and corridor doors appear to be notional 30-minute fire doors.</p>	
Section	Common Area Fire Doors		
Action ID	130667		
Quantity		<p>Recommendation: Common area fire door(s) as noted should be replaced with lockable FD30S fire doors, including appropriate 'Fire door keep locked' signage to the outer face.</p>
