Fire Risk Assessment

Property assessed: B Pasteur Court Nightingale
Avenue London HA1 3GX

Client: Network Homes Ltd

FRA Inspection Date: 20/08/2020
FRA Issued to Client: 21/10/2020
FRA valid to: 21/10/2021
FRA completed by: Savills (UK) Ltd,
33 Margaret Street, London W1G 0JD
T: 020 7409 8737
E: fireriskhousing@savills.com

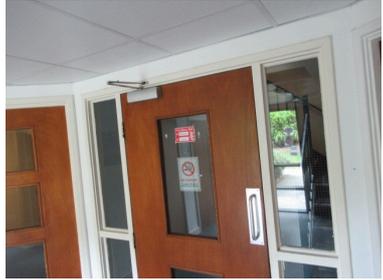
Question	O.2	<p>Comment: Fire door signage is not considered adequate. No fire door sign is provided to the ground floor stair door.</p> <p>Recommendation: Provide 'Fire door keep shut' notices to common area fire doors as noted.</p>

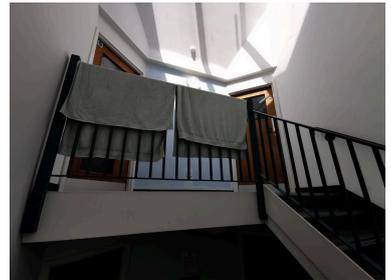
Comment: There were combustible items or waste materials in the escape routes. Towels were noted on the third-floor landing at the time of the assessment. As the quantity involved is relatively minor this can be dealt with via written contact with the residents.

Recommendation: Management should contact residents to advise that the common area/escape routes should be kept free from all combustibles and/or trip hazards. A programme of regular checks should be put in place to ensure that the common area is kept clear.

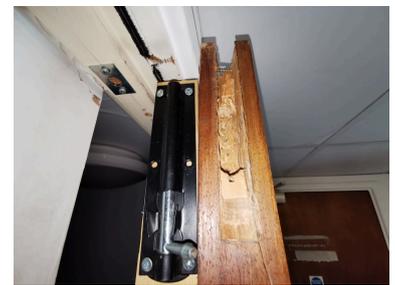
Comment: Previous comment - The following common area doors were noted as damaged and in need of repair or replacement: The 1st-floor service cupboard door (B08) is damaged at the top of the door. The top floor staircase door to cluster 313-318 has an excessive gap at the bottom of the door. The top floor alternative fire exit door is a bad fit in its frame (daylight visible between the door and frame). In addition to the above comment, the following doors were noted as having excessive gaps between the door and door-frames over 3mm (sides/top) and 6mm (bottom/threshold) Ground-floor: 019-024 Cluster lobby door - top and leading-edge gaps. 014-018 Cluster lobby door - top gap. B04 - leading-edge gap. 042 - Cluster kitchen - leading-edge and top gaps. Alternative exit stairwell door - top and leading-edge gaps. Alternative exit lobby door - leading-edge and top gaps. First-floor: 113-118 Cluster lobby door - top and leading-edge gaps. 142 Cluster kitchen top gap. 119-124 Cluster lobby door - top gap. Link door - leading-edge gaps. A13 - top gap. Second-floor: 213-218 Cluster lobby door - top gap. 242 Cluster kitchen - top and leading-edge gaps. B13 - Leading-edge gap. 219-224 Cluster lobby door - top and leading-edge gaps. Link door to alternative exit - top gap. Third-floor: 313-318 Cluster lobby door - top gap. Damage was noted to the following fire doors: B03 - delaminated stiles to the leading edge of both doors. B11 - appears to be split on the inside edge. B15 - damage to the top of the door. Cluster kitchen - 243 was not accessible at the time of the assessment.

Recommendation: Common area doors and frames as noted should be replaced with FD30S lockable fire door sets, installed strictly in accordance with the manufacturer's test certification, including appropriate 'Fire door keep locked' signage to the outer face.

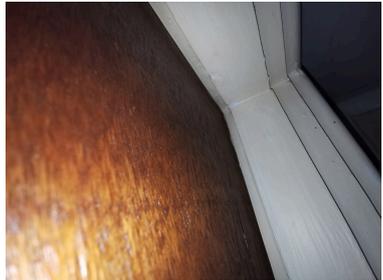
Comment: Previous comment - Not all self-closing devices fitted to common area fire doors (where required) are considered adequate. The 1st-floor kitchen door is not fully closing into the frame with the aid of the self-closing device. Network Homes confirmed previous recommendation is complete; to check all communal fire doors on a regular basis. In addition to the above comment - The ground floor door leading to the alternative exit lobby and cluster kitchen doors 243 and 242 were not fitting flush into the doorframes.

Recommendation: The self-closing device should be repaired or an effective self-closing device should be fitted to the doors as noted.

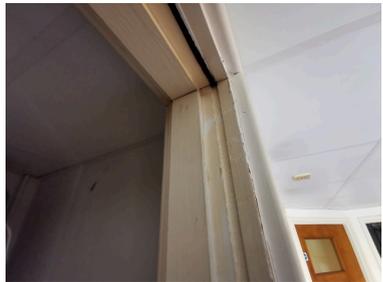
Comment: There were various common fire doors which have defective/damaged or missing combined intumescent strips and cold smoke seals, they are as follows: B02, B08, 143, A13, Link door to block C, 219-224 lobby door, 342 -cluster kitchen door - excessive paint. 319-324 link door, third-floor alternative exit lobby door. All double door riser cupboards noted will required combined intumescent strips and cold smoke seals to the middle of the door set (one side)

Recommendation: Common area fire doors as noted should be fitted with intumescent strips and smoke seals.

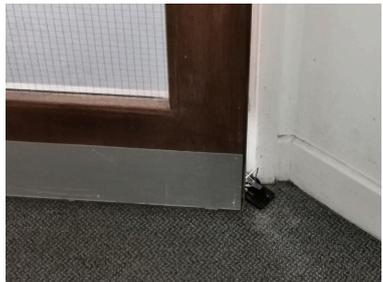
Comment: Common area fire doors were noted being wedged open or otherwise obstructed at the time of inspection. Cluster kitchen 343 was being wedged open at the time of the assessment. The wedges/obstructions were removed by or for the assessor at the time of inspection.

Recommendation: Management should inform/remind all staff and/or residents that self-closing fire doors must not be wedged open or otherwise obstructed. A programme of regular checks should be put in place to ensure that the fire doors remain unobstructed.

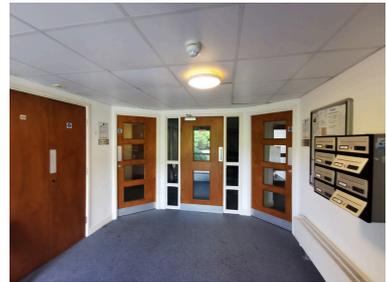
Comment: Previous comment - Fire door signage is not considered adequate. No fire door sign is provided to the ground floor stair door. In addition to the above, the following is required: The following fire doors are provided with the wrong signage: B07, B11, B15. - The fire door signage in situ should be replaced with 'Fire door keep locked' signage. The following fire doors require 'Fire door keep locked' signage: B03, B08, B12, B16, B17, A07. (Both openable doors within the double door cupboards will require adequate fire door signage)

Recommendation: Provide 'Fire door keep locked' notices to common area fire doors as noted.

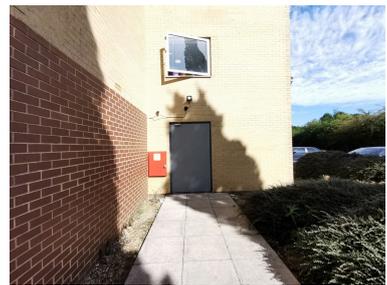
Comment: Directional and exit signage is not considered adequate. The fire exit door requires the 'Fire exit' signage to be positioned above the associated exit door.

Recommendation: Provide adequate signage, bespoke, as noted in the FRA comment.

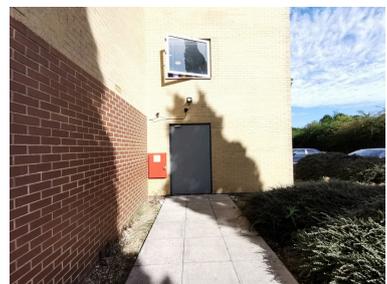
Comment: Previous comment - No fire exit door signage provided to the exterior side of the ground floor alternate fire exit door. Do not use lift signage missing from the 2nd-floor lift lobby. In addition to the above comment - signage was also missing to the dry riser inlet.

Recommendation: Provide adequate signage, bespoke, as noted in the FRA comment.

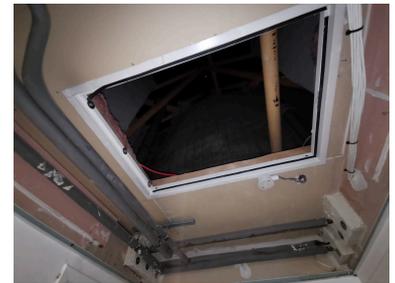
Comment: There were various compartmentation breaches noted throughout the escape route above the suspended ceilings adjacent to the bedroom riser cupboards. As previously recommended - an intrusive inspection should be undertaken throughout the communal areas (above suspended ceilings) and noted breaches fire-stopped to provide 60 minutes of fire-resistance. Breaches were noted above the suspended ceiling within the following areas: Ground-floor: 019-024 Cluster lobby area above bedroom riser cupboard doors. Above the exit door leading to the alternative escape route, A. 014-018 Cluster lobby area above bedroom riser cupboard doors. First-floor: 113-118 Cluster lobby area above bedroom riser cupboards. Above bedroom riser cupboard 121. Third-floor: 319-324 CLuster lobby area various holes to the ceiling. No roof void access panel.

Recommendation: The open roof void access point should be secured with a fire-rated hatch which affords 60 minutes of fire protection.

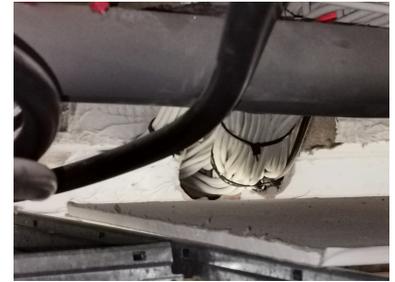
Comment: The bedroom service riser cupboards on the ground, first and second-floors appear to have no internal lining provided within the cupboards and above the door. Network Homes confirmed previous recommendation is complete; to check all risers are suitably fire stopped - (All bedroom riser cupboards have been fire-stopped to the floor) The top floor bedroom riser cupboards have been fire stopped to the ceiling and above the door (Internally) to an adequate standard. There were various breaches noted within the electrical intake cupboard A07.

Recommendation: The holes noted should be sealed with a suitable fire-stopping material such as an intumescent paste. Period of fire resistance required is 60 minutes.

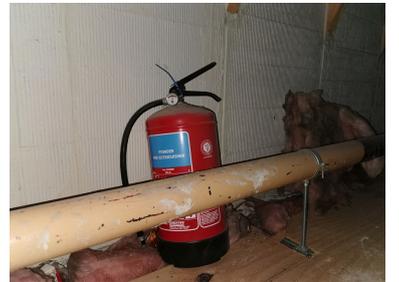
Comment: Dry powder type fire extinguishers are installed. A redundant unit noted within the roof void. This type of fire extinguisher is not considered to be suitable for indoor use and should be removed.

Recommendation: The noted redundant fire extinguisher should be removed as not required within this property type.
