Fire Risk Assessment

Property assessed: 1-140 Avery Court 40, 41 & 45
Capitol Way London NW9 0AU

Client: Network Homes Group

FRA Inspection Date: 20/06/2022
FRA Issued to Client: 28/06/2022
FRA valid to: 28/06/2023
FRA completed by: Savills (UK) Ltd,
33 Margaret Street, London W1G 0JD
T: 020 7409 8737
E: fireriskhousing@savills.com

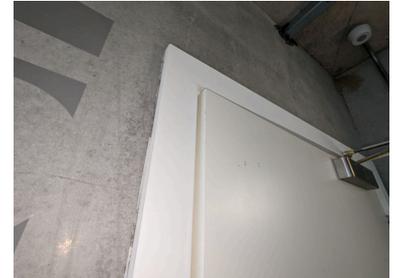
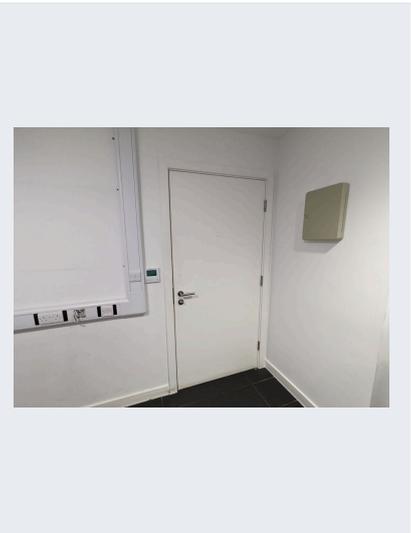
Question	M.5	<p>Comment: Not all common area fire doors are fitted with adequate self-closing devices where required - The self closing mechanisms fitted to the cross corridor doors adjacent to Flats 13, 66, 72, 91 and 113 as well as the stairwell doors adjacent to Flats 68, 92, 101 and 137 do not fully self close the doors into the frames. - There were no self closing mechanisms fitted to the 2 x common area fire doors within the management office. Management confirms via the Riskhub Client Portal that the previous recommendation is Assigned so this has been marked as Unresolved.</p>	
Section	Common Area Fire Doors		
Action ID	844114		
Quantity		<p>Recommendation: The self-closing devices should be repaired or effective self-closing devices should be fitted to the doors as noted (cross corridor doors adjacent to Flats 72, 91 and 113 as well as the stairwell doors adjacent to Flats 68, 92, 101 and 137) N.B. - The action from the previous report covered the cross corridor doors adjacent to Flats 13 and 66 and this has been marked as 'unresolved'.</p>

- Known	7		
- Potential	7		
Priority	A	Due Date: 28/09/2022	Client Status: Assigned
Question	M.5	<p>Comment: Not all common area fire doors are fitted with adequate self-closing devices where required - The self closing mechanisms fitted to the cross corridor doors adjacent to Flats 13, 66, 72, 91 and 113 as well as the stairwell doors adjacent to Flats 68, 92, 101 and 137 do not fully self close the doors into the frames. - There were no self closing mechanisms fitted to the 2 x common area fire doors within the management office. Management confirms via the Riskhub Client Portal that the previous recommendation is Assigned so this has been marked as Unresolved.</p>	
Section	Common Area Fire Doors		
Action ID	844129		
Quantity		<p>Recommendation: An effective self-closing device should be fitted to the 2 x common area doors within the management office as noted. 'Fire door keep shut' signage should also be fitted.</p>

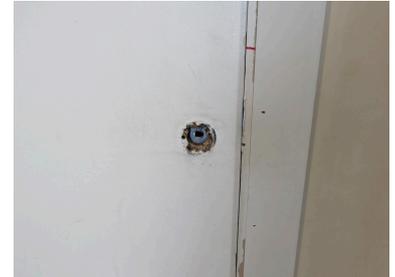
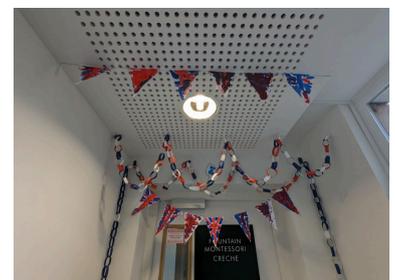
Question	M.7	<p>Comment: Other common area fire door issues noted at the time of inspection include - - The stairwell door on the 5th floor (63-105 Avery Court) was noted being wedged open or otherwise obstructed at the time of inspection. There were contractors on carrying out work on the 5th floor, however, doors must not be wedged open. The wedges/obstructions were removed by or for the assessor at the time of inspection. - There were screws missing from the door hinges to some common area fire doors (3rd floor stairwell door (1-62 Avery Court) and the cross corridor door adjacent to Flat 13). - The door handle was missing from the 1st floor stairwell door (63 - 105 Avery Court - adjacent to the lift). As a result residents would not be able to access the protected stairwell (leading to the final exit) from the 1st floor landing.</p>	
Section	Common Area Fire Doors		
Action ID	844131		
Quantity		<p>Recommendation: The missing door handle from the 1st floor stairwell door (63 - 105 Avery Court - adjacent to the lift) should be replaced.</p>

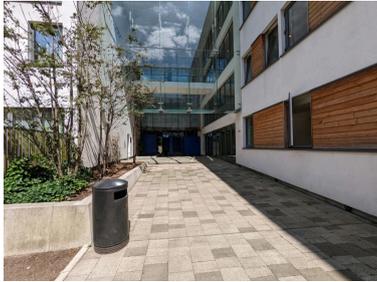
- Known	1		
- Potential	1		
Priority	B	Due Date: 28/06/2023	Client Status: Assigned
Question	O.3	<p>Comment: Directional and exit signage is not considered adequate: - There is no directional/exit signage located within the enclosed central courtyard. This forms part of the means of escape from the property and a number of doors from each block discharge into this central courtyard with no clear exit route signed for residents. Directional/exit signage is required to direct residents to the doorway of 1-62 Avery Court where the means of escape continues onwards to the ground floor final exit of this block. - The directional signage located on the 1st, 2nd, 3rd and 4th floors within 1-62 Avery Court is unclear. There are illuminated fire exit signs fitted to the ceilings within the flat lobbies, however, due to the fact that the signs are 2 sided and visible from within the lift lobbies they could cause confusion and lead residents in the wrong direction (into the flat lobby where there is no exit route rather than down the stairwell accessed off of the lift lobby). - There is no final exit signage located above the stairwell door on the 1st floor (within 1-62 Avery Court) this is required to direct residents down the stairwell to the ground floor and final exit.</p> <p>Recommendation: Provide adequate exit and/or directional signage as noted.</p>

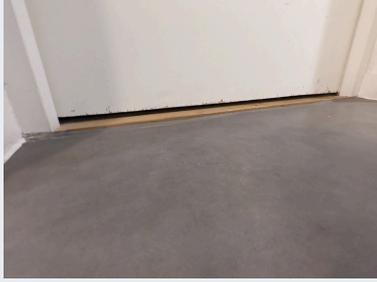
Section	Fire Safety Signs and Notices		
Action ID	844121		
Quantity			
- Known	3		
- Potential	3		
Priority	B	Due Date: 28/06/2023	Client Status: Assigned
Question	L.2	<p>Comment: Fire rated flat entrance doors and frames appear to be in good condition except for: - The flat entrance door to Flat 66 has an excessive threshold gap (12mm) noted under the door which will not resist the passage of cold smoke.</p> <p>Recommendation: The flat entrance door noted should be repaired (or if necessary replaced) to reduce the threshold gap to a maximum of 3mm. Alternatively, a threshold seal capable of resisting cold smoke should be fitted.</p>

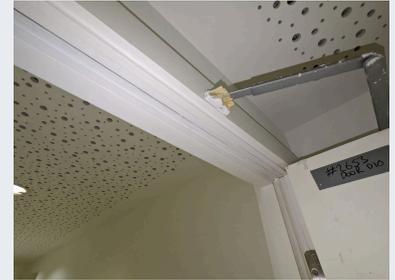
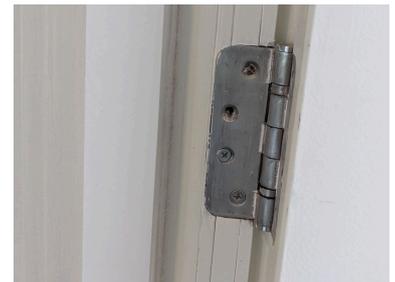
- Known	2		
- Potential	2		
Priority	C	Due Date: 28/12/2023	Client Status: Assigned
Question	M.7	<p>Comment: Other common area fire door issues noted at the time of inspection include - - The stairwell door on the 5th floor (63-105 Avery Court) was noted being wedged open or otherwise obstructed at the time of inspection. There were contractors on carrying out work on the 5th floor, however, doors must not be wedged open. The wedges/obstructions were removed by or for the assessor at the time of inspection. - There were screws missing from the door hinges to some common area fire doors (3rd floor stairwell door (1-62 Avery Court) and the cross corridor door adjacent to Flat 13). - The door handle was missing from the 1st floor stairwell door (63 - 105 Avery Court - adjacent to the lift). As a result residents would not be able to access the protected stairwell (leading to the final exit) from the 1st floor landing.</p>

Section	Common Area Fire Doors		
Action ID	844117		
Quantity		<p>Recommendation: The missing screws should be replaced to the 3rd floor stairwell door (1-62 Avery Court).</p>

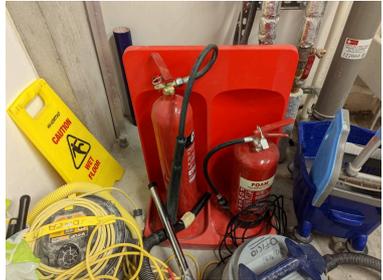
- Known	24		
- Potential	24		
Priority	C	Due Date: 28/12/2023	Client Status: Assigned
Question	R.2	<p>Comment: The provision of portable fire extinguishers is not considered appropriate in these premises. Management confirmed that there is no policy in place to provide fire extinguishers within staff/plant rooms within the building and that these extinguishers are believed to have been left here by contractors carrying out remedial works within the building. These extinguishers are not appropriate for the risks associated in these rooms and they have not been regularly serviced/maintained.</p>

Section	Fire Extinguishing Appliances		
Action ID	844130		
Quantity		<p>Recommendation: The fire extinguishers and associated signage should be removed from the electrical intake/ meter cupboards as noted (Extinguishers located within the electrical intake/meter cupboard opposite Flat 9 and the electrical intake/meter cupboard opposite Flat 136) as management confirmed that there is no policy in place to provide fire extinguishers within staff/plant rooms within the building and that these extinguishers are believed to have been left here by contractors carrying out remedial works within the building (extinguishers are not appropriate for the risks associated in these rooms and they have not been regularly serviced/maintained) - Estimated number of extinguishers to remove is 5</p>

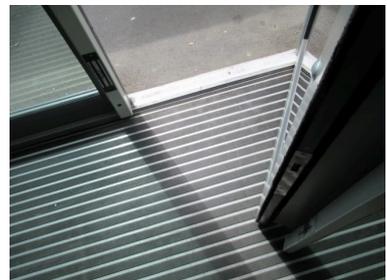
- Known	N/A		
- Potential	N/A		
Priority	Man2	Due Date: 17/09/2020	Client Status: Approved
Question	K.8	<p>Comment: The final exit door opens inwards. This is not considered satisfactory as it will potentially be used by more than 60 people.</p>

Section	Means of Escape		
Action ID	488830		
Quantity		<p>Recommendation: The door swing of the noted doors should be reversed to open in the direction of escape as it is expected that more than 60 people will potentially use it in an evacuation.</p>

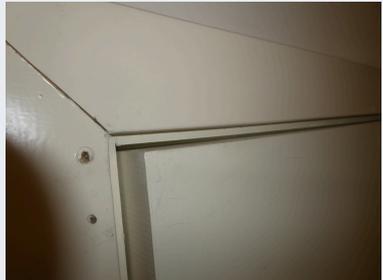
- Known	4		
- Potential	4		
Priority	C	Due Date: 15/12/2022	Client Status: Assigned
Question	M.5	<p>Comment: Not all self-closing devices fitted to common area fire doors (where required) are considered adequate. The door to the cleaners cupboard 1st floor accessed from staircase 1-62, cross corridor door adjacent to flat 13, cross corridor door adjacent to flat 86, cross corridor door adjacent to flat 66, door to the bin store ground floor off the staircase to flats 106-140.</p>

Section	Common Area Fire Doors		
Action ID	669519		
Quantity		<p>Recommendation: The self-closing device should be repaired or an effective self-closing device should be fitted to the doors as noted.</p>

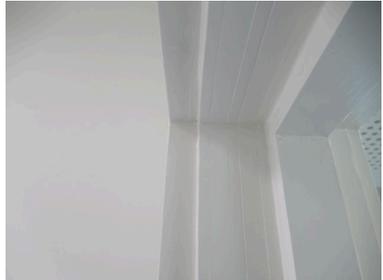
- Known	5		
- Potential	5		
Priority	A	Due Date: 15/09/2021	Client Status: Assigned
Question	M.6	<p>Comment: Common area fire doors are provided with adequate intumescent strips and smoke seals except for:- the stair door in block A1 on the 2nd & 3rd floor have no smoke seals.</p>

Section	Common Area Fire Doors		
Action ID	488833		
Quantity		<p>Recommendation: Common area fire doors as noted should be fitted with intumescent strips and smoke seals.</p>

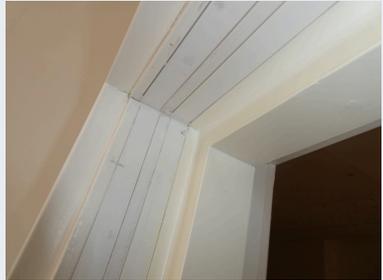
Question	M.6	<p>Comment: Common area fire doors are provided with adequate intumescent strips and smoke seals except for the following which are provided with intumescent strips only (ie no cold smoke seals): Staircase 1-62 door to staircase 6th floor, staircase 1-62 door to staircase 4th floor, staircase 1-62 door to staircase 3rd floor, door to lobby to flats 44-46, door to lobby to flats 42 & 43, door to lobby to flats 24 & 25, door to lobby to flats 21-23, door to lobby to flats 19 & 20, door to the lobby to flats 16-18, opening edge double doorset to balcony atrium 4th floor, opening edge of double doorset to balcony atrium 3rd floor, and door to staircase 1-62 2nd floor. Furthermore, part of the combined intumescent strip and cold smoke seal was missing from the cross corridor door adjacent to flat 13.</p>

Section	Common Area Fire Doors		
Action ID	669520		
Quantity		<p>Recommendation: The common area fire doors as noted, which have intumescent strips but no cold smoke seals should have replacement combined intumescent strips and smoke seals fitted.</p>

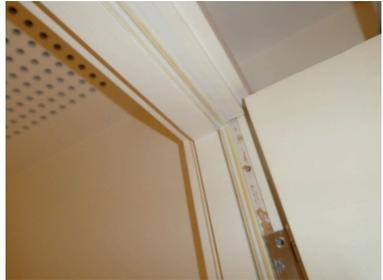
- Known	8		
- Potential	8		
Priority	C	Due Date: 15/12/2022	Client Status: Assigned
Question	M.6	<p>Comment: Common area fire doors are provided with adequate intumescent strips and smoke seals except for the following which are provided with intumescent strips only (ie no cold smoke seals): Staircase 1-62 door to staircase 6th floor, staircase 1-62 door to staircase 4th floor, staircase 1-62 door to staircase 3rd floor, door to lobby to flats 44-46, door to lobby to flats 42 & 43, door to lobby to flats 24 & 25, door to lobby to flats 21-23, door to lobby to flats 19 & 20, door to the lobby to flats 16-18, opening edge double doorset to balcony atrium 4th floor, opening edge of double doorset to balcony atrium 3rd floor, and door to staircase 1-62 2nd floor. Furthermore, part of the combined intumescent strip and cold smoke seal was missing from the cross corridor door adjacent to flat 13.</p>

Section	Common Area Fire Doors		
Action ID	669521		
Quantity		<p>Recommendation: Common area fire doors as noted should be fitted with intumescent strips and smoke seals.</p>

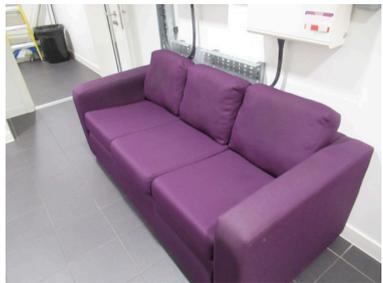
- Known	N/A		
- Potential	1		
Priority	Man2	Due Date: 15/09/2021	Client Status: Approved
Question	Q.11	<p>Comment: There were no labels seen on the soft furnishings in the management area.</p> <p>Recommendation: When it is time for replacement, the soft furnishings noted in the common areas should be replaced by furniture conforming to BS 7176 for medium hazard premises</p>

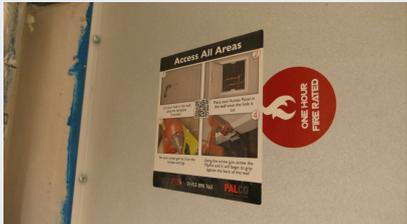
- Known	1		
- Potential	1		
Priority	R	Due Date: N/A	Client Status: Approved
Question	Q.15	<p>Comment: Common area service riser access panels are provided with a proprietary steel door/frameset. The panels are labelled as one-hour fire rated, and the Palco website has a fire assessment which indicates 2 hours integrity only. The panels are not tested, and in any case, require insulation as well as integrity (90 minutes for protected shafts).</p> <p>Recommendation: Access panels with the appropriate fire resistance should be provided to the services risers throughout - estimated number 100</p>

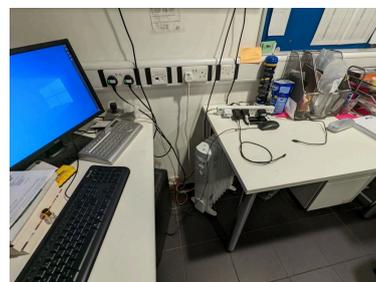
Comment: The use of multi-way adaptors and/or extension leads observed during the inspection was not considered acceptable. Multi-way plug adaptors were seen in regular use within the management office.

Recommendation: Additional fixed sockets should be provided in the locations noted within the common areas to limit the use of adaptors and leads.

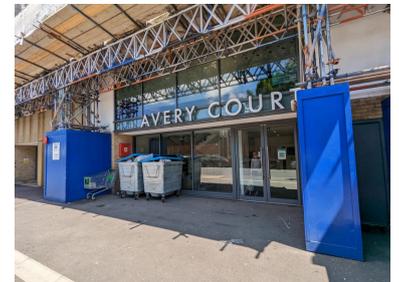
Comment: Integral bin storage rooms are provided within each block (accessed off of the ground floor lobbies), however, bins were being stored outside of these rooms at the time of inspection (located against the front of the building). The location of the bins was also blocking access to the dry riser inlet.

Recommendation: The Paladin/wheelie bins currently outside the designated bin storage area/ room should be relocated inside.

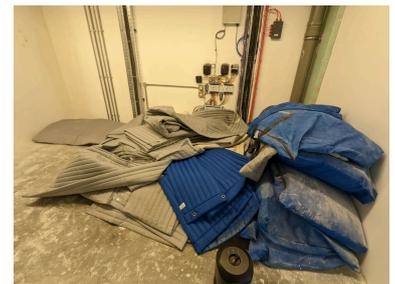
Comment: A sample of electrical intake/meter cupboards were inspected and combustible items were noted close to an ignition source/ electrical equipment. A large quantity of passenger lift protection sheets were being stored within the 2nd floor electrical meter cupboard (lift lobby of Avery Court 1 - 62); contractor equipment/refuse was being stored within the 1st floor electrical intake/meter cupboard (opposite Flat 9). This issue should be dealt with as soon as possible.

Recommendation: All combustible items should be removed from the electrical intake cupboard as soon as possible and the door kept locked.

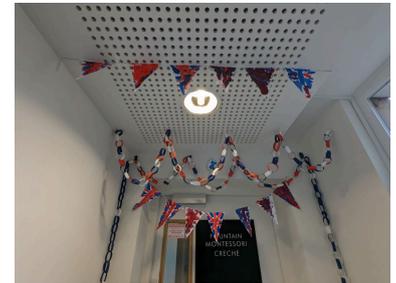
Comment: There were combustible items or waste materials in the escape routes: A refuse bin was located within the ground floor entrance of Avery Court 1 - 62; bunting/decorations were hung outside the entrance door to the Fountain Montessori Creche (1st floor - Avery Court 1 - 62). The previous recommendation has been approved however; combustibles are still being stored in escape routes. Management should reinforce the policy

Recommendation: Management should inform the Fountain Montessori Creche that combustible materials must not be stored within the common areas (including bunting/decorations) and these items should be removed. A programme of regular checks should be put in place to ensure that the common area is kept clear.

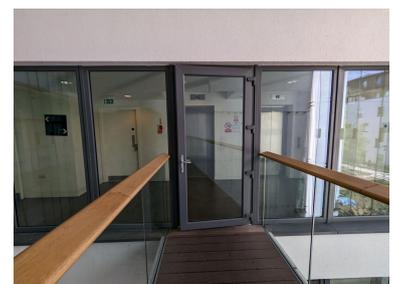
Question - K.5: Are doors on escape routes easily opened (and are sliding or revolving doors avoided)?	No
Comment: Some doors along the escape routes are fitted with locks which require the use of a key to open them and may not be suitable for means of escape - the door along the link balcony leading into the 3rd floor lift lobby of 1 - 62 Avery Court; the 2 doors on the 5th floor (106 - 140 Avery Court) which lead from the external balcony approach of Flats 138 & 139 into the main building.

Recommendation: The locking devices fitted to the doors along escape routes (as noted) should be removed or replaced with locks which can be easily opened without the use of a key.			
Priority: A	Known Quantity: 3	Potential Quantity: 3	Action ID: 844109

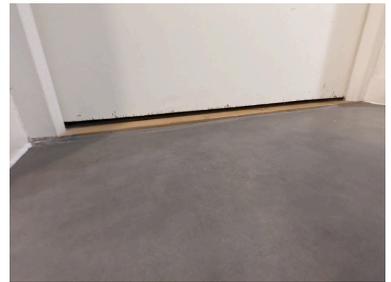
Comment: Fire rated flat entrance doors and frames appear to be in good condition except for: - The flat entrance door to Flat 66 has an excessive threshold gap (12mm) noted under the door which will not resist the passage of cold smoke.

Recommendation: The flat entrance door noted should be repaired (or if necessary replaced) to reduce the threshold gap to a maximum of 3mm. Alternatively, a threshold seal capable of resisting cold smoke should be fitted.

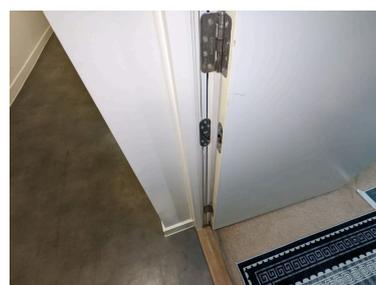
Comment: Network Homes advises that flat entrance doors are checked for adequacy (including self-closers and intumescent strips and smoke seals) as part of a rolling programme. The self closing mechanism fitted to the flat entrance door to Flat 5 (sampled flat) was damaged/ disconnected from the door. The self closing mechanism fitted to the flat entrance door to Flat 87 requires adjustment as the door slams shut (which may lead to damaged to the door/frame). All other flat entrance doors sampled at the time of my inspection were fitted with adequate self closing mechanisms (Flats 7, 67, 83, 84, 110, 111, 115, 121 & 130). No access to other flats.

Recommendation: An effective self-closing device should be fitted to the flat entrance door to Flat 5 as noted.

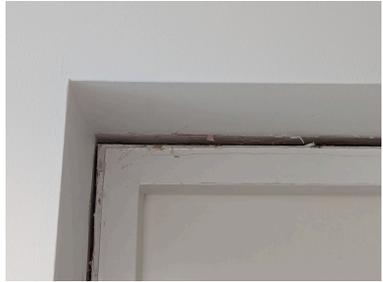
Comment: Firestopping was missing or inadequate around the door frame of Flat 34.

Recommendation: Adequate firestopping should be provided/replaced around the door frame of Flat 34 as noted using a suitable material such as an intumescent paste to ensure 30 minutes fire resistance is achieved.

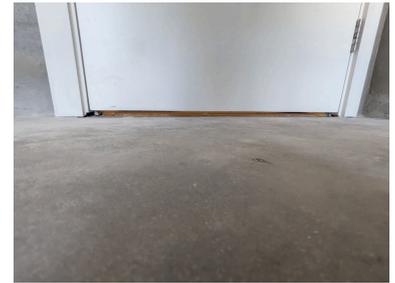
Comment: The following issues were noted to common area fire doors: - Excessive perimeter and/or threshold gaps were noted to a large number of common area fire doors throughout the building including stairwell doors, electrical riser cupboard doors, cross corridor doors, etc. It was evident at the time of my inspection that the issues identified within the previous report had not been rectified and additional issues were also noted. Management confirmed that they were aware the issues noted and that a full fire door survey is being carried out to identify/rectify all defects to common area fire doors. - The management office door (mezzanine level within 1-62 Avery Court) did not fully self close into the frame as the base of the door become wedged open on the tiled floor. - The 3rd floor stairwell door (106 - 140 Avery Court) was misaligned with the frame and could not close flush into the frame.

Recommendation: Management to ensure that a full fire door survey is carried out by an FDIS consultant on the common area fire doors throughout the building in order to identify/rectify all defects.

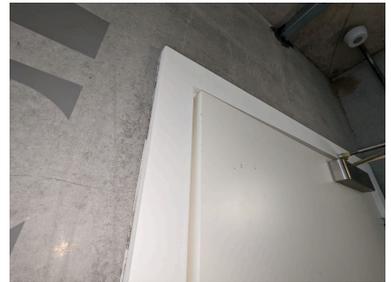
Comment: Not all common area fire doors are fitted with adequate self-closing devices where required - The self closing mechanisms fitted to the cross corridor doors adjacent to Flats 13, 66, 72, 91 and 113 as well as the stairwell doors adjacent to Flats 68, 92, 101 and 137 do not fully self close the doors into the frames. - There were no self closing mechanisms fitted to the 2 x common area fire doors within the management office. Management confirms via the Riskhub Client Portal that the previous recommendation is Assigned so this has been marked as Unresolved.

Recommendation: The self-closing devices should be repaired or effective self-closing devices should be fitted to the doors as noted (cross corridor doors adjacent to Flats 72, 91 and 113 as well as the stairwell doors adjacent to Flats 68, 92, 101 and 137) N.B. - The action from the previous report covered the cross corridor doors adjacent to Flats 13 and 66 and this has been marked as 'unresolved'.

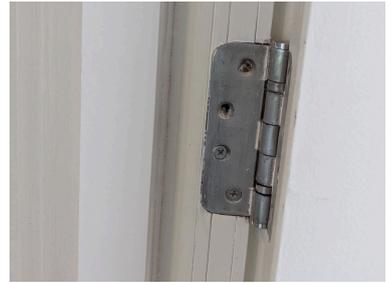
Comment: Other common area fire door issues noted at the time of inspection include - - The stairwell door on the 5th floor (63-105 Avery Court) was noted being wedged open or otherwise obstructed at the time of inspection. There were contractors on carrying out work on the 5th floor, however, doors must not be wedged open. The wedges/obstructions were removed by or for the assessor at the time of inspection. - There were screws missing from the door hinges to some common area fire doors (3rd floor stairwell door (1-62 Avery Court) and the cross corridor door adjacent to Flat 13). - The door handle was missing from the 1st floor stairwell door (63 - 105 Avery Court - adjacent to the lift). As a result residents would not be able to access the protected stairwell (leading to the final exit) from the 1st floor landing.

Recommendation: The missing screws should be replaced to the 3rd floor stairwell door (1-62 Avery Court).

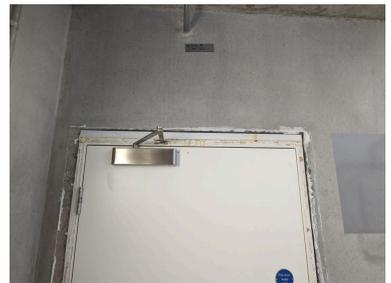
Comment: Firestopping was missing or inadequate to the back of the frame of common area fire doors as noted:- 5th floor stairwell door (adjacent to Flat 140). Management confirms via the Riskhub Client Portal that the previous recommendation is Assigned so this has been marked as Unresolved

Recommendation: Adequate firestopping should be provided/replaced to the back of the frame of the common area fire door set as noted using a suitable material such as an intumescent paste to ensure 30 minutes fire resistance is achieved.

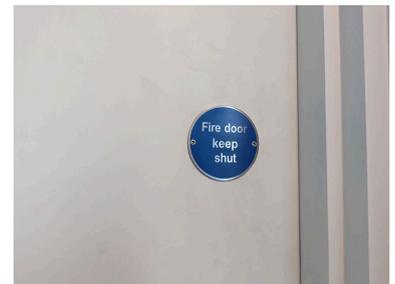
Comment: Fire door signage is not considered adequate: - Some common area fire doors which are fitted with magnetic hold open devices are also fitted with with inappropriate 'fire door keep shut' signage. These signs should be replaced with the appropriate 'Automatic fire door keep clear' signage: lobby door leading to Flats 16-18, lobby door leading to Flats 19-20, lobby door leading to Flats 21-23, lobby door leading to Flats 24-25, lobby door leading to Flats 39-41, lobby door leading to Flats 42-43, cross corridor door adjacent to Flat 57, cross corridor door adjacent to Flat 104 and the 2nd floor double doors leading to the balcony/atrium (63 - 105 Avery Court). - All electrical intake/meter cupboards throughout the building were fitted with 'fire door keep shut' signage, however, these should be replaced with 'fire door keep locked shut' signage. - An 'automatic fire door keep clear' sign was fitted to the management office door, however, there is no hold open device fitted to the door and this should be replaced with a 'fire door keep shut' sign. Management confirms via the Riskhub Client Portal that the previous recommendation is Assigned so this has been marked as Unresolved.

Recommendation: Replace the incorrect 'fire door keep shut' signage with 'Fire door keep locked' signage to all electrical intake/meter cupboards as noted.

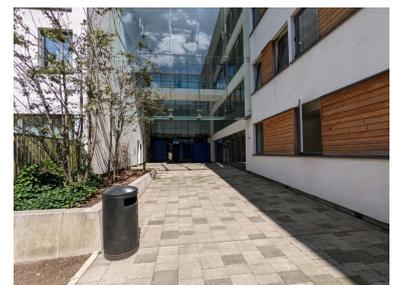
Comment: Directional and exit signage is not considered adequate: - There is no directional/exit signage located within the enclosed central courtyard. This forms part of the means of escape from the property and a number of doors from each block discharge into this central courtyard with no clear exit route signed for residents. Directional/exit signage is required to direct residents to the doorway of 1-62 Avery Court where the means of escape continues onwards to the ground floor final exit of this block. - The directional signage located on the 1st, 2nd, 3rd and 4th floors within 1-62 Avery Court is unclear. There are illuminated fire exit signs fitted to the ceilings within the flat lobbies, however, due to the fact that the signs are 2 sided and visible from within the lift lobbies they could cause confusion and lead residents in the wrong direction (into the flat lobby where there is no exit route rather than down the stairwell accessed off of the lift lobby). - There is no final exit signage located above the stairwell door on the 1st floor (within 1-62 Avery Court) this is required to direct residents down the stairwell to the ground floor and final exit.

Recommendation: Provide adequate exit and/or directional signage as noted.

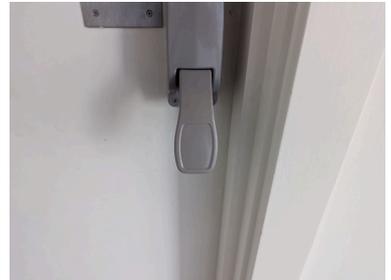
Comment: Other fire safety signs issues noted include: - The 'push to open' signage is faded/missing from the push pads fitted to stairwell doors throughout the building. This signage is required to illustrate how to open these doors fitted along the means of escape.

Recommendation: Provide 'Push to open' signage to the push pads fitted to the stairwell doors in all blocks.

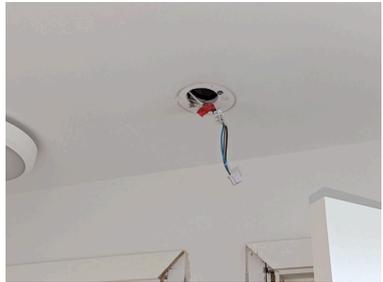
Comment: Network Homes advises that flats are checked for working hard-wired smoke alarms as part of a rolling programme: No suitable Grade D smoke alarm was noted in the entrance hallway of Flat 83. The wiring appears to be present, however, the Grade D alarm has been removed (N.B. - The flat is currently vacant whilst maintenance work is carried out within the flat to resolve a water ingress/damp issue); The Grade D smoke alarm fitted in the entrance hallway of Flat 7 is not securely fixed to the ceiling and some cables/wiring appear to be disconnected; Grade D smoke alarms were noted within the entrance hallways of sampled Flats 5, 67, 84, 87, 110, 111, 115, 1221 & 130); No access to other flats.

Recommendation: A Grade D1 LD2 smoke alarm system to BS 5839-6:2019 should be installed in Flat 83 as noted.

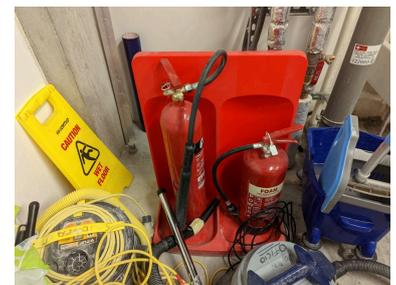
Comment: The provision of portable fire extinguishers is not considered appropriate in these premises. Management confirmed that there is no policy in place to provide fire extinguishers within staff/plant rooms within the building and that these extinguishers are believed to have been left here by contractors carrying out remedial works within the building. These extinguishers are not appropriate for the risks associated in these rooms and they have not been regularly serviced/maintained.

Recommendation: The fire extinguishers and associated signage should be removed from the electrical intake/meter cupboards as noted (Extinguishers located within the electrical intake/meter cupboard opposite Flat 9 and the electrical intake/meter cupboard opposite Flat 136) as management confirmed that there is no policy in place to provide fire extinguishers within staff/plant rooms within the building and that these extinguishers are believed to have been left here by contractors carrying out remedial works within the building (extinguishers are not appropriate for the risks associated in these rooms and they have not been regularly serviced/maintained) - Estimated number of extinguishers to remove is 5
